## Site: High Street, Dilhorne

## Section 4

## Descriptive Report with Remarks and Observation Images

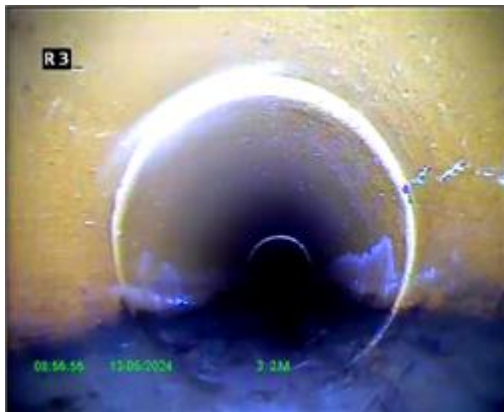
| Pos | Video Ref | Code | Description | Image |
|---|---|---|---|---|
| 03.20m | 0:00:20 | JDM | Joint displaced medium - Severity 3 | Image Provided - Ref: 2_4<br> |

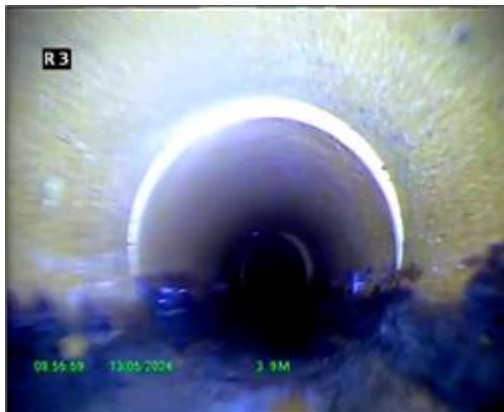
| Pos | Video Ref | Code | Description | Image |
|---|---|---|---|---|
| 03.90m | 0:00:23 | JDM | Joint displaced medium - Severity 3 | Image Provided - Ref: 2_5<br> |

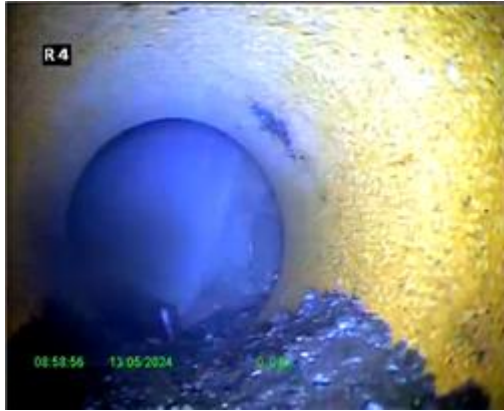
| Pos | Video Ref | Code | Description | Image |
|---|---|---|---|---|
| 00.00m | 0:00:00 | DES | Settled deposits fine: 10% Cross sectional area loss - Severity 3 | Image Provided - Ref: 3_2<br> |

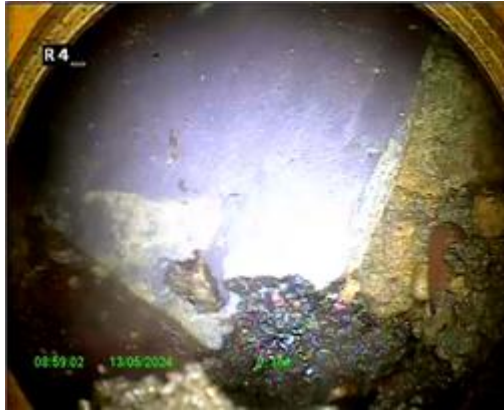
| Pos | Video Ref | Code | Description | Image |
|---|---|---|---|---|
| 00.10m | | SA | Survey abandoned EOT- Unable to Camera Further. Unknown Endpoint Reached | Image Provided - Ref: 3_9999<br> |

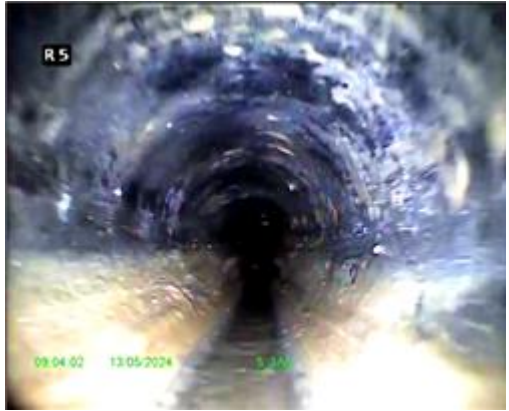
| Pos | Video Ref | Code | Description | Image |
|---|---|---|---|---|
| 05.30m | 0:00:26 | S1 DEG | Attached deposits, grease<br>5.3m - 12.2m from 04 o'clock<br>to 08 o'clock: 5% Cross<br>sectional area loss - Severity 3 | Image Provided - Ref: 4_4<br> |

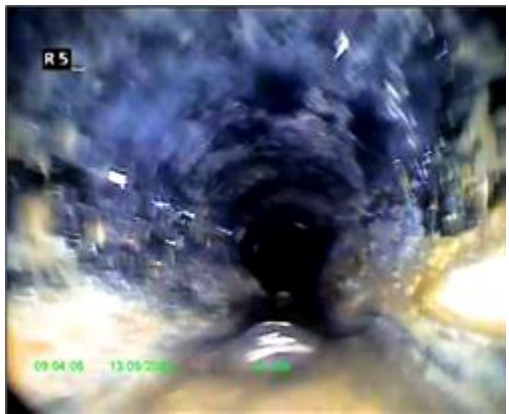
| Pos | Video Ref | Code | Description | Image |
|---|---|---|---|---|
| 06.50m | 0:00:30 | DEG | Attached deposits, grease at 06 o'clock: 10% Cross sectional area loss - Severity 3 | Image Provided - Ref: 4_3<br> |

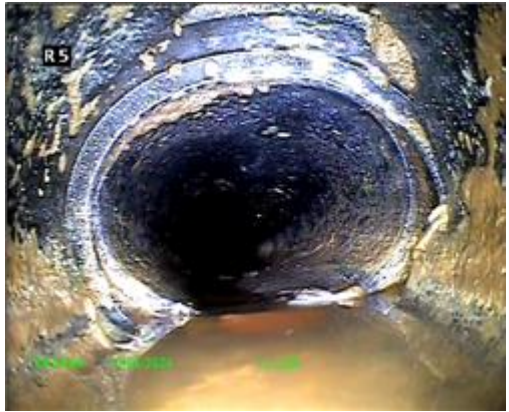
| Pos | Video Ref | Code | Description | Image |
|---|---|---|---|---|
| 12.20m | 0:01:08 | JDM | Joint displaced medium - Severity 3 | Image Provided - Ref: 4_6<br> |

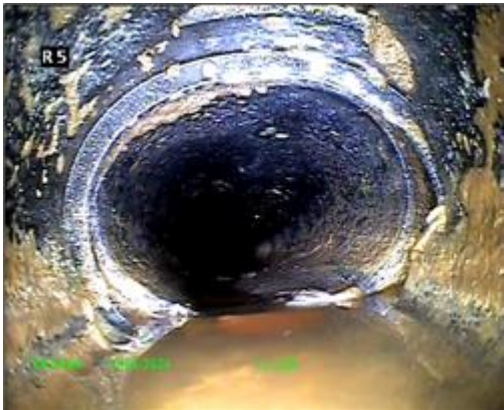
| Pos | Video Ref | Code | Description | Image |
|---|---|---|---|---|
| 12.20m | 0:01:08 | D | Deformed drain/sewer: 15% Height/Diameter - Severity 4 | <p>Image Provided - Ref: 4_7</p> |

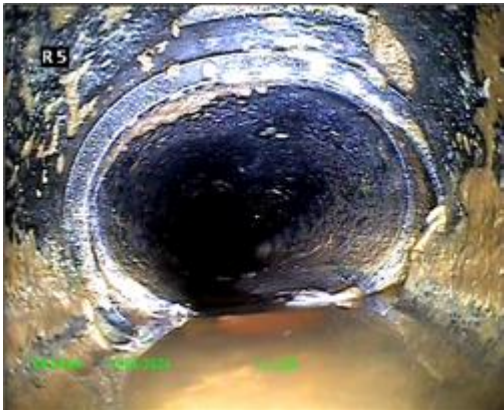
| Pos | Video Ref | Code | Description | Image |
|---|---|---|---|---|
| 12.30m | | SA | Survey abandoned EOT- Unable to Camera Further Due to Deformed Sewer | <p>Image Provided - Ref: 4_9999</p> |

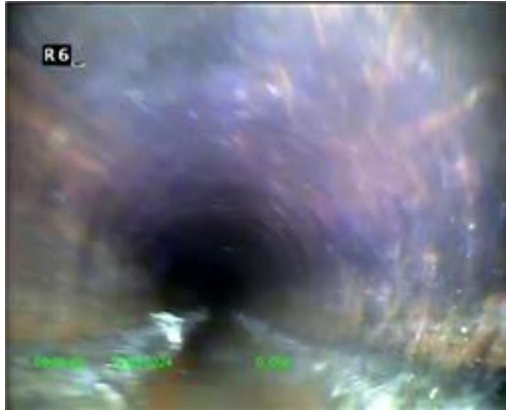
| Pos | Video Ref | Code | Description | Image |
|---|---|---|---|---|
| 00.00m | 0:00:04 | DEG | Attached deposits, grease from 05 o'clock to 07 o'clock: 5% Cross sectional area loss - Severity 3 | Image Provided - Ref: 5_3<br> |

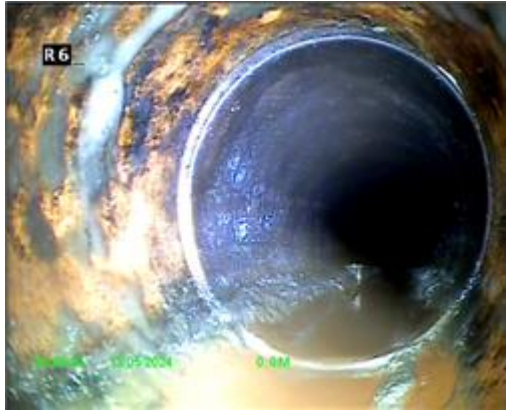
| Pos | Video Ref | Code | Description | Image |
|---|---|---|---|---|
| 00.10m | 0:00:00 | LRQ | Line of drain/sewer deviates right [quarter] | Image Provided - Ref: 5_2<br> |

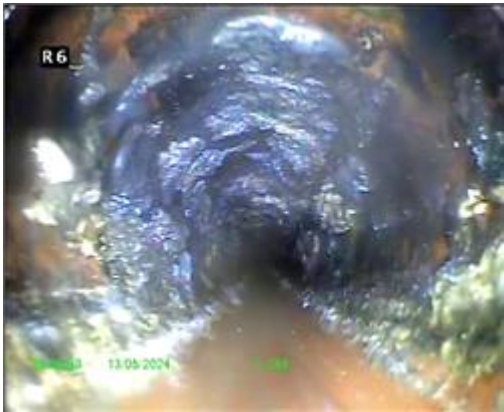
| Pos | Video Ref | Code | Description | Image |
|---|---|---|---|---|
| 01.20m | 0:00:10 | DEG | Attached deposits, grease from 01 o'clock to 12 o'clock: 10% Cross sectional area loss - Severity 3 | Image Provided - Ref: 5_4<br> |

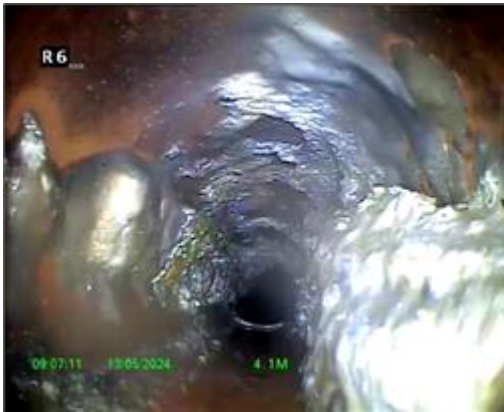
| Pos | Video Ref | Code | Description | Image |
|---|---|---|---|---|
| 04.10m | 0:00:28 | DEG | Attached deposits, grease from 01 o'clock to 12 o'clock: 30% Cross sectional area loss - Severity 3 | Image Provided - Ref: 5_5<br> |

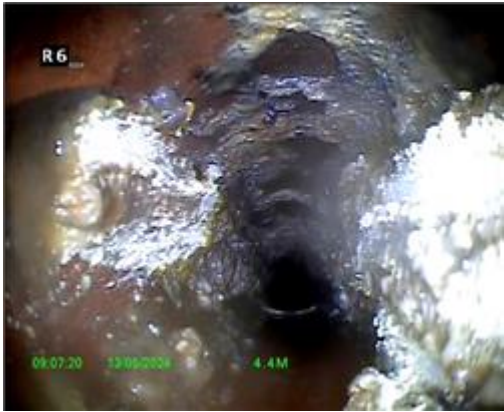
| Pos | Video Ref | Code | Description | Image |
|---|---|---|---|---|
| 04.40m | | SA | Survey abandoned EOT- Unable to Camera Further Due to Grease | Image Provided - Ref: 5_9999<br> |

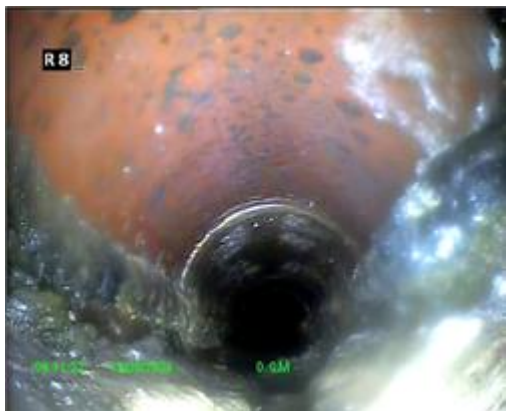
| Pos | Video Ref | Code | Description | Image |
|---|---|---|---|---|
| 00.00m | 0:00:00 | DES | Settled deposits fine: 20% Cross sectional area loss - Severity 3 | Image Provided - Ref: 7_2<br> |

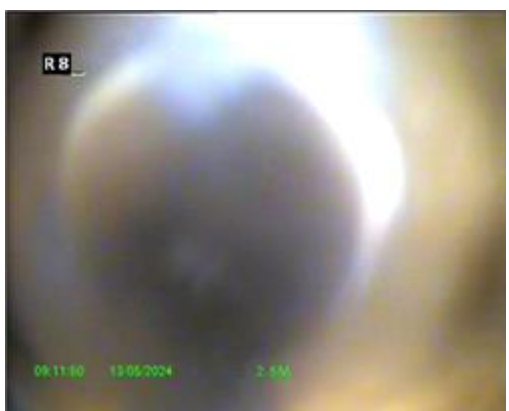
| Pos | Video Ref | Code | Description | Image |
|---|---|---|---|---|
| 02.50m | 0:00:18 | JDM | Joint displaced medium - Severity 3 | Image Provided - Ref: 7_3<br> |

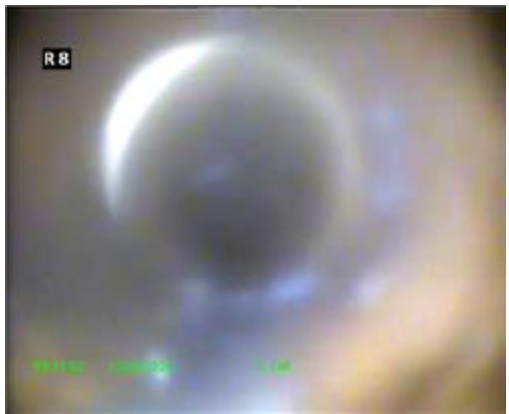
| Pos | Video Ref | Code | Description | Image |
|---|---|---|---|---|
| 03.10m | 0:00:19 | JDM | Joint displaced medium - Severity 3 | <p>Image Provided - Ref: 7_4</p> |

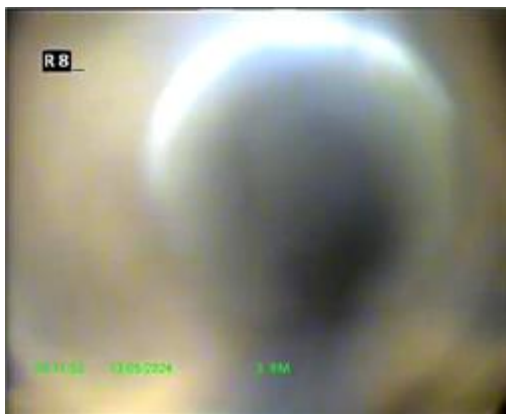
| Pos | Video Ref | Code | Description | Image |
|---|---|---|---|---|
| 03.90m | 0:00:21 | JDM | Joint displaced medium - Severity 3 | <p>Image Provided - Ref: 7_5</p> |

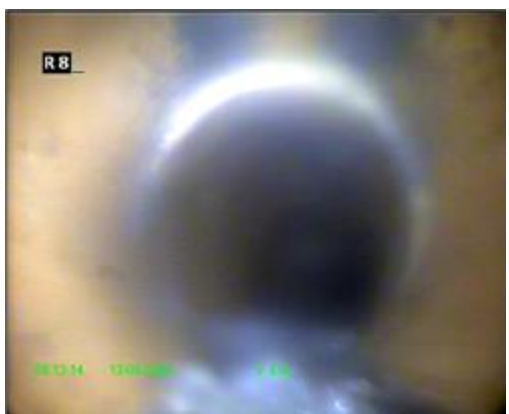
| Pos | Video Ref | Code | Description | Image |
|---|---|---|---|---|
| 09.80m | 0:00:41 | JDM | Joint displaced medium - Severity 3 | <p>Image Provided - Ref: 7_6</p> |

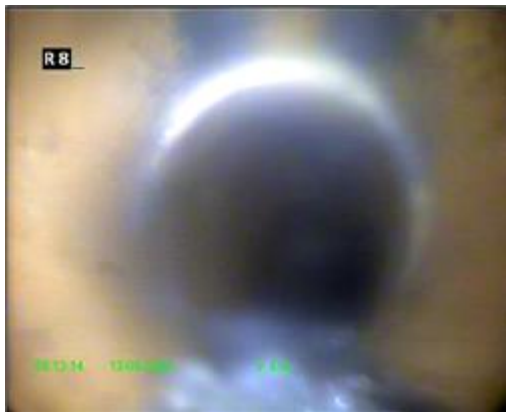
| Pos | Video Ref | Code | Description | Image |
|---|---|---|---|---|
| 09.80m | 0:00:41 | DES | Settled deposits fine: 10%<br>Cross sectional area loss -<br>Severity 3 | <p>Image Provided - Ref: 7_7</p> |

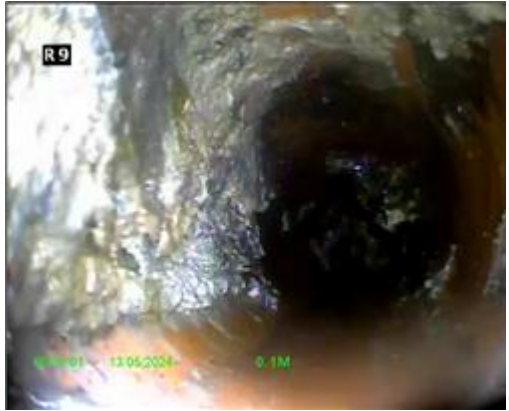
| Pos | Video Ref | Code | Description | Image |
|---|---|---|---|---|
| 00.10m | 0:00:00 | DEG | Attached deposits, grease from 07 o'clock to 05 o'clock: 20% Cross sectional area loss - Severity 3 | Image Provided - Ref: 8_2<br> |

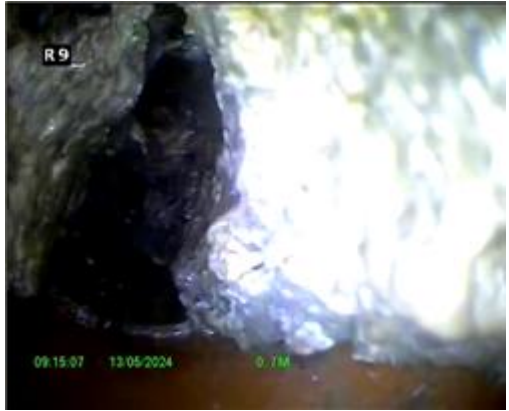
| Pos | Video Ref | Code | Description | Image |
|---|---|---|---|---|
| 00.70m | 0:00:06 | DEG | Attached deposits, grease from 07 o'clock to 06 o'clock: 50% Cross sectional area loss - Severity 3 | Image Provided - Ref: 8_3<br> |
