## Descriptive Report with Remarks and Observation Images

## Site: High Street, Dilhorne

## Section 11

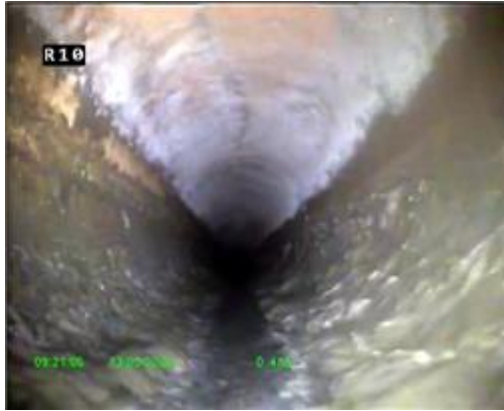
| Pos | Video Ref | Code | Description | Image |
|---|---|---|---|---|
| 00.40m | 0:00:05 | S1 DEG | Attached deposits, grease 0.4m - 36m from 03 o'clock to 08 o'clock: 5% Cross sectional area loss - Severity 3 | Image Provided - Ref: 9_2<br> |

| Pos | Video Ref | Code | Description | Image |
|---|---|---|---|---|
| 36.00m | 0:00:05 | F1 DEG | Attached deposits, grease<br>Defect End from 03 o'clock to<br>08 o'clock: 5% Cross sectional<br>area loss - Severity 3 | |

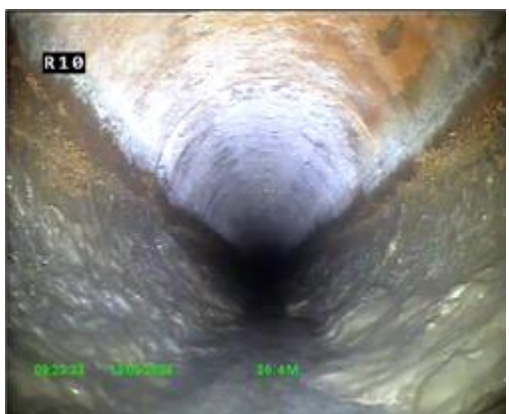
| Pos | Video Ref | Code | Description | Image |
|---|---|---|---|---|
| 36.00m | 0:02:28 | DEG | Attached deposits, grease from<br>04 o'clock to 06 o'clock: 15%<br>Cross sectional area loss -<br>Severity 3 | |
| 36.40m | | SA | Survey abandoned<br>EOT- Unable to Camera<br>Further Due to Restricted<br>Leverage | Image Provided - Ref: 9_9999<br> |

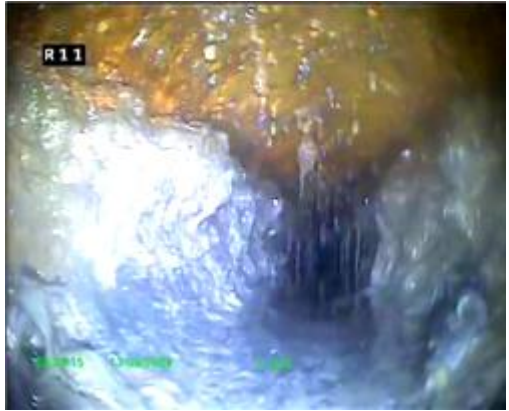
| Pos | Video Ref | Code | Description | Image |
|---|---|---|---|---|
| 00.00m | 0:00:00 | DEG | Attached deposits, grease from 02 o'clock to 10 o'clock: 20% Cross sectional area loss - Severity 3 | Image Provided - Ref: 10_2<br> |

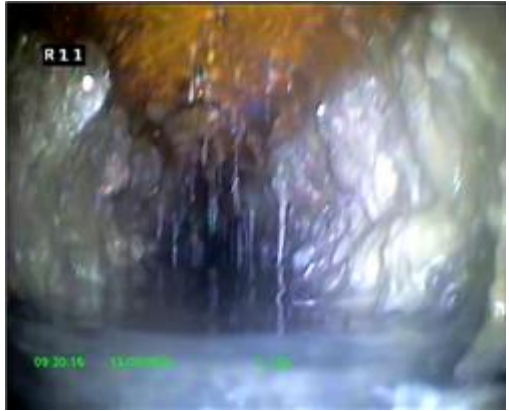
| Pos | Video Ref | Code | Description | Image |
|---|---|---|---|---|
| 00.20m | 0:00:01 | WL | Water level: 30% Height/Diameter | Image Provided - Ref: 10_3<br> |

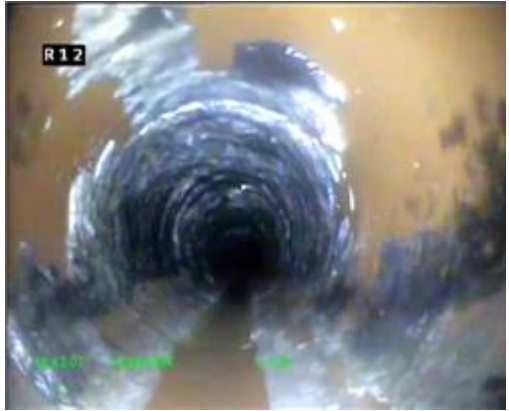
| Pos | Video Ref | Code | Description | Image |
|---|---|---|---|---|
| 00.00m | 0:00:00 | DEG | Attached deposits, grease from 01 o'clock to 12 o'clock: 5% Cross sectional area loss - Severity 3 | Image Provided - Ref: 11_2<br> |

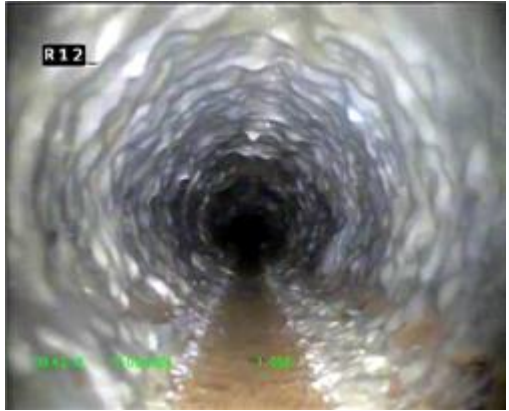
| Pos | Video Ref | Code | Description | Image |
|---|---|---|---|---|
| 01.00m | 0:00:08 | S1 DEG | Attached deposits, grease 1m - 7.9m from 07 o'clock to 05 o'clock: 15% Cross sectional area loss - Severity 3 | Image Provided - Ref: 11_3<br> |

| Pos | Video Ref | Code | Description | Image |
|---|---|---|---|---|
| 07.90m | 0:00:08 | F1 DEG | Attached deposits, grease<br>Defect End from 07 o'clock to 05 o'clock: 15% Cross sectional area loss - Severity 3 | |

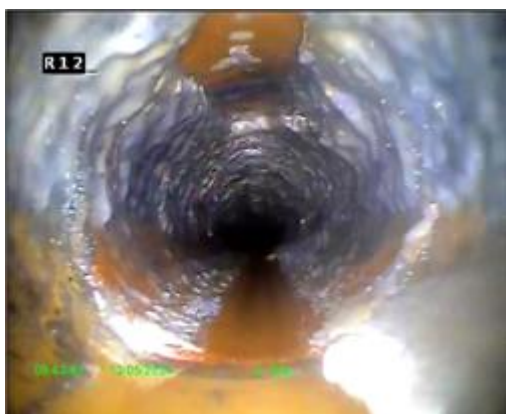
| Pos | Video Ref | Code | Description | Image |
|---|---|---|---|---|
| 04.30m | 0:00:34 | JDM | Joint displaced medium - Severity 3 | Image Provided - Ref: 11_6<br> |

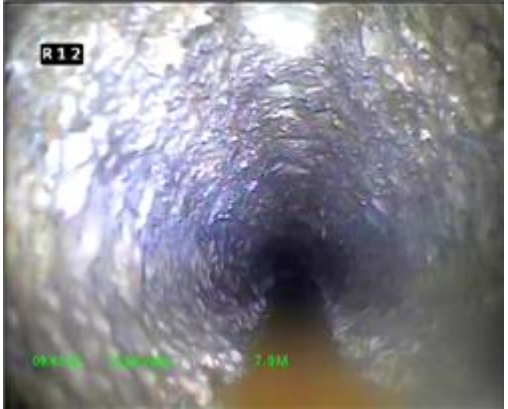
| Pos | Video Ref | Code | Description | Image |
|---|---|---|---|---|
| 07.90m | 0:00:48 | DEG | Attached deposits, grease from 07 o'clock to 05 o'clock: 20% Cross sectional area loss - Severity 3 | Image Provided - Ref: 11_7<br> |

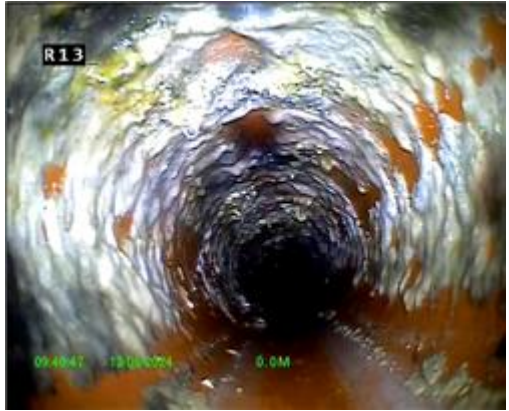
| Pos | Video Ref | Code | Description | Image |
|---|---|---|---|---|
| 00.00m | 0:00:00 | DEG | Attached deposits, grease from 07 o'clock to 04 o'clock: 5% Cross sectional area loss - Severity 3 | Image Provided - Ref: 12_2<br> |

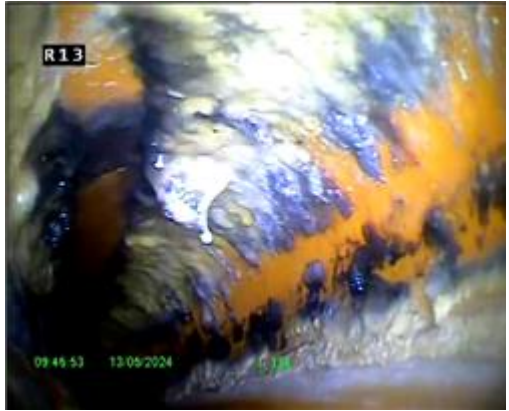
| Pos | Video Ref | Code | Description | Image |
|---|---|---|---|---|
| 01.10m | 0:00:06 | LLH | Line of drain/sewer deviates left [half] | Image Provided - Ref: 12_3<br> |

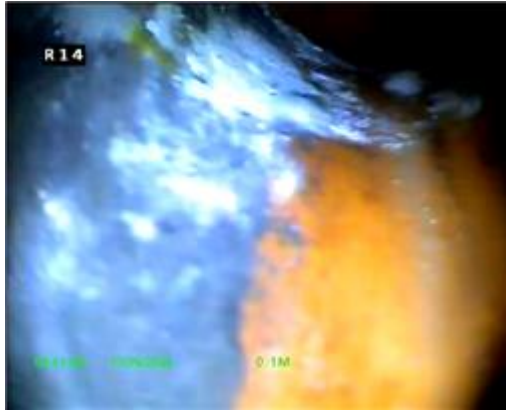
| Pos | Video Ref | Code | Description | Image |
|---|---|---|---|---|
| 00.10m | 0:00:02 | LUH | Line of drain/sewer deviates up [half] | Image Provided - Ref: 13_2<br> |

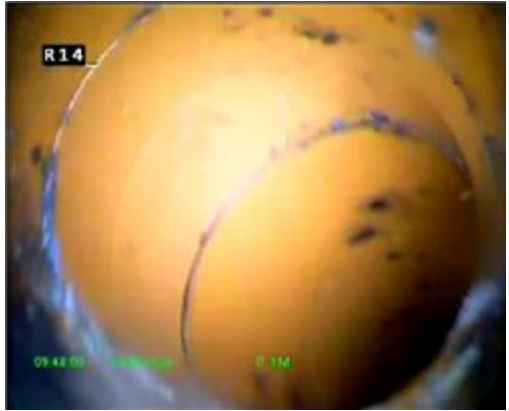
| Pos | Video Ref | Code | Description | Image |
|---|---|---|---|---|
| 00.20m | 0:00:04 | LRH | Line of drain/sewer deviates right [half] | Image Provided - Ref: 13_3<br> |

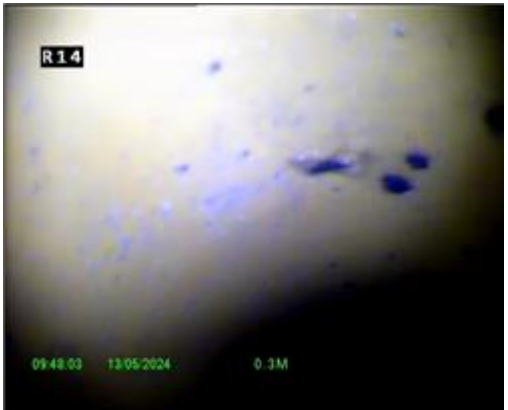
| Pos | Video Ref | Code | Description | Image |
|---|---|---|---|---|
| 00.30m | 0:00:06 | LDQ | Line of drain/sewer deviates down [quarter] | <p>Image Provided - Ref: 13_4</p> |

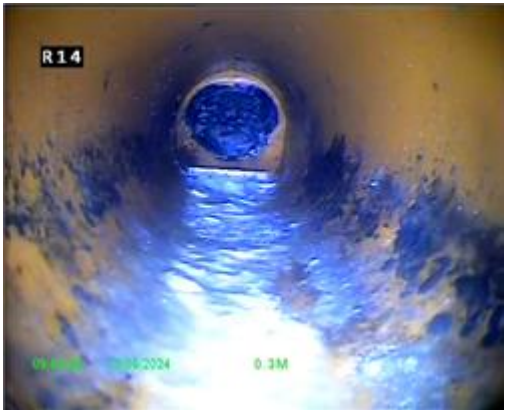
| Pos | Video Ref | Code | Description | Image |
|---|---|---|---|---|
| 00.30m | 0:00:09 | DEG | Attached deposits, grease from 05 o'clock to 07 o'clock: 5% Cross sectional area loss - Severity 3 | <p>Image Provided - Ref: 13_5</p> |

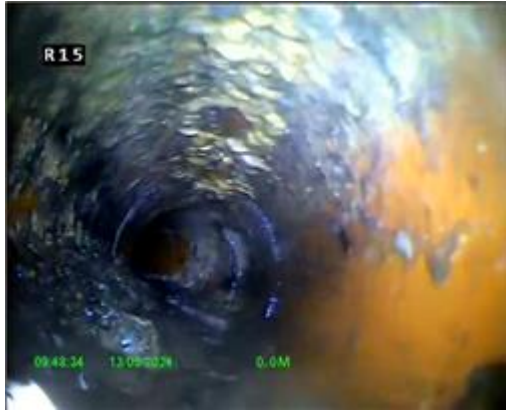
| Pos | Video Ref | Code | Description | Image |
|---|---|---|---|---|
| 00.00m | 0:00:00 | DEG | Attached deposits, grease from 05 o'clock to 02 o'clock: 10% Cross sectional area loss - Severity 3 | Image Provided - Ref: 14_2<br> |

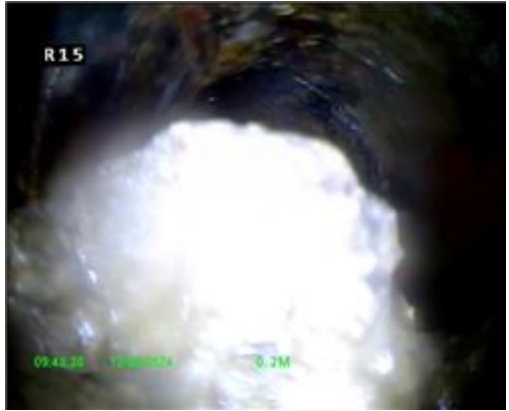
| Pos | Video Ref | Code | Description | Image |
|---|---|---|---|---|
| 00.20m | 0:00:04 | LLH | Line of drain/sewer deviates left [half] | Image Provided - Ref: 14_3<br> |
