## Site: High Street, Dilhorne

## Section 16

## Descriptive Report with Remarks and Observation Images

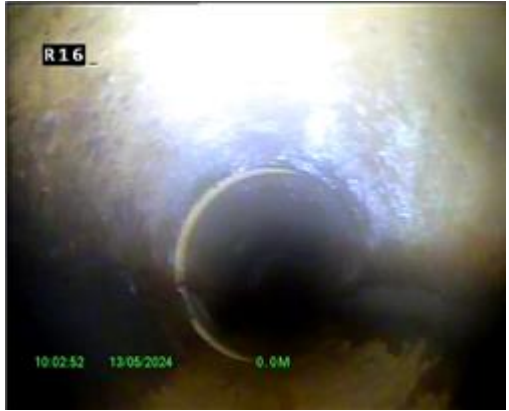
| Pos | Video Ref | Code | Description | Image |
|---|---|---|---|---|
| 00.00m | 0:00:00 | WL | Water level: 0% Height/Diameter | Image Provided - Ref: 15_1<br> |

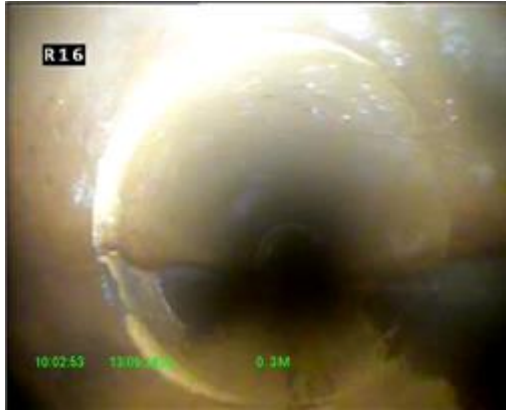
| Pos | Video Ref | Code | Description | Image |
|---|---|---|---|---|
| 00.30m | 0:00:01 | JDM | Joint displaced medium - Severity 3 | Image Provided - Ref: 15_2<br> |

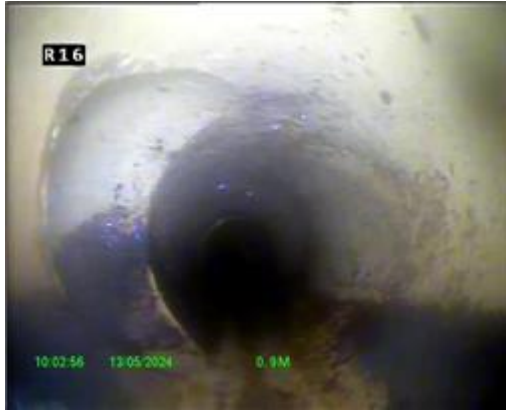
| Pos | Video Ref | Code | Description | Image |
|---|---|---|---|---|
| 00.90m | 0:00:04 | JN | Junction at 09 o'clock: 100mm Diameter | Image Provided - Ref: 15_3<br> |

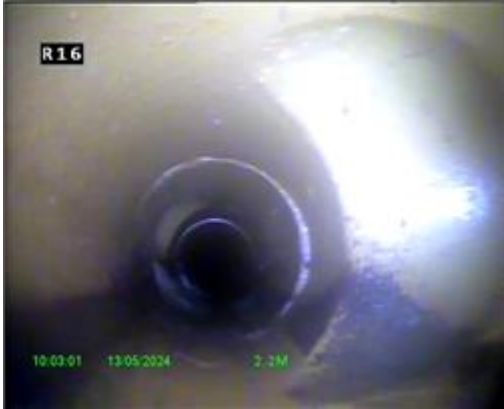
| Pos | Video Ref | Code | Description | Image |
|---|---|---|---|---|
| 02.20m | 0:00:08 | JN | Junction at 03 o'clock: 100mm Diameter | <p>Image Provided - Ref: 15_4</p> |

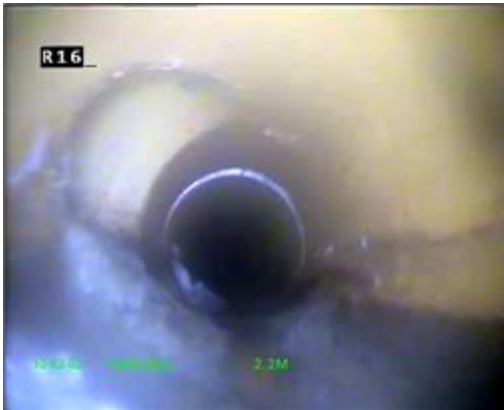
| Pos | Video Ref | Code | Description | Image |
|---|---|---|---|---|
| 02.20m | 0:00:10 | DES | Settled deposits fine: 10% Cross sectional area loss - Severity 3 | <p>Image Provided - Ref: 15_5</p> |

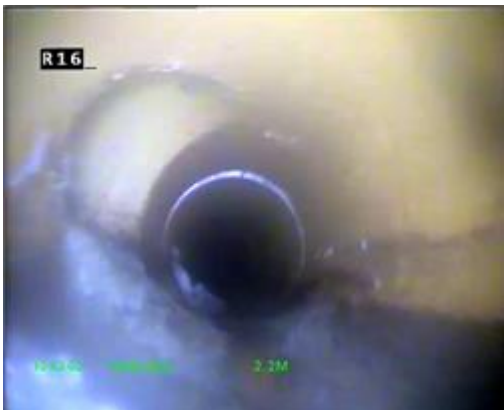
| Pos | Video Ref | Code | Description | Image |
|---|---|---|---|---|
| 02.40m | 0:00:10 | JN | Junction at 09 o'clock: 100mm Diameter | <p>Image Provided - Ref: 15_6</p> |

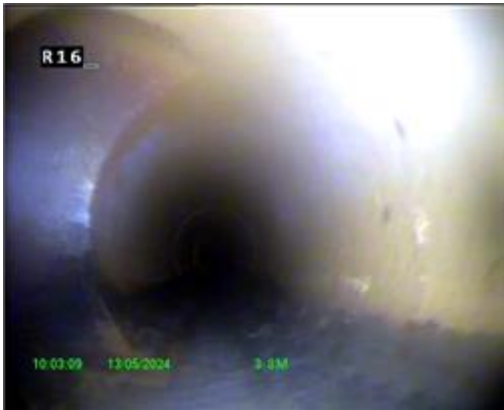
| Pos | Video Ref | Code | Description | Image |
|---|---|---|---|---|
| 03.80m | 0:00:17 | JN | Junction at 09 o'clock: 100mm Diameter | <p>Image Provided - Ref: 15_7</p> |

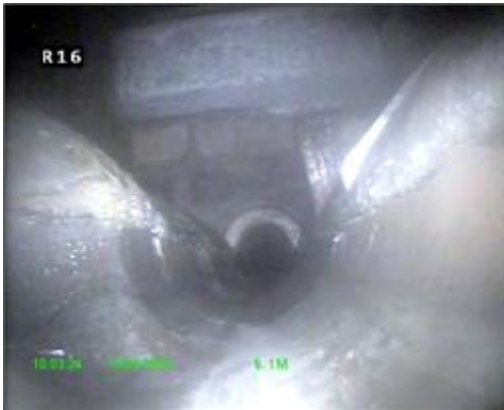
| Pos | Video Ref | Code | Description | Image |
|---|---|---|---|---|
| 06.10m | | MHF | Finish node type, manhole MH 7 Reached | <p>Image Provided - Ref: 15_9999</p> |

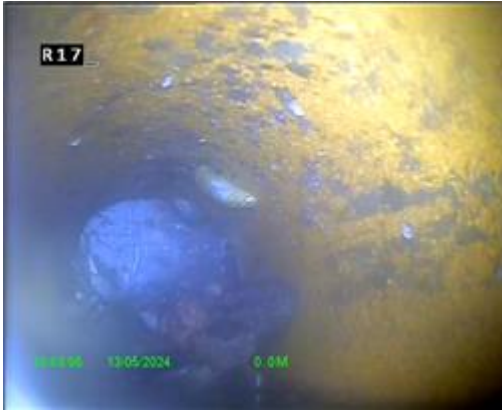
| Pos | Video Ref | Code | Description | Image |
|---|---|---|---|---|
| 00.00m | 0:00:00 | WL | Water level: 0% Height/Diameter | Image Provided - Ref: 16_1<br> |

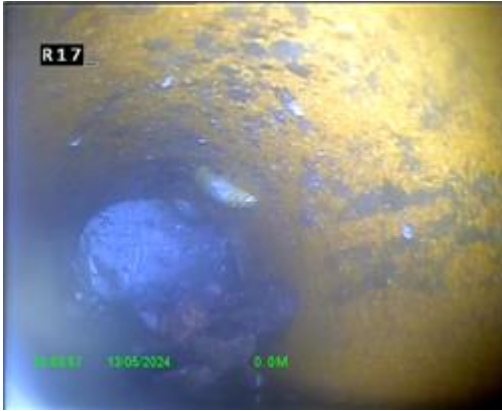
| Pos | Video Ref | Code | Description | Image |
|---|---|---|---|---|
| 00.00m | 0:00:01 | DER | Settled deposits coarse: 20% Cross sectional area loss - Severity 3 | Image Provided - Ref: 16_2<br> |

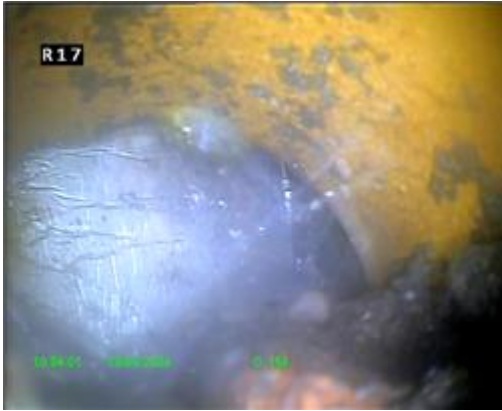
| Pos | Video Ref | Code | Description | Image |
|---|---|---|---|---|
| 00.10m | | SA | Survey abandoned EOT- Unable to Camera Further, Unknown End Reached | Image Provided - Ref: 16_9999<br> |

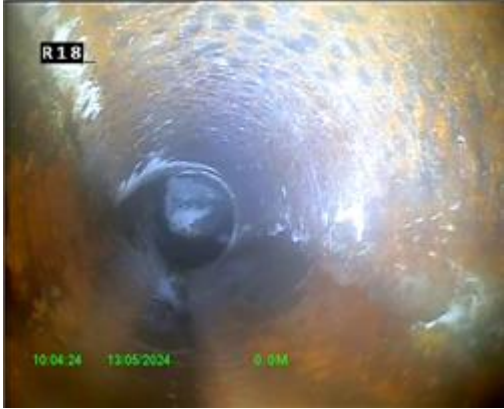
| Pos | Video Ref | Code | Description | Image |
|---|---|---|---|---|
| 00.00m | 0:00:00 | WL | Water level: 0% Height/Diameter | Image Provided - Ref: 17_1<br> |

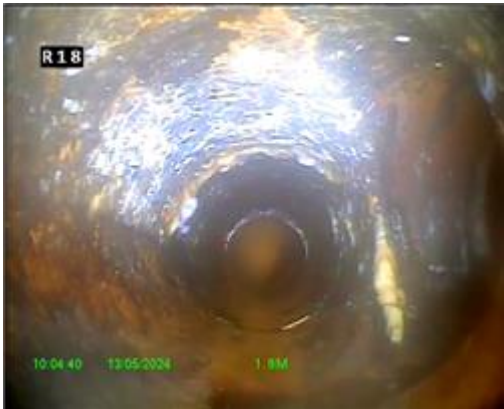
| Pos | Video Ref | Code | Description | Image |
|---|---|---|---|---|
| 01.90m | 0:00:15 | JN | Junction at 03 o'clock: 100mm Diameter | Image Provided - Ref: 17_3<br> |

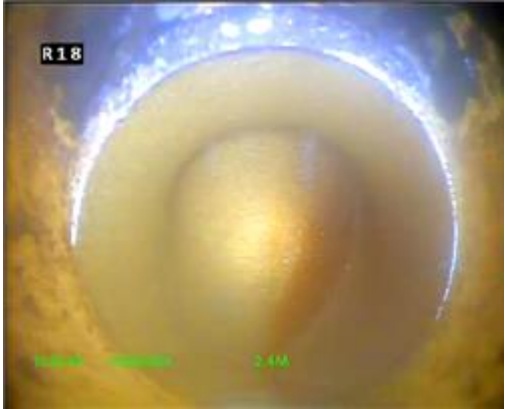
| Pos | Video Ref | Code | Description | Image |
|---|---|---|---|---|
| 02.40m | 0:00:18 | JDM | Joint displaced medium - Severity 3 | <p>Image Provided - Ref: 17_4</p> |

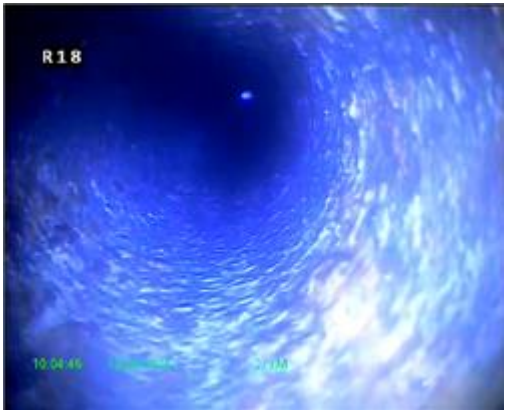
| Pos | Video Ref | Code | Description | Image |
|---|---|---|---|---|
| 02.90m | | OCF | Finish node type, other special chamber SVP Reached | <p>Image Provided - Ref: 17_9999</p> |

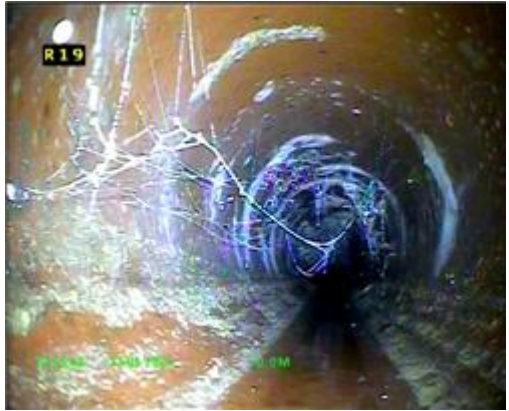
| Pos | Video Ref | Code | Description | Image |
|---|---|---|---|---|
| 00.00m | 0:00:00 | WL | Water level: 0% Height/Diameter | Image Provided - Ref: 18_1<br> |

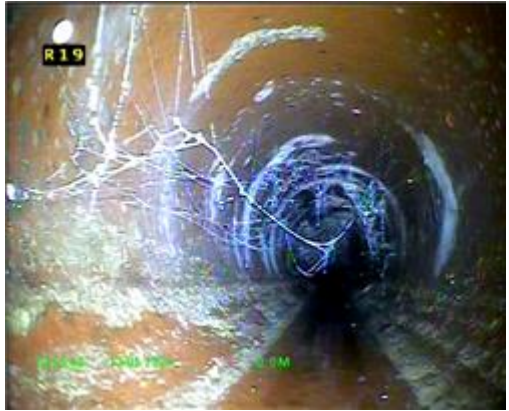
| Pos | Video Ref | Code | Description | Image |
|---|---|---|---|---|
| 00.00m | 0:00:00 | S1 DEG | Attached deposits, grease 0m - 43m from 05 o'clock to 07 o'clock: 5% Cross sectional area loss - Severity 3 | Image Provided - Ref: 18_2<br> |

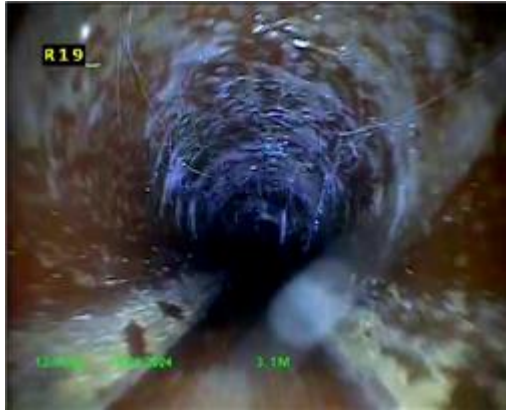
| Pos | Video Ref | Code | Description | Image |
|---|---|---|---|---|
| 03.10m | 0:00:14 | WL | Water level: 5% Height/Diameter | Image Provided - Ref: 18_3<br> |

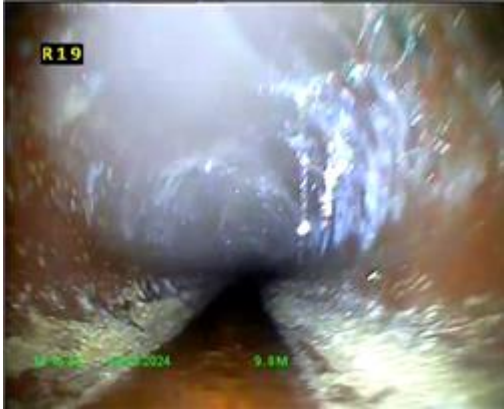
| Pos | Video Ref | Code | Description | Image |
|---|---|---|---|---|
| 09.80m | 0:00:45 | REM | General remark<br>General Condition Photo | Image Provided - Ref: 18_4<br> |

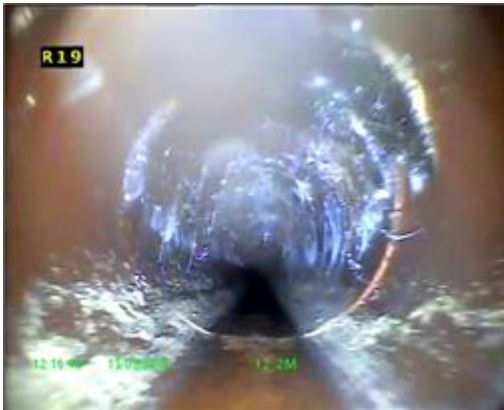
| Pos | Video Ref | Code | Description | Image |
|---|---|---|---|---|
| 12.20m | 0:00:55 | DEG | Attached deposits, grease from<br>07 o'clock to 03 o'clock: 5%<br>Cross sectional area loss -<br>Severity 3 | Image Provided - Ref: 18_5<br> |

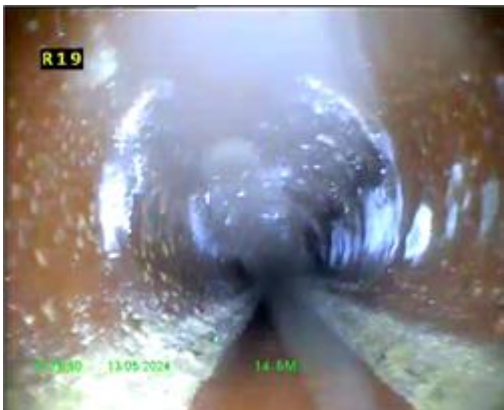
| Pos | Video Ref | Code | Description | Image |
|---|---|---|---|---|
| 14.50m | 0:01:02 | DEG | Attached deposits, grease from<br>07 o'clock to 03 o'clock: 5%<br>Cross sectional area loss -<br>Severity 3 | Image Provided - Ref: 18_6<br> |

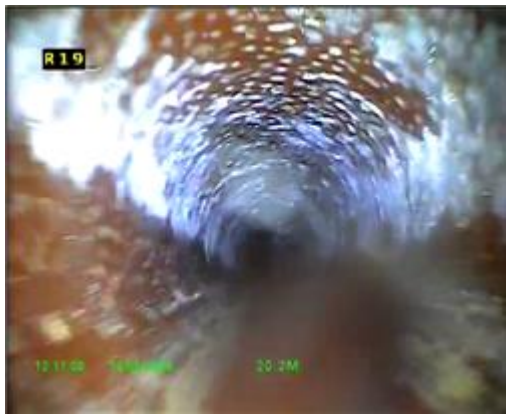
| Pos | Video Ref | Code | Description | Image |
|---|---|---|---|---|
| 20.20m | 0:01:20 | REM | General remark<br>General Condition Photo | <p>Image Provided - Ref: 18_7</p> |

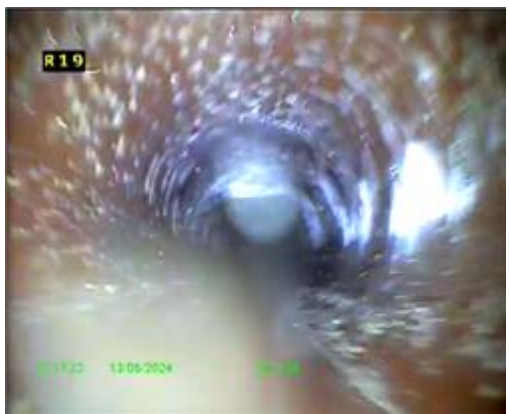
| Pos | Video Ref | Code | Description | Image |
|---|---|---|---|---|
| 26.10m | 0:01:34 | REM | General remark<br>General Condition Photo | <p>Image Provided - Ref: 18_8</p> |

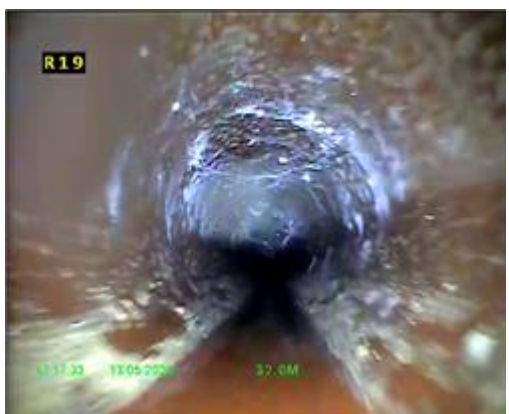
| Pos | Video Ref | Code | Description | Image |
|---|---|---|---|---|
| 32.00m | 0:01:45 | REM | General remark<br>General Condition Photo | <p>Image Provided - Ref: 18_9</p> |

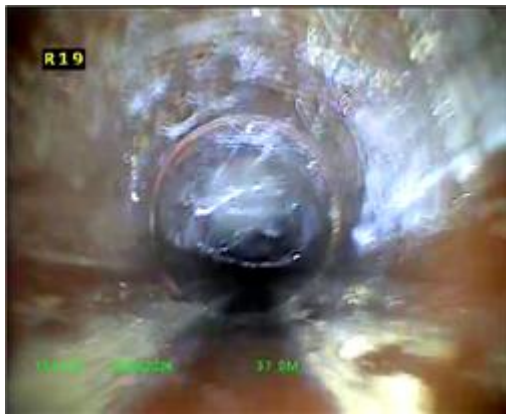
| Pos | Video Ref | Code | Description | Image |
|---|---|---|---|---|
| 37.00m | 0:01:53 | REM | General remark<br>General Condition Photo | Image Provided - Ref: 18_10<br> |

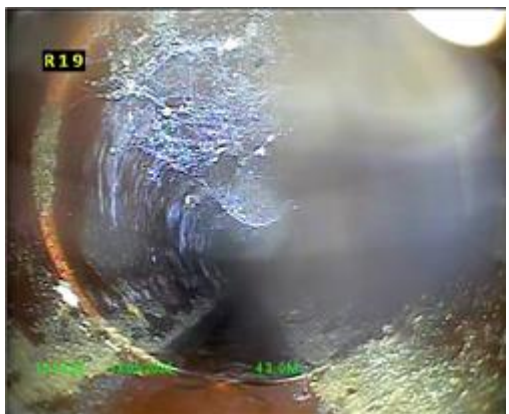
| Pos | Video Ref | Code | Description | Image |
|---|---|---|---|---|
| 43.00m | 0:00:00 | F1 DEG | Attached deposits, grease<br>Defect End from 05 o'clock to<br>07 o'clock: 5% Cross sectional<br>area loss - Severity 3 | Image Provided - Ref: 18_-2<br> |

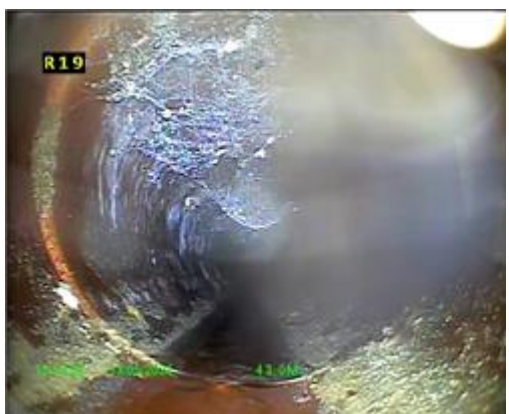
| Pos | Video Ref | Code | Description | Image |
|---|---|---|---|---|
| 43.00m | | SA | Survey abandoned<br>EOT- Unable to Camera<br>Further Due to Restricted<br>Leverage | Image Provided - Ref: 18_9999<br> |

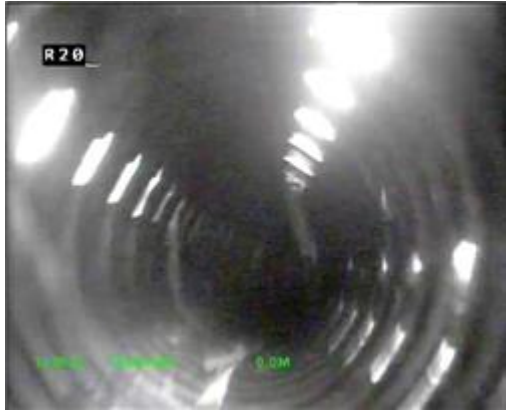
| Pos | Video Ref | Code | Description | Image |
|---|---|---|---|---|
| 00.00m | 0:00:00 | WL | Water level: 0%<br>Height/Diameter | Image Provided - Ref: 19_1<br> |

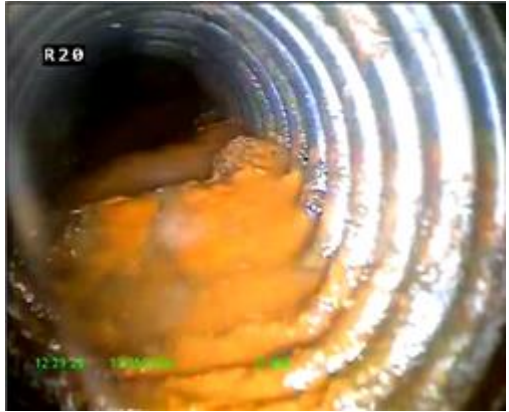
| Pos | Video Ref | Code | Description | Image |
|---|---|---|---|---|
| 00.90m | 0:00:07 | REM | General remark<br>General Condition Photo | Image Provided - Ref: 19_2<br> |

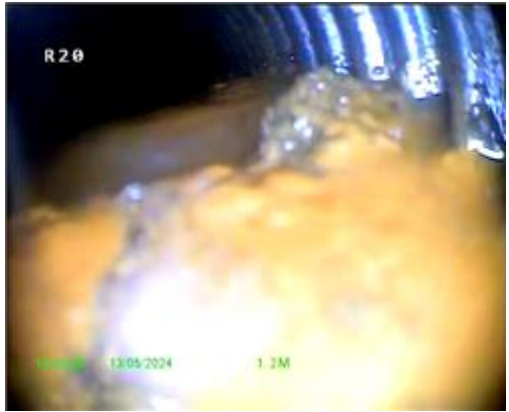
| Pos | Video Ref | Code | Description | Image |
|---|---|---|---|---|
| 01.20m | 0:00:08 | DES | Settled deposits fine: 30%<br>Cross sectional area loss -<br>Severity 3 | Image Provided - Ref: 19_3<br> |

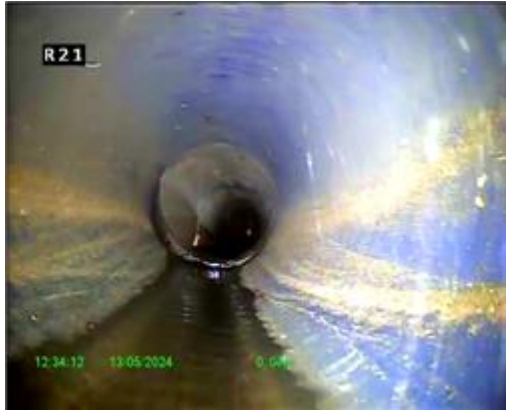
| Pos | Video Ref | Code | Description | Image |
|---|---|---|---|---|
| 00.00m | 0:00:00 | WL | Water level: 5% Height/Diameter | Image Provided - Ref: 20_1<br> |

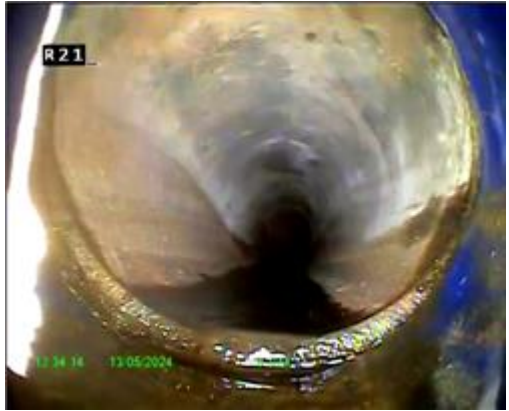
| Pos | Video Ref | Code | Description | Image |
|---|---|---|---|---|
| 00.20m | 0:00:02 | JDM | Joint displaced medium - Severity 3 | Image Provided - Ref: 20_2<br> |

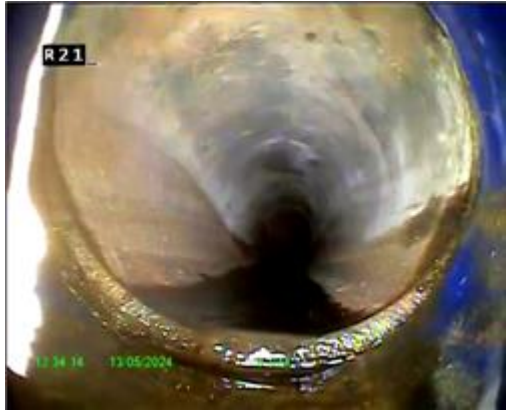
| Pos | Video Ref | Code | Description | Image |
|---|---|---|---|---|
| 00.20m | 0:00:02 | MCVC | Material of pipe changes to Vitrified Clay (i.e. all clayware) | Image Provided - Ref: 20_3<br> |
