**Barn, Sheephouse Cottage– Structural Appraisal**

Project No: 2909

## **STRUCTURAL APPRAISAL REPORT BARN CONVERSION**

**Sheephouse Cottage,  
Cheddleton Road,  
Leekbrook,  
Leek,  
ST13 7DP**

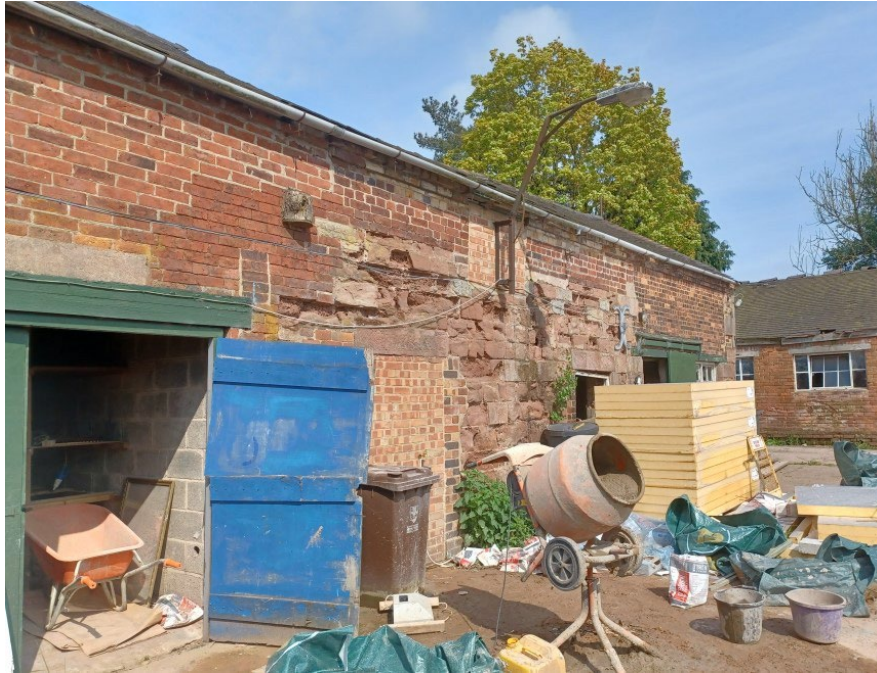
**Photo 1– Eastern Elevation**

The eastern wall is a mixture of stonework and brickwork that has been changed and repaired on different occasions over many years. The corner appears to be the original keystones full height with a small section of stonework remaining over a bricked-up doorway.

The corner stones are in good condition but the stones over the door are heavily weathered. The remainder of the masonry is 3 different types of brickwork in different bonds. In some areas the outside skin is in a stretcher bond and in other areas an English garden wall bond has been used. The masonry appears to be 3 bricks thick (without a cavity) in all areas. A number of vertical cracks are present in the brickwork particularly where different sections of walls meet but haven't been bonded or tied.

A tiled roof is present which can be seen to dip along the ridge towards the centre.

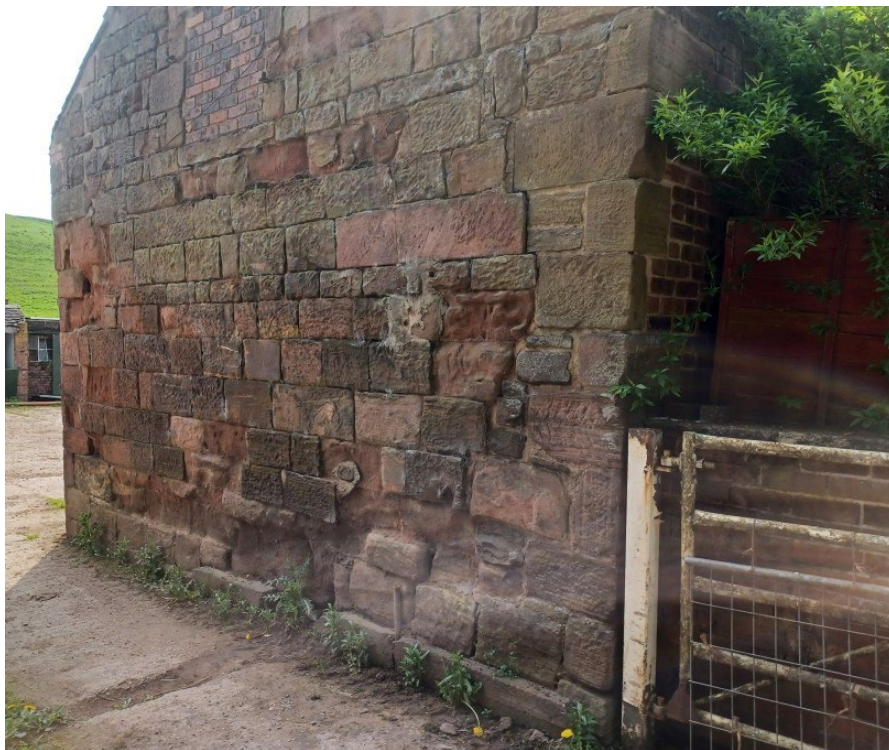
**Photo 2– Northern Gable wall**

The gable is constructed full height in stonework (approx. 450mm wide). The wall is in relatively good condition for the bottom 2/3 height but the top 1/3 is bowing inwards where it appears the purlins sit, and are pulling on the wall, as the roof starts to sag.

A high-level window has been bricked up, no other openings are present.

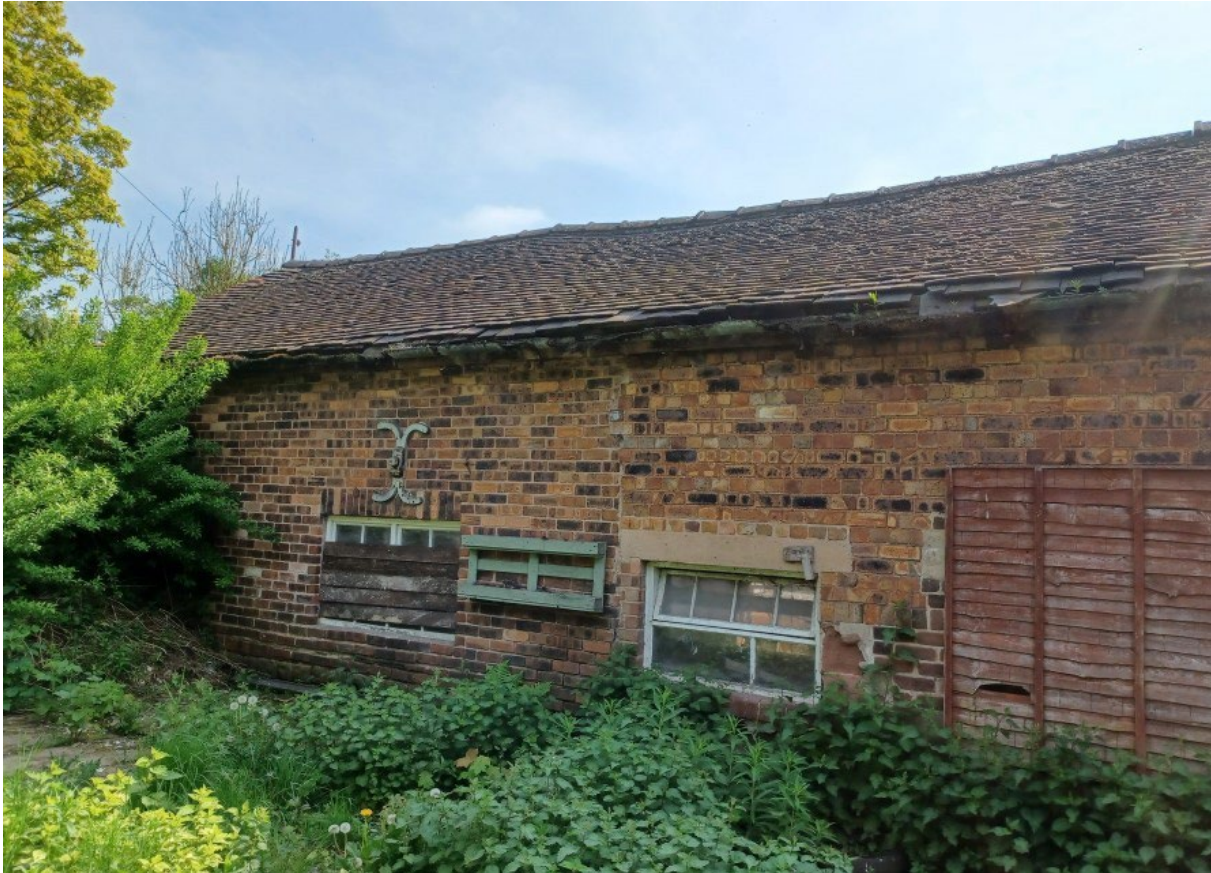
**Photo 3– Western elevation**

The ground to the western elevation is approximately 1.5m's higher than the eastern with the northern wall of the barn acting as a retaining wall. Below ground and the 1<sup>st</sup> 200mm above ground level is built from (assumed) 450mm wide stone. Above this is brickwork, 2 different bricks / style are used. The left side (gable side) has a stretcher bond and the right side using an English garden wall bond. A straight joint is present between the wall types.

A steel plate and rod is present over the 2<sup>nd</sup> window, which has been installed post construction to prevent movement and tie the longitudinal walls together.

The top section of wall appears to be pushing outwards and a difference of 50mm is viable at the top of the wall where the 2 different brick types meet.

A tiled roof is present which can be seen to dip along the ridge towards the centre.

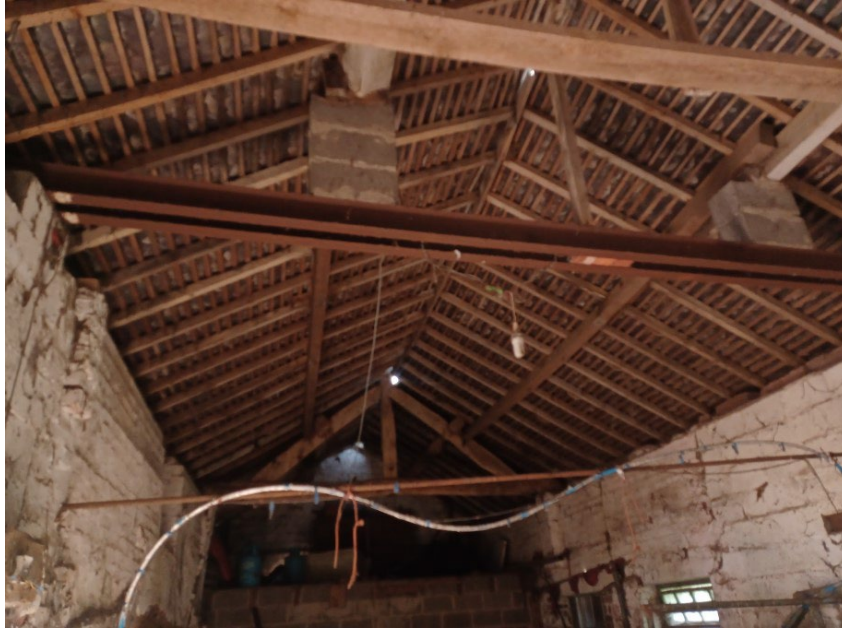
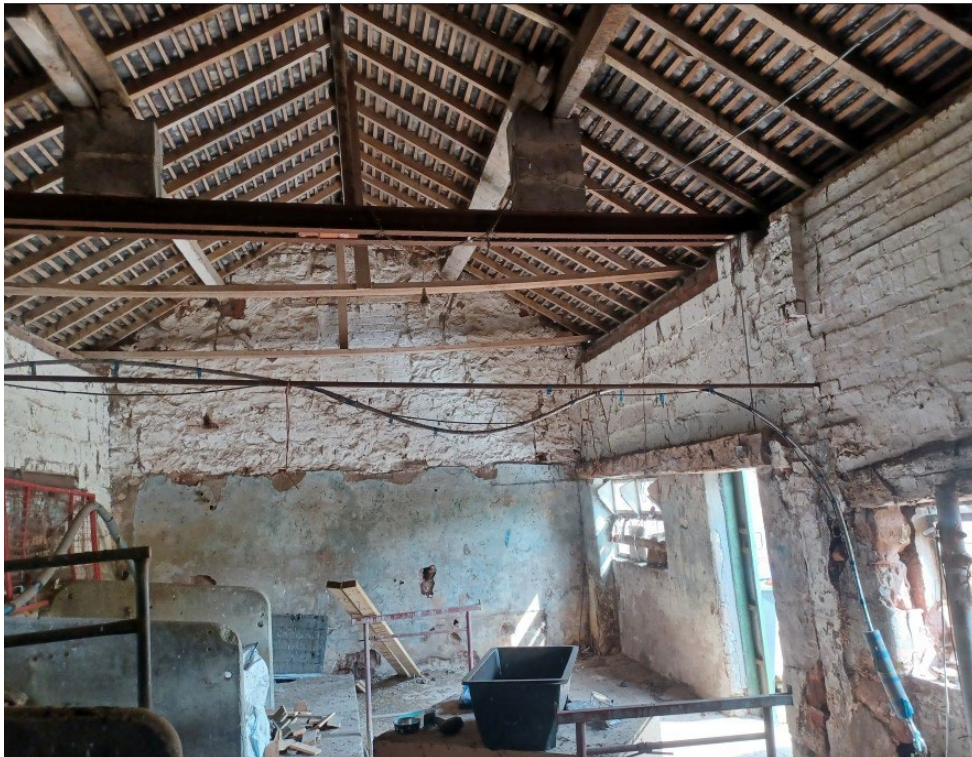
**Photo 4 & 5– Internal**

The roof is constructed with timber rafters spanning from the eastern / western wall up to a ridge board. A mid- span timber purlin is present either side of the slope split into 3 sections. The 1<sup>st</sup> purlin runs from the gable stone wall to a 440x225mm block pillar built off 2 steel beams spanning between the eastern and western wall at eaves height. The 2<sup>nd</sup> length of purlin is the longest and spans from the block pillar onto a king post timber truss. The 3<sup>rd</sup> span is from the king post truss to the gable wall of the main farmhouse.

The middle purlins in particular appear to be over spanning resulting in the roof dropping and pushing out on the longitudinal walls.

The steel beams supporting the block pillar / purlins are in a good condition but have

surface corrosion.

The timber king post truss has also deformed and the section properties at the bearings and also where the purlins are supported would need checking / strengthening.

The barn in its current condition is structurally sound but will need some modernising in the future to ensure it doesn't worsen. The priority would be to give added support to the roof by introducing a second line of steels / blockwork or truss to reduce the span of the middle purlins and also strapping the roof to the walls which will help prevent any further movement.
