# Bradley Hall Farm, Bradley-In-The- Moors, Alton ST10 4DF

Structural Appraisal Report

Ian Titley Design

MAY 2025

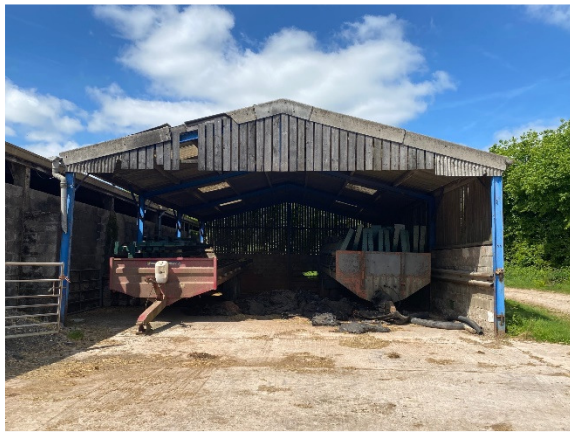
**Barn – Front Elevation**

The steel framed Barn under consideration appeared in good structural order and comprised 3 no. bays (i.e. 4 no. steel portal frames in total) of approximately 9.0m span and at approximately 5.0m centres. The frames themselves comprised 178 x 102 UB columns with 178 x 102 UB rafters, interconnected using timber sheeting 'rails' which measured 75 x 175mm at approximately 1250mm vertical centres. The sheeting extended for the upper 50% of the external walls, with the lower 50% being formed in blockwork.

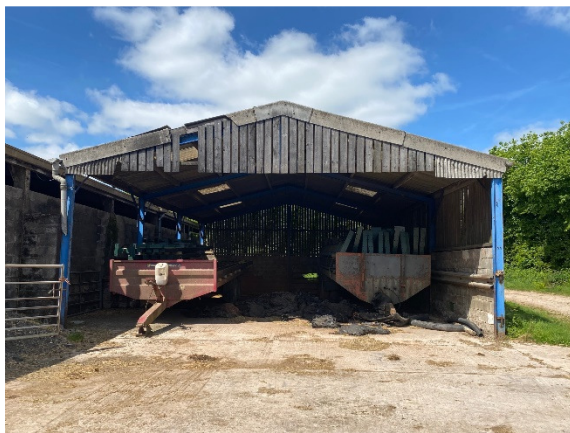
**Main Barn – Front Elevation**

The structure of the steel portal frames and the associated timbers appear to be in good order generally with no signs of any leaks within the roof.

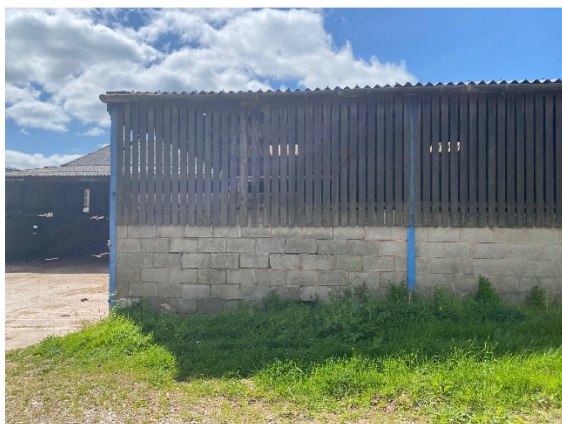
**Bay #1 – Side Elevation**

The blockwork forming the lower 50% of the side wall appeared to have suffered from vehicular impact sometime during its lifespan as the panels of blockwork in both the 1<sup>st</sup> and 3<sup>rd</sup> of the three bays showed signs of historical lateral impact in the form of bulging and cracked blockwork.

The blockwork panels that the form the lower sections of the side walls show signs of bowing and deflection due to impact from within, in all probability from historical vehicular impact, and these walls will require localised rebuilding to bring them into line. The walls are not structural and the repairs would therefore be considered as being required primarily for aesthetic purposes, but nevertheless we would strongly recommend that these blockwork repairs are carried out in the short term for the safety of anyone working within the vicinity of the side wall to the barn.

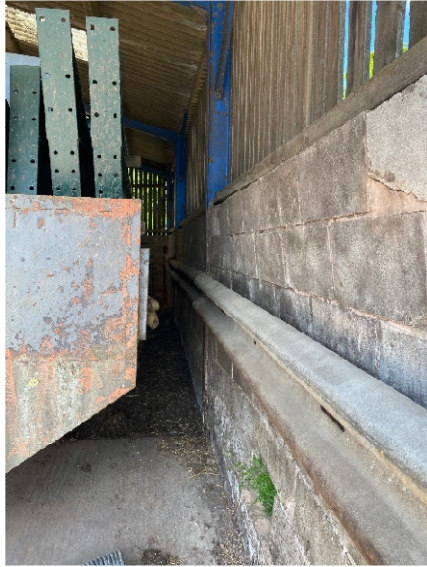
**Bay #1 – Internal Elevation note: bowing in blockwork due to historical vehicular impact**
