**Woodhouse Farm : Barn and Coal Store– Structural Appraisal**

Project No: 3380

Date: May 2025

**Woodhouse Farm,  
Sands Lane,  
Brown Edge,  
ST8 6EG.**

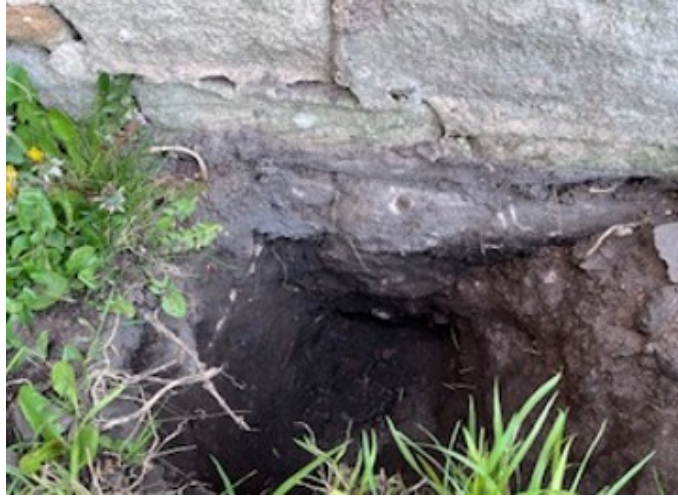
**Photo 1– Trial Hole**

A trial hole was dug at the rear of the coal store.

This indicated the wall which had larger foundation stones at the base level (same wall width) but stopped approx. 200-300mm below ground level.

No spreader foundation is present to the a store where exposed.

A trial hole was dug at the rear of the barn.

This indicated the wall which had larger foundation stones at the base level (same wall width) but stopped just below ground level.

No spreader foundation is present to the barn where exposed.

Foundations were exposed in two locations, and relied on spreaders and walls only taken into a shallow ground depth. However, having said that the store and barn don't show any signs of any ground movement / foundation problems based on the current load and use.

Underpinning may be required where additional loads are added, or where any dig depth is required for a new ground floor construction, but these could be carefully designed to avoid any excessive or unnecessary works to the existing structure.

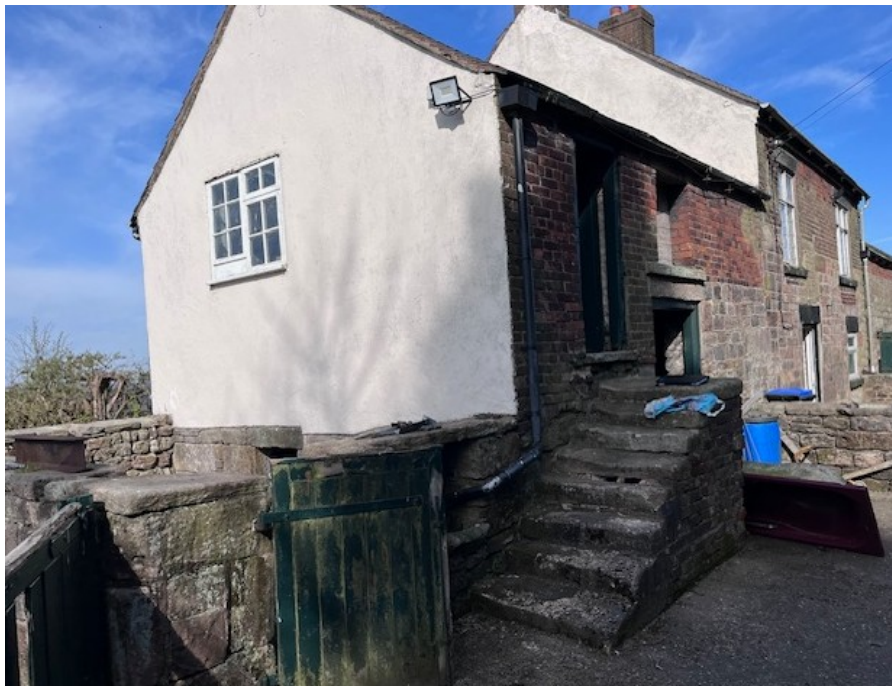
**Photo 2– Coal Store : Front and Side View**

The front wall is a mixture of stonework and brickwork, with the 450mm wide stonework appearing original and built upto 1<sup>st</sup> floor level. A solid 225mm brickwork is then present over. A brick wall with concrete steps are present externally from the front left corner. A door is present at ground floor just beyond the steps giving access into the ground floor level of the store. A stone lintel is present over. A door is present at ½ height off the external steps giving access into the upper section of the store, it appears no lintel is present over as this runs flush with the roof. A boarded up window opening is present directly over the ground floor door with a stone lintel over.

The side gable wall is seen as stonework from the lower level upto approx 1.0m above the front ground floor level, this elevation then has a rendered finish with a single window within the 1<sup>st</sup> floor area.

The stone / brickwork on all sides appears in good condition with no structural cracks of concerns.

The roof has a tiled finish with gutters running the length of the front and rear elevation. The roof appears true without any major sagging or hogging.

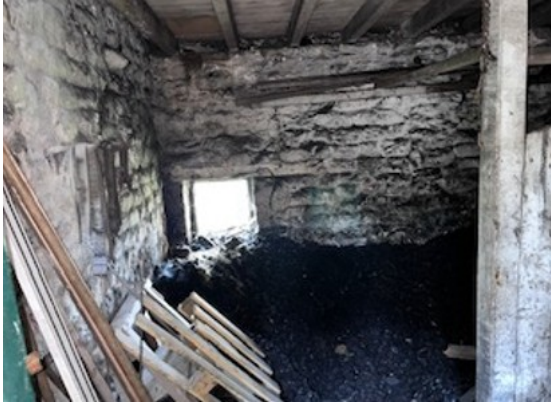
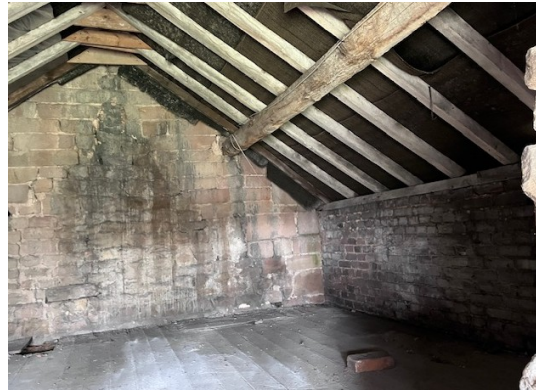
**Photo 3 & 4– Coal Store (Ground floor / 1<sup>st</sup> floor)**

Within the ground floor of the store, a rougher finish stonework is present on all sides, but in a relatively good condition.

The 1<sup>st</sup> floor store area accessed from the external stairs is set lower over the pig-cote and then steps up over the coal store. Timber floor joists are present spanning front to back.

The roof has timber rafters, with 1 number timber purlin along each slope, The purlin runs between the gable walls and has a timber prop off the wall between the pig cote and coal store (the prop will need to be replaced). Main roof timber work in a relatively good condition.

A horizontal crack is present in the masonry over the pig-cote but no major structural concerns noted.

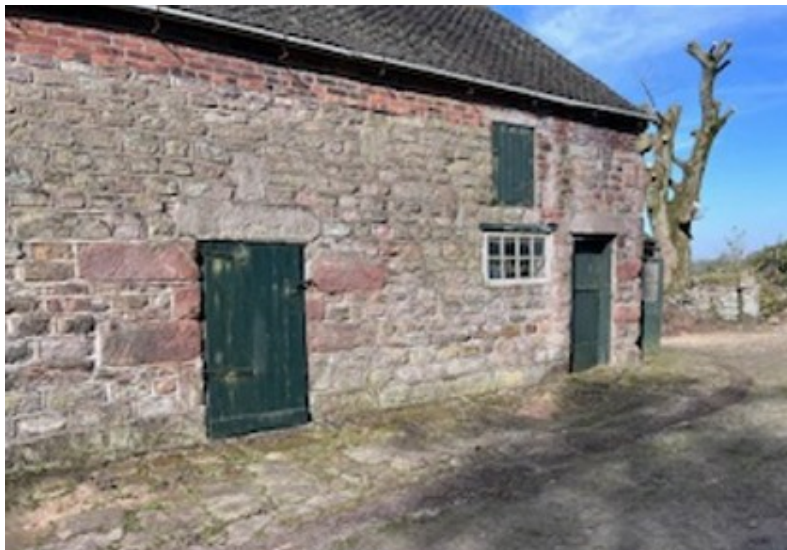
**Photo 6– Barn : front elevation**

The front wall is original stonework with 5 courses of brickwork added over at the top.

3 Doors are present along the front elevation all with larger stone lintels over, a single window is present close to the 3<sup>rd</sup> door which has a timber lintel over.

The stone / brickwork on all sides appears in good condition with no structural cracks of concerns.

The roof has a tiled finish with gutters running the length of the front and rear elevation. The roof appears true without any major sagging or hogging.

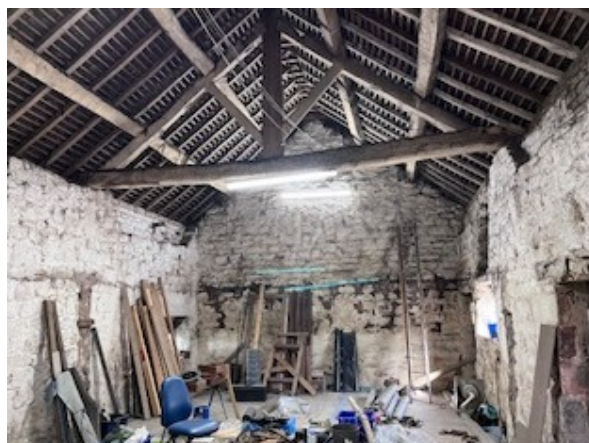
**Photo 7– Barn : Internal**

All elevations show a rougher finish stonework is present, but in a relatively good condition.

The barn is one open space with 3 doors and 1 window located on the front elevation with timber lintels (internally) present over. A crack in the stonework is present at low level between the small section of masonry between the door and window.

2 windows and 1 door are present along the rear elevation with timber lintels (internally) present over. Both gables' walls are stonework, the external gable is in a good condition, 2 small cracks are present in the corners of the main house stonework but not currently of a structural concern.

king posts trusses splitting the purlin span into 3. The end bay of purlins (closest the existing house) have some sections missing and should be monitored for any future deterioration or deflection in the roof. The other roof members are in a relatively good condition for the age and are not of a structural concern.

The walls are currently relatively straight and plum but are long sections without any buttressing. Any future development should consider incorporating buttress piers / posts into the layout.
