# Preliminary Roost Assessment

London Mill, Ashbourne Road, Leek,  
Staffordshire, ST13 5AP

*November 2025*

| Report Ref. | 25-065-PRA |

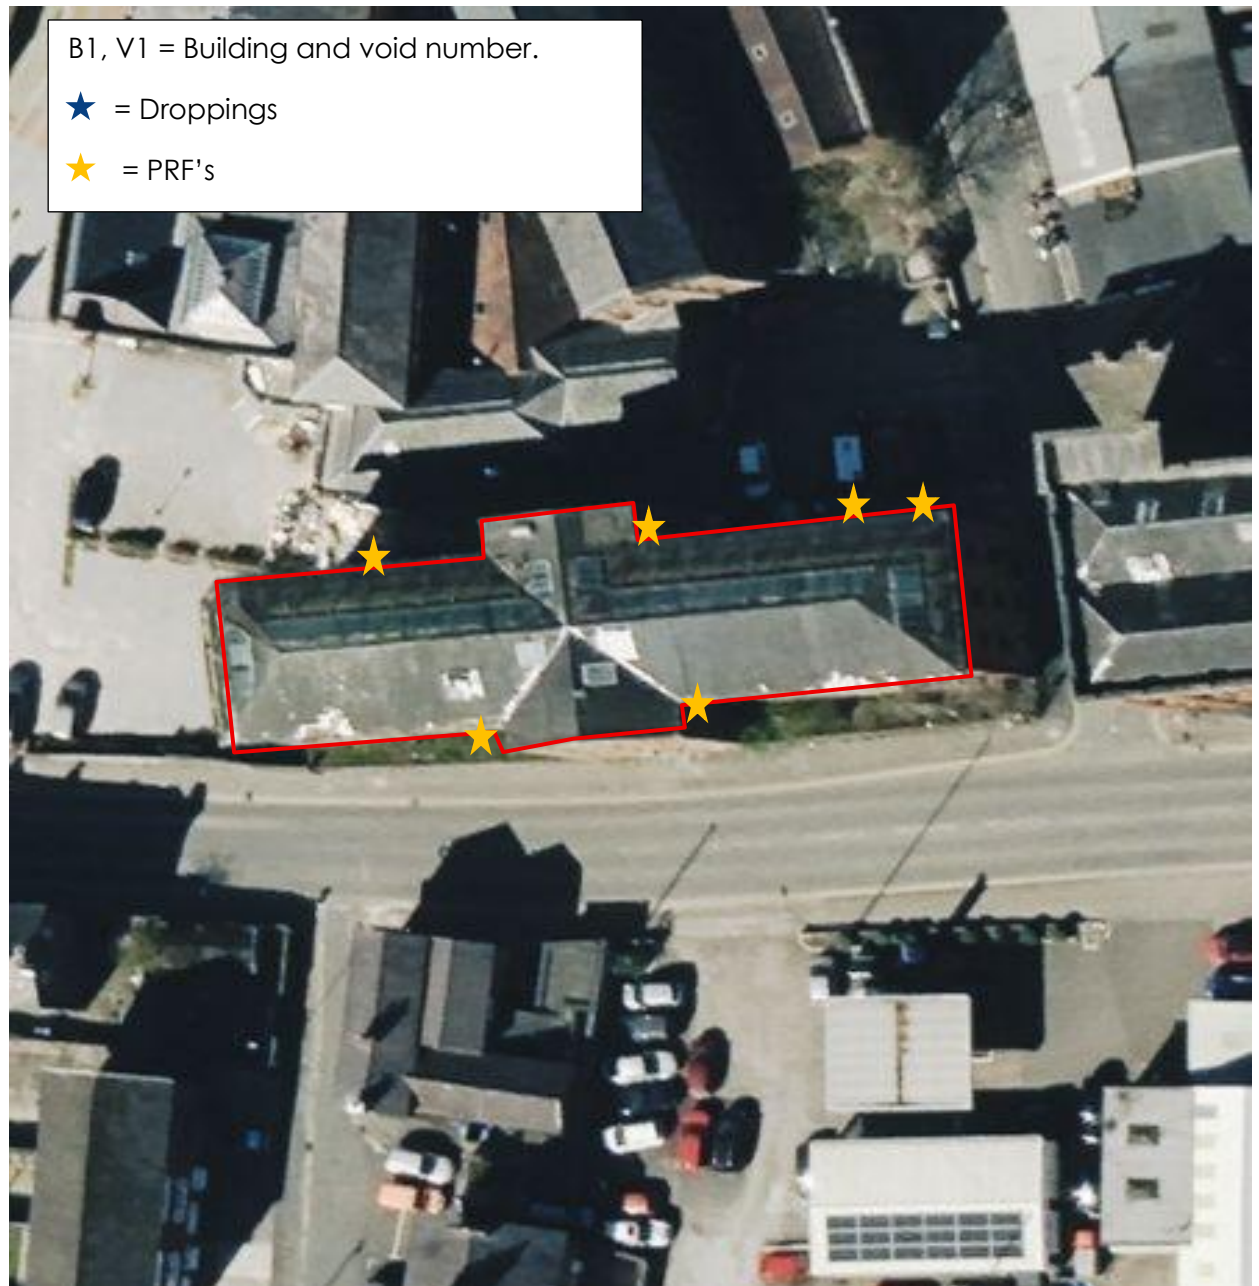
Figure 4 – Roof plan of B1. Outline based on aerial image (Apple, 2025) and not to scale, all measurements are approximate.

| | Building/Tree and PRF Descriptions | Suitability/Likelihood |
|---|---|---|
| B1 – Main Building | <p>Although the building offers moderate potential, due to the number of potential roosting features present, the deterioration of the building and the damage caused by water ingress should be taken into consideration when determining whether the building is likely to be offering habitable conditions for bats.</p> <p>Features present include damage soffit boxes, lost mortar and damaged bricks.</p> <p>No “attic” space is present, rather a small void between the tiles and thin wooden batons. The “ceiling” of the building is very damaged throughout due to water ingress. Where possible, these areas were inspected, including the void and tiles. The slate tiles are generally in good condition and tightly held, damage has taken place where the building has a substantial crack on the western gable end, where it is no longer structurally sound.</p> <p>A type of “attic” is present where the clock used to be. This was checked for bats and no evidence found. It was very well sealed compared to the rest of the roofline.</p> | Moderate/Negligible |

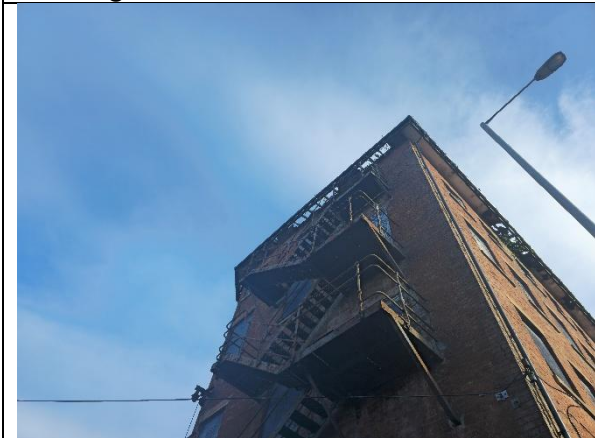
Image 3: Western aspect, visible structural cracks visible in brickwork.

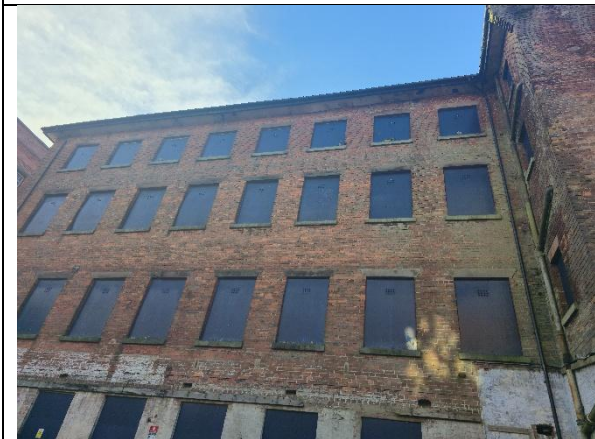
| | Results | Impacts | Recommendations |
|---|---|---|---|
| Main building | <p>The property is in poor condition. Significant structural damage on the eastern gable end is allowing significant water into the buildings on this aspect.</p> <p>The building was occupied by at least twenty pigeons upon the day of the survey. Multiple deceased pigeons were noted within the building. Along with several nests, none of which were presently active.</p> <p>Features as noted previously still exist, but soffits holes have become larger and less suited. Damaged bricks and mortar continue to exist, however the building is becoming more affected by weather and less likely to offer suitability for bats.</p> | No impacts identified | <p>No further surveys for bats are required.</p> <p>If bats are found at any stage of the works, then works must stop and a suitably qualified ecologist contacted for advice.</p> <p>A check for nesting birds is required before roofline works commence to ensure no pigeons are trapped within the building.</p> |

Image 5: Rear eastern end of the building.

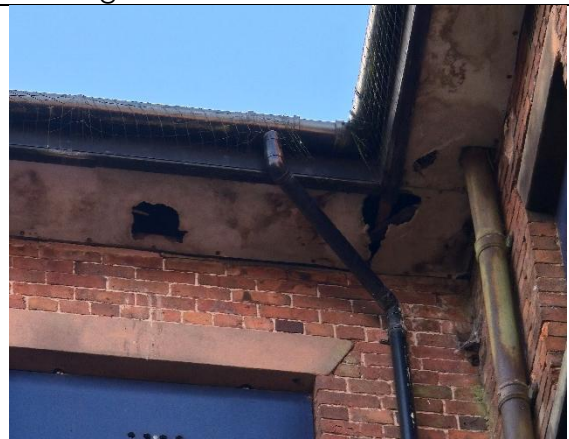
Image 6: Close view of damage soffits, rear central section.

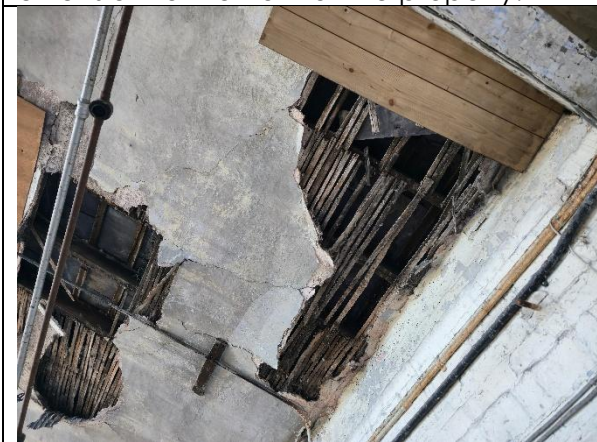
| | Building and PRF Descriptions | Suitability |
|---|---|---|
| B1 - Main Building | <p>The building offers no hibernation potential for bats. The slate roofing tiles are generally in good condition, where tiles or damage is present water ingress is significant enough to remove any roosting opportunities. Significant internal damage is present, and continues to take place due to water ingress throughout the building. These conditions are highly unsuitable for bats, which require static temperatures and protection from adverse weather conditions.</p> | None |

Image 9: View of the type of extensive water damage noted within the top floor. Rear view of the slate tiles is visible behind damage sections. Large amounts of chicken wire present in these gaps.
