13<sup>th</sup> June 2025

250561-C2C-XX-XX-LTR-S-C01

**RE: LONDON MILL, LEEK – STRUCUTRAL CONDITION OF EXISITNG TIMBER FLOORS**

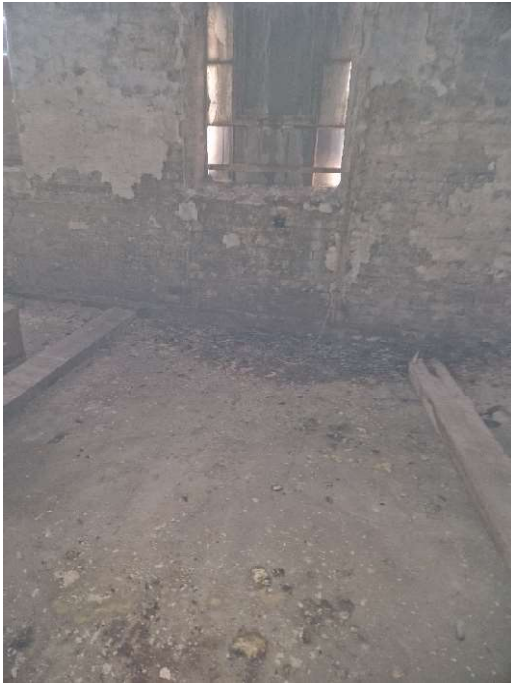
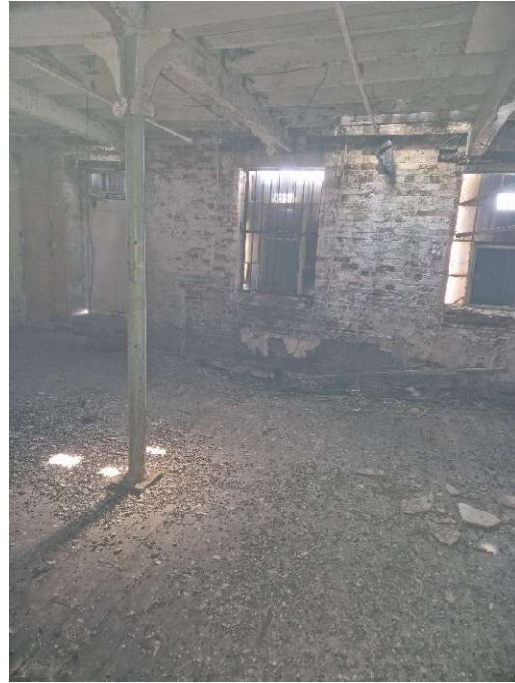
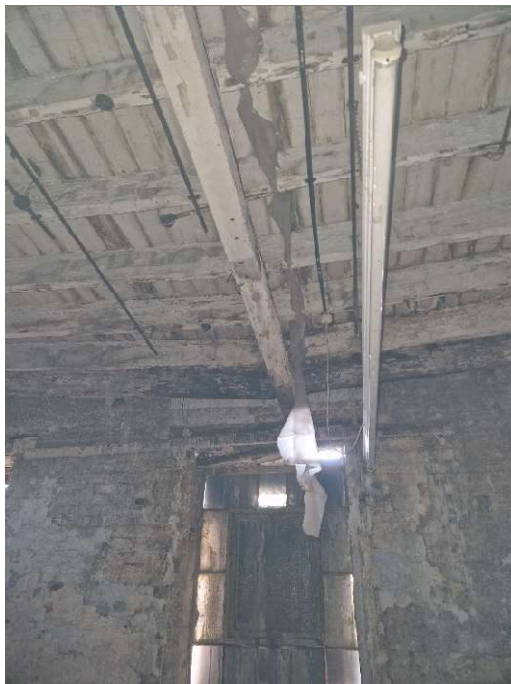
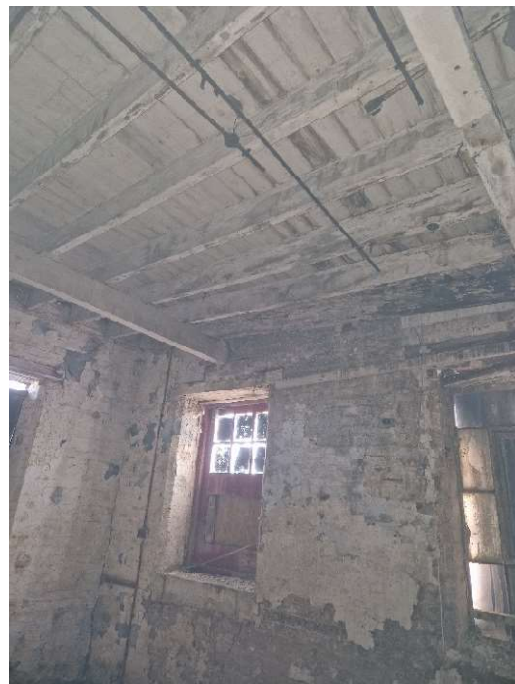
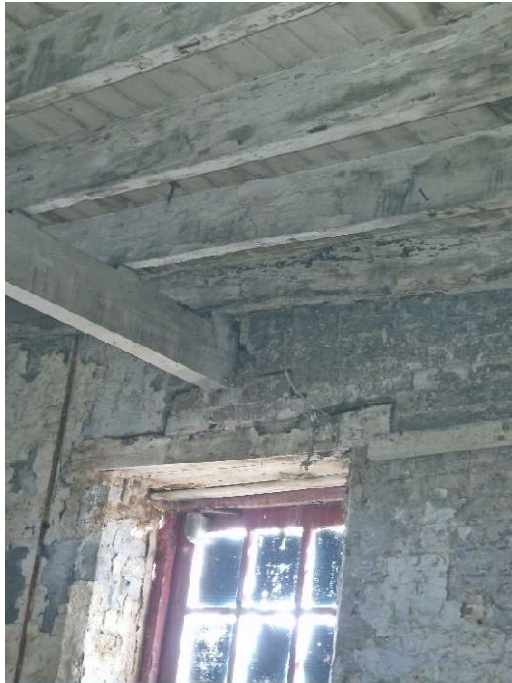
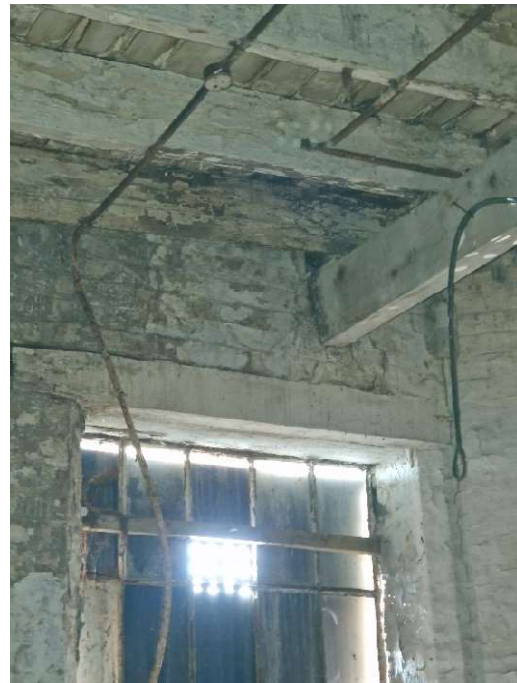
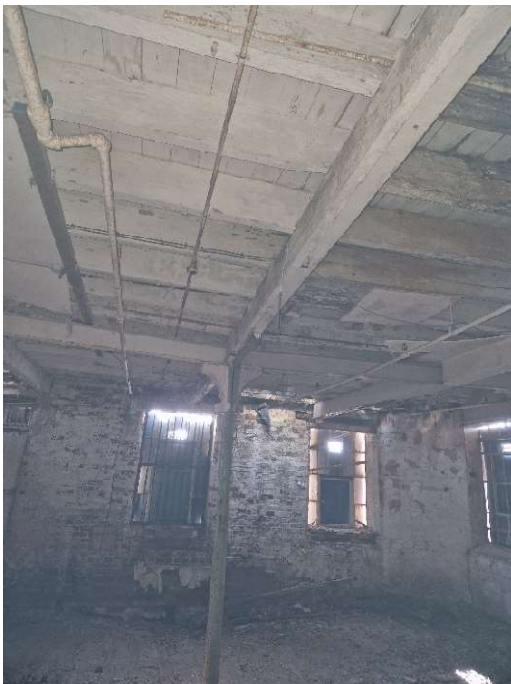
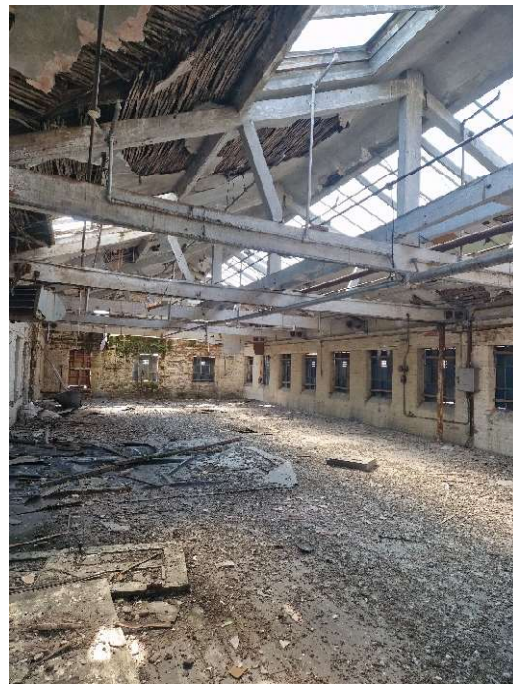
## APPENDIX A

The purpose of the investigation completed by C2C was to determine whether the damaged floor structure adjacent to the western elevation could be temporarily propped and made safe to allow building surveyors to inspect and record the historic interior features of the building at each floor level. The existing floor structure is supported via a series of central cast-iron posts which support a central beam which is scarfed at intervals along its length. This beam then supports timber joists which span from the perimeter walls. During the inspection, it became apparent that the extent of wood rot was significant. At each floor level, the floor structure (timber beams, joists and floorboards) has dropped on the western end of the building. Some of the primary timber beams in this zone appear to have sheared at the support location, others have dropped due to failure of the inner leaf timber lintels. Photographic evidence of the damage described above is provided in Appendix A.

Due to the extent of the current floor deformation and structural damage, a safe method of temporary propping the existing timber floors is not considered feasible. We therefore recommend that the impacted floor area shown in Appendix B is demolished and reinstated in a bottom up approach. With the first floor structure reinstated, remediation works at upper levels may then be completed safely as access can be made via the reinstated floor below. To account for potential instability and disturbance of the damaged floors above, we advise that a crash deck is provided to ensure that any debris from the floors above does not fall on the contractors when completing the construction work at lower levels.

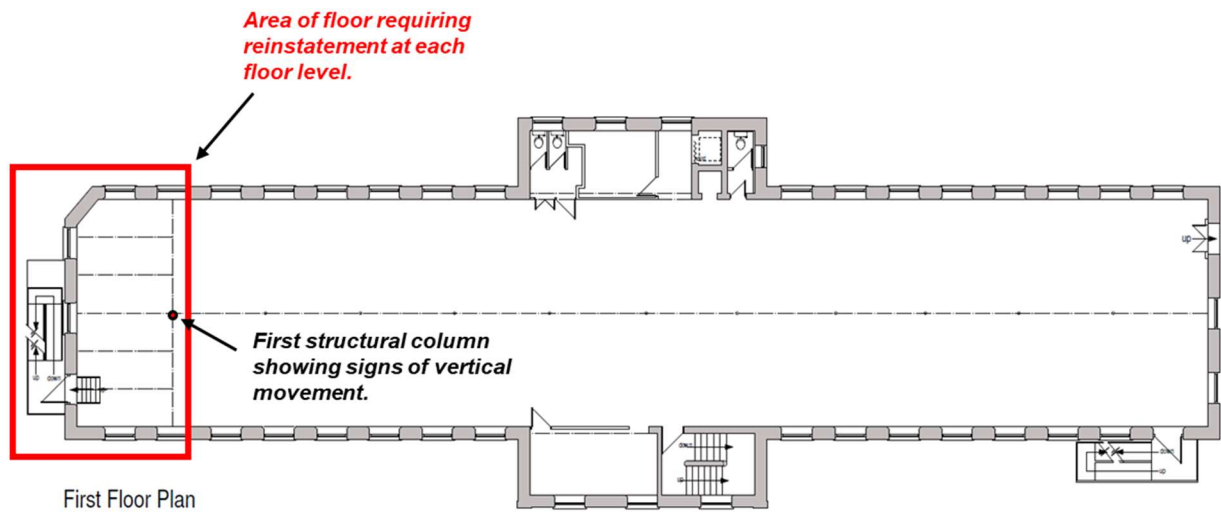
## APPENDIX B

During the inspection, the first central column from the western elevation appeared to have dropped slightly at each floor level (for column location, see Appendix B). Prior to completing any reinstatement works, this defect should be investigated further. As part of the floor replacement work, this central support member may need to be removed and reinstated back to its original position.
