## **SITE REPORT AND PROPOSED METHODOLOGY.**

**SITE.** London Mill Leek

**PROJECT.** Restoration, structural repairs and cleaning to Brickwork and stone facings.

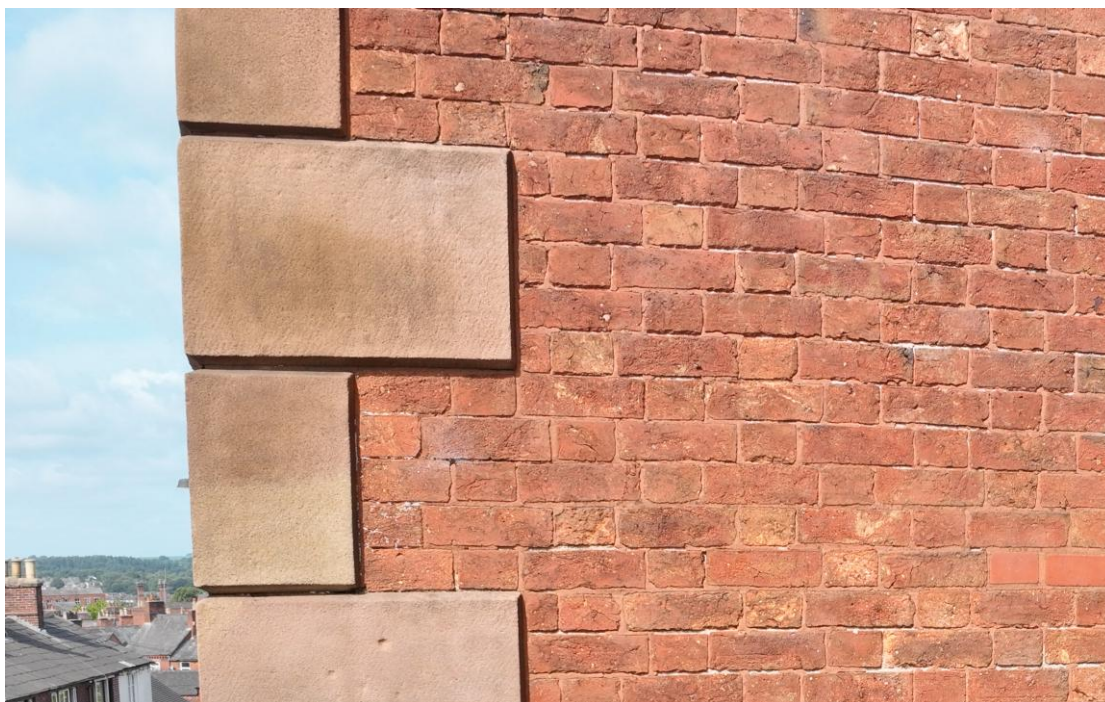
The external walls are constructed of brickwork with sandstone ashlar facings cornices, quoins, window cills, heads etc. which show varying levels of degradation, staining and discolouration. The front and Well Street elevations appear to have been quite aggressively cleaned in the past with much of the fire face of the bricks now absent. Pointing appears to be a mix of original pointing and later strong cement pointing overlying the bedding mortar.

Image 1. Loss of Fired face, coarsening of surface due to previous cleaning.

To facilitate cleaning, use of the DOFF or Thermatech steam systems would be considered, allowing carefully controlled temperatures and pressures to be maintained. Pressure should be limited (a maximum of 1000 psi) with a good distance from the brickwork maintained to protect substrates from degradation by the cleaning process.

It is not possible to design a perfect cleaning system, as the variables are incalculable however the aim must be to achieve a good overall result without detriment to the building. The cleaning process should not alter the surface properties i.e. by abrading the surface resulting in excessively coarse finishes. The systems we are suggesting should give a good aesthetic result without degrading the substrates unnecessarily, the building integrity will be maintained, and long-term implications minimised.

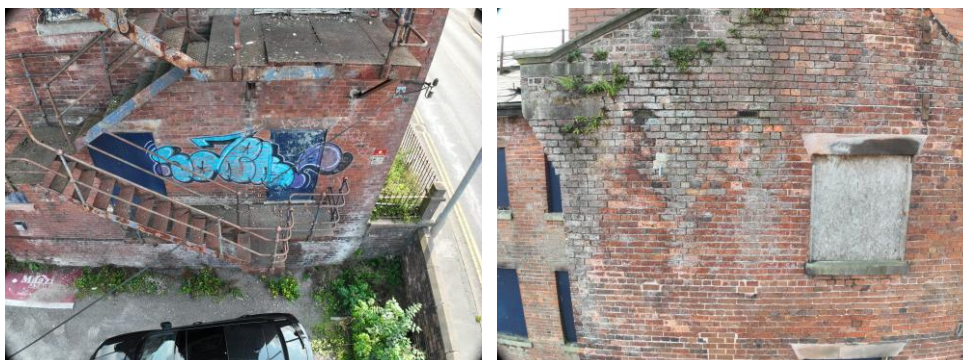
There are areas of Graffiti application which appear to be a sprayed on paint, possibly cellulose car paint or similar. The paint is likely to have been absorbed into the face of the brickwork to some degree, especially where previous cleaning has coarsened the surface, and therefore some residual shadowing is possible following removal and cleaning

Image 1& 2: Graffiti, salts and atmospheric staining.

Where Graffiti is in evidence our recommendation is to again use the DOFF or Thermatech steam systems but used in conjunction with chemical agents, if required, to assist in the removal of the spray-painted coatings. It is to be expected that the steam systems alone will not completely remove the graffiti, and some degree of

chemical application will be necessary. Application, dilution and contact times of the chemical agent will be kept to the minimum effective and it is expected this will vary across the range of graffiti incidents and adjustments will need to be made.

Following applications of chemical graffiti removal agents, the brickwork and adjacent façade will be thoroughly washed down and neutralised.

Should the graffiti be impervious to the steam or chemical applications the JOS system utilising a calcium carbonate or calcite or similar media may be effective the media choice would be selected to be softer than the substrate material.

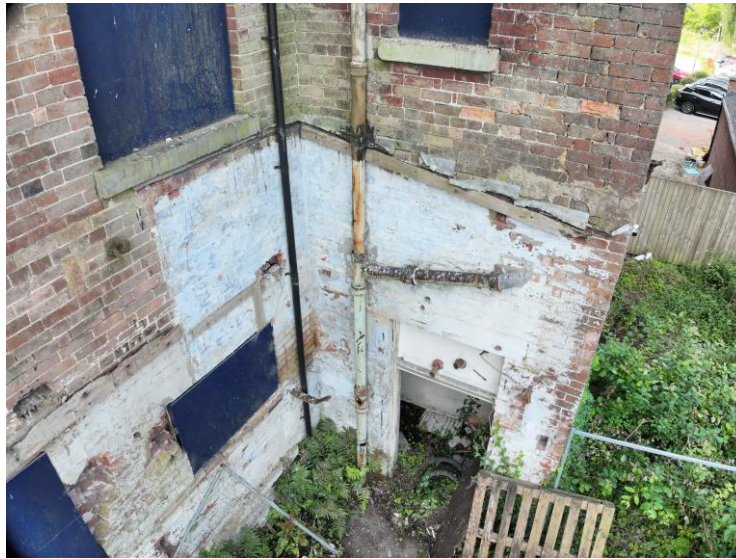
Further painted coatings are present where previous alterations and demolitions have caused internal finished surfaces to become external finishes.

Image 3: Internal painted coatings exposed by demolitions.

Where previous structures have been removed and previously internal finishes are now on external walls these could also be removed by a combination of the above systems.
