# Design and Heritage Statement

Location: 1, High Street, Alton, ST10 4AQ

## Application Title: Chimney and Roofing Repair Works - Listed Building Consent Phase 1

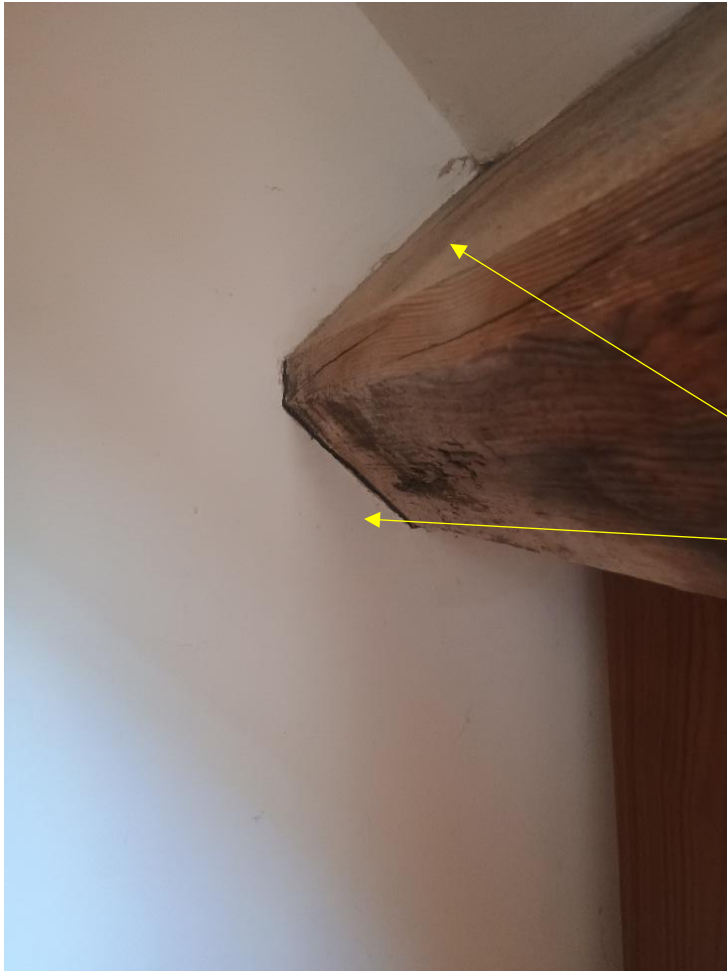
There is evidence of water ingress from the chimney stack in the attic. Water staining is evident on the attic internal wall (dry-lined) and wooden purlins where the purlins meet the gable end wall.

Water staining to  
upper face of  
wooden beam and  
water marks on  
plaster above and  
below beam

The roofer's recommendation is to remove the damaged flaunching and incorrectly installed tiles from the chimney top and check which chimney flue is connected to the ground floor fireplace. A suitable clay pot and cowl, in keeping with the surroundings, will be installed on the correct flue to replace the current cowl, with the flaunching replaced using a lime mortar. The remaining two flues will be closed to prevent water ingress. Repairs to adjacent render/pointing, in keeping with the building's appearance, will be undertaken to prevent further water ingress.

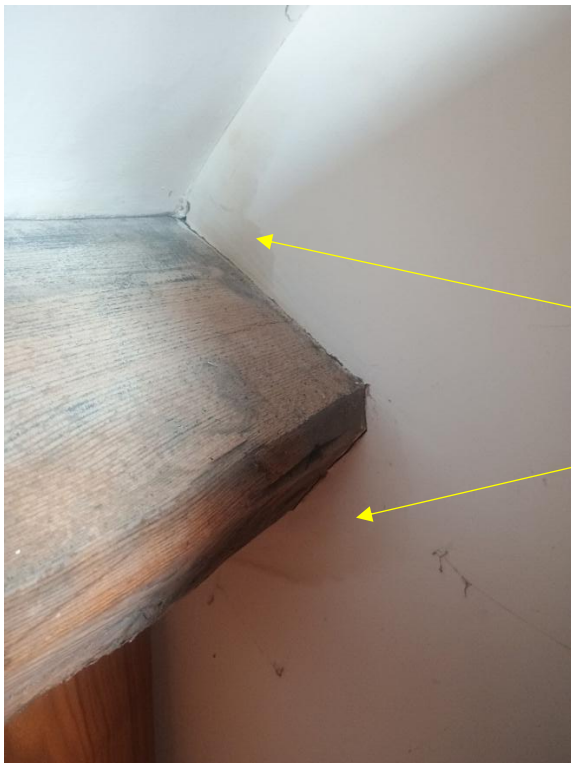
Water staining to plaster  
above and below beam.

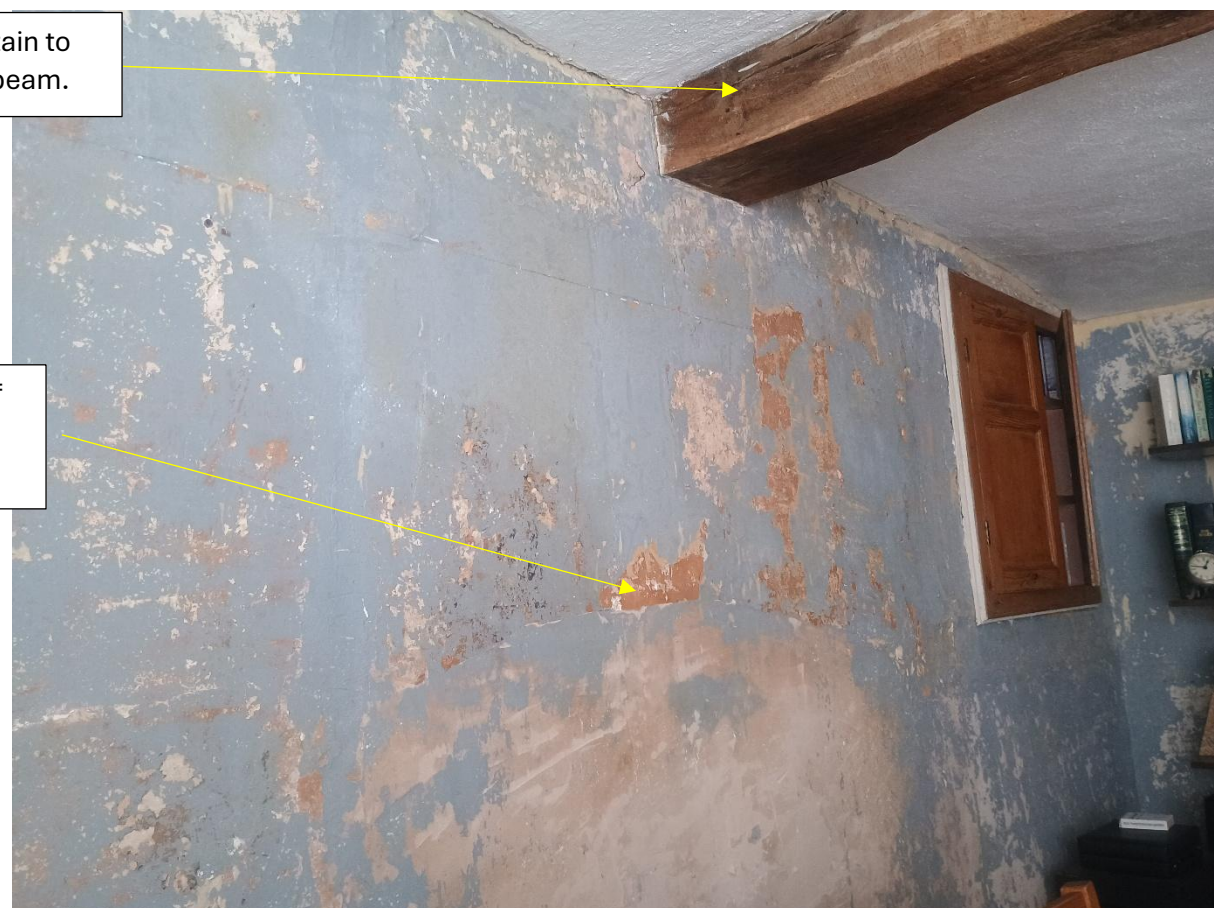
The central beam shows evidence of water staining, plus evidence of damp and mould on the gable end wall.

Four layers of wallpaper and a thin layer of polystyrene have been removed from the wall, to allow the plaster to breathe and dry out. On removal, the wall was found to be damp, with evidence of mould and cracked plaster in one corner.

Damp stain to  
central beam.

Evidence of  
previous  
fireplace

Mould and  
plaster cracks

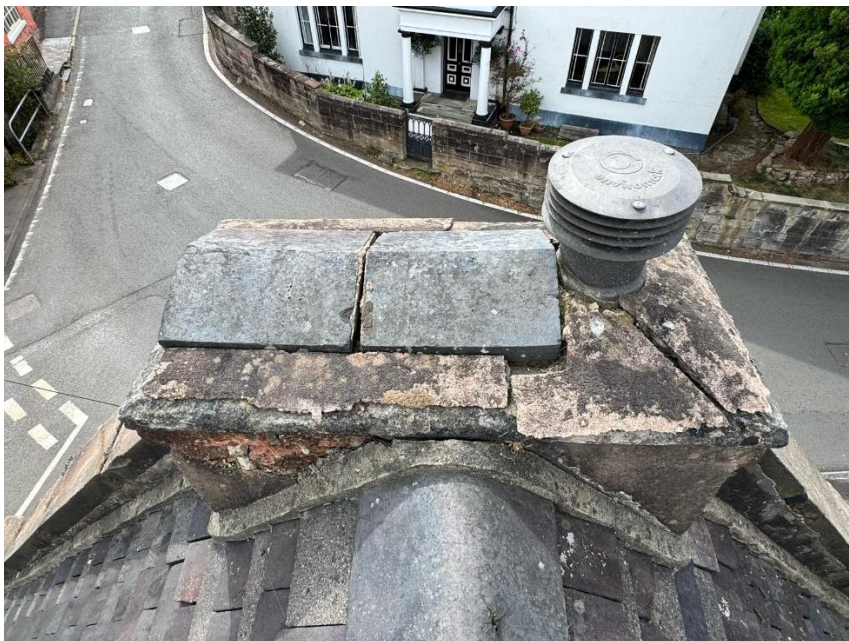
A survey of the roofing and chimneys by a professional roofer, who has experience of working with SMDC on listed buildings, was undertaken on 28<sup>th</sup> August 2025. They observed that the existing chimney flaunching had cracked, there was deterioration of the brickwork on the chimney below the flaunching, and two ridge tiles had been previously placed over two chimney flues rather than re-instatement of chimney pots and cowls on redundant flues.

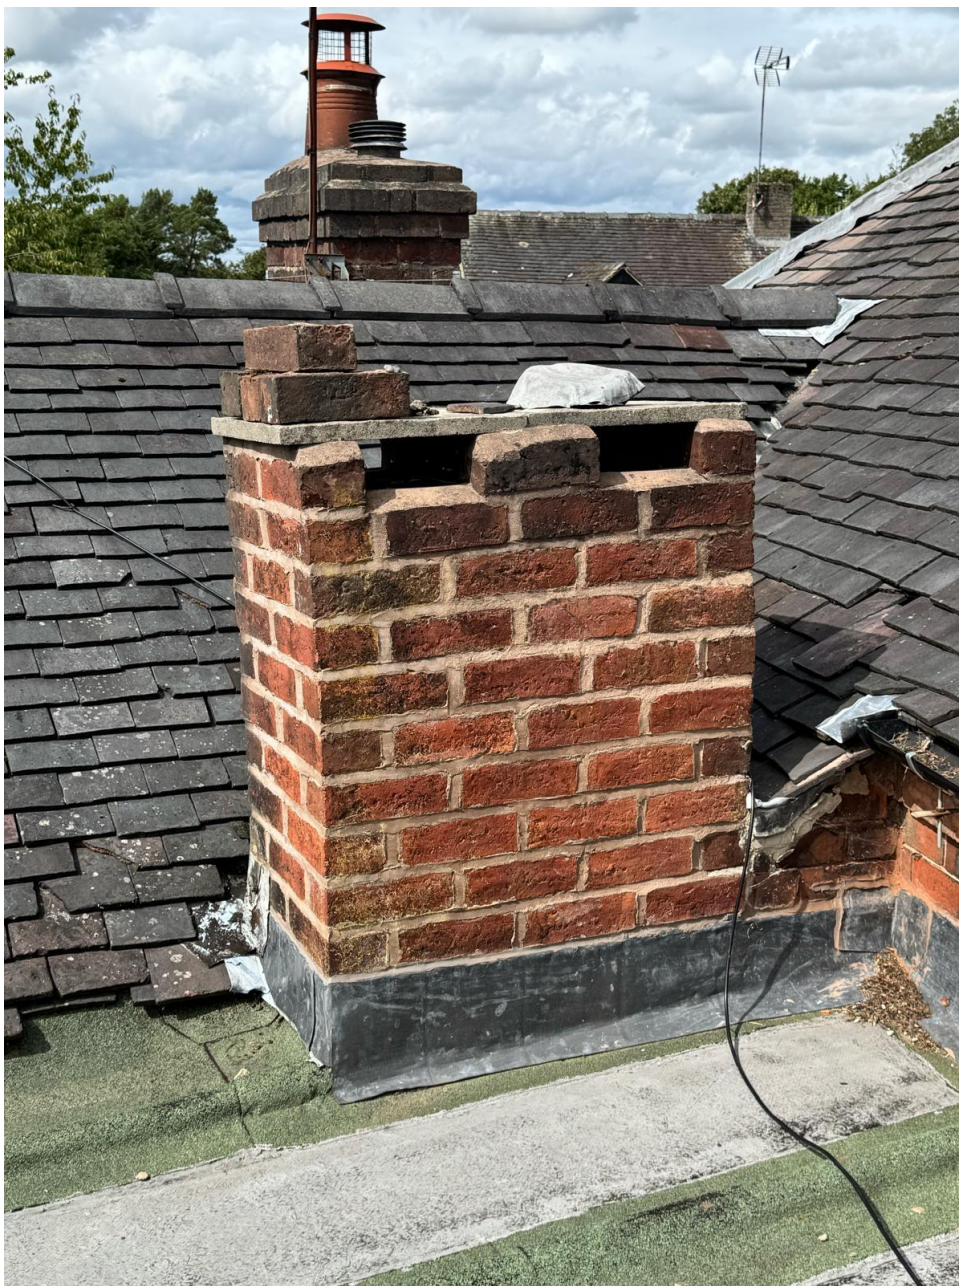
The chimney stack has previously incorrectly been capped with two concrete floor tiles, and no rain or bird protection has been applied to the resultant openings. The top three/four courses of brick have been previously laid such that the chimney stack splays out towards the top.

The roofer's recommendation is to remove the concrete floor tiles and check which chimney flue is connected to the kitchen fireplace, which is already vented. They recommend reduction of the chimney stack height to reduce the splay and improve stability. They will correctly re-cap the chimney with lime mortar flaunching and fit a suitable clay pot and cowl, in keeping with the surroundings.

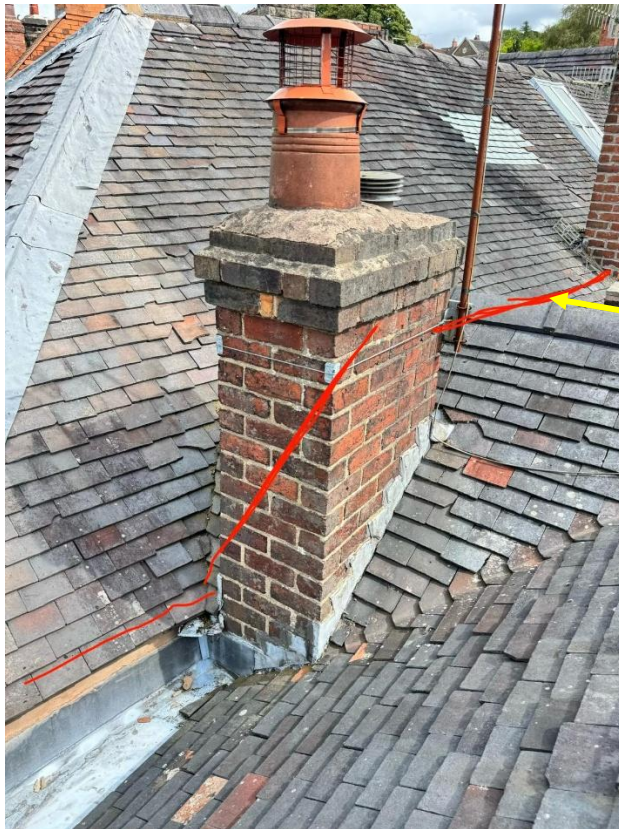
Boundary with  
Bulls Head  
Rooms property

There is evidence of significant water ingress from the chimney to the two rooms below.

The roofer's recommendation is to remove the rear chimney stack as the stack is redundant and there is significant water ingress down the stack. The roof will be re-instated with new rafters and plain blue Staffordshire roof tiles to prevent any further water ingress, improve future roof performance and negate the requirement for continued maintenance of the chimney stack.

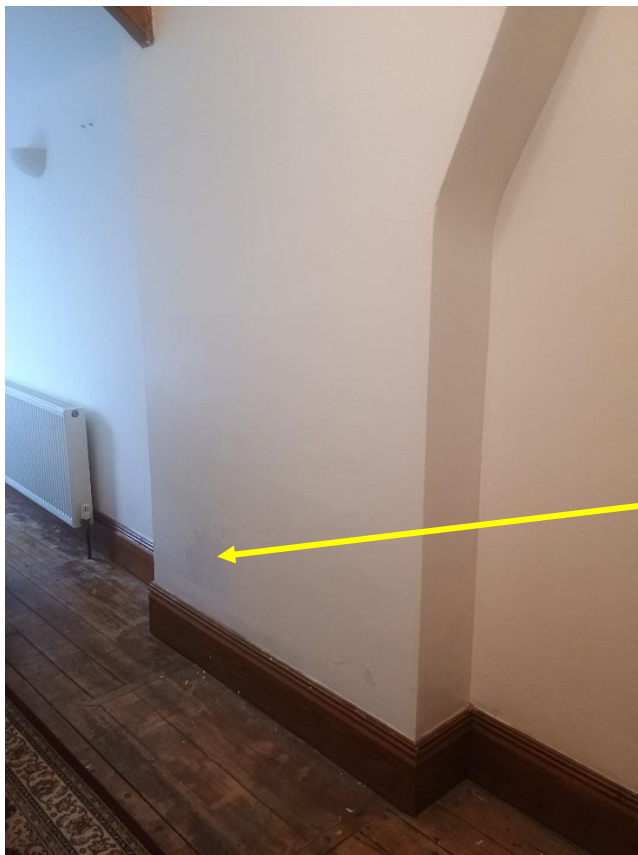
Evidence of damp  
ingress through  
upper room chimney  
breast

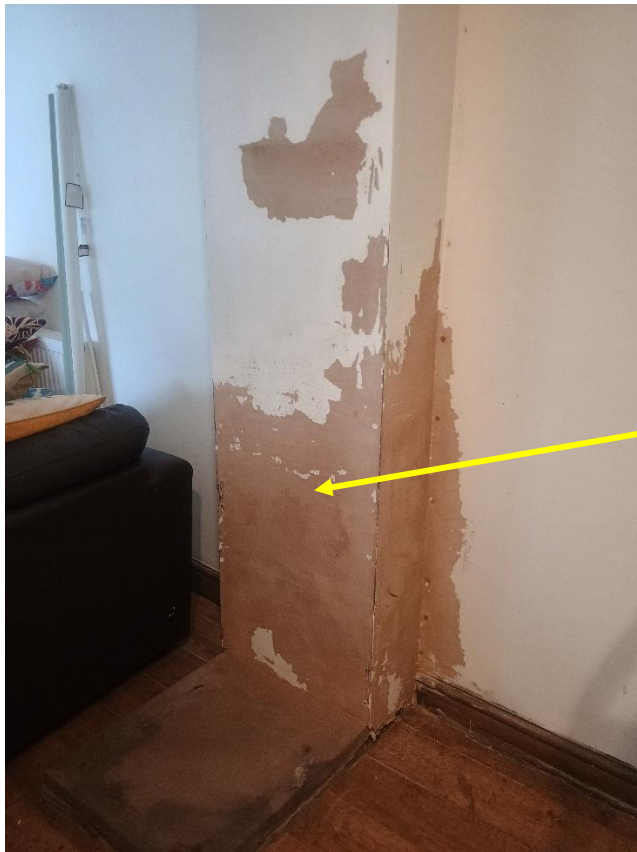
Significant damp ingress in lower room
