**D20-ONE**  
STRUCTURAL DESIGN

# **Structural Report for Proposed Conversion**

**Barn at Dilhorne House**

| | Project<br><br>Structural Survey Report – Barn at Dilhorne House, ST10 2PH | Sheet no./rev.<br><br>2 | Job Ref.<br><br>0625-01 |

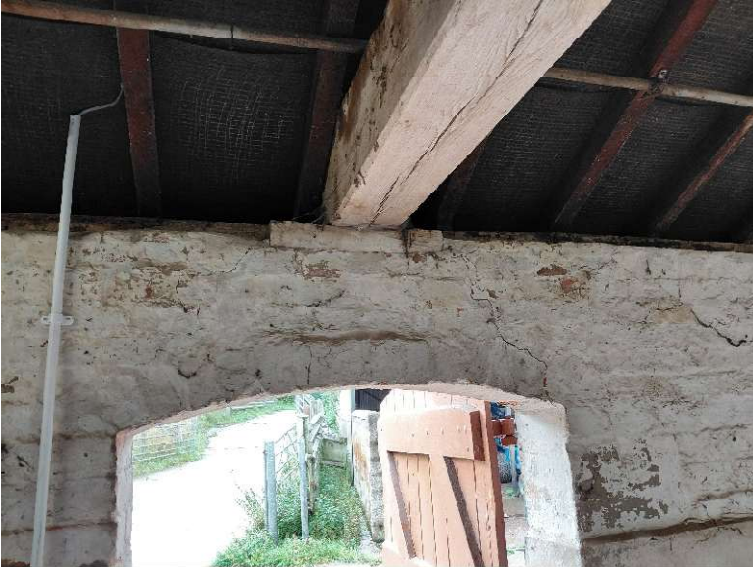
Truss support over doorway

- 4.5 Consideration to replacement or repair of timber purlins at their supports is required. It is recommended that the existing truss supports are assessed during detailed design, especially where these sit over doorways.

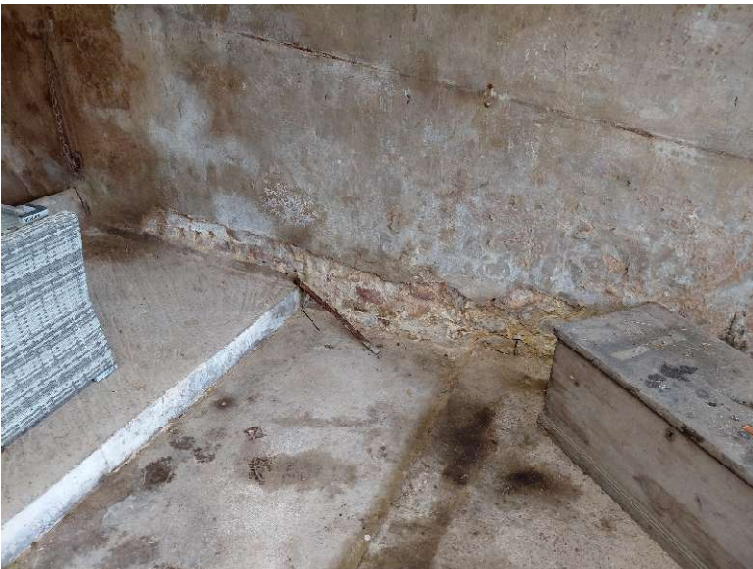
- 3.1.1.2 Some slight debonding of internal buttress walls.
  - 3.1.1.3 Minor cracking to masonry over some lintels.
  - 3.1.1.4 Evidence of rising damp.

Damp

- 4.2 Isolated sections of masonry are to be replaced where bricks have failed, damaged or cracked and repointing carried out as necessary. The introduction of damp proofing and control of surface water should be considered to control damp ingress.

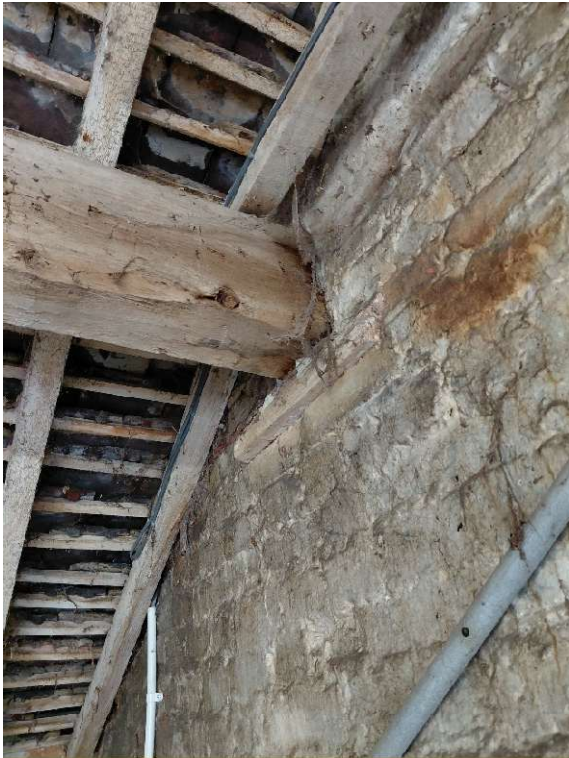
- 3.1.2.3 Purlin ends that are seated in brickwork appear to be suffering from degradation.
  - 3.1.2.4 Truss members appear to be repurposed timbers.

Purlin ends

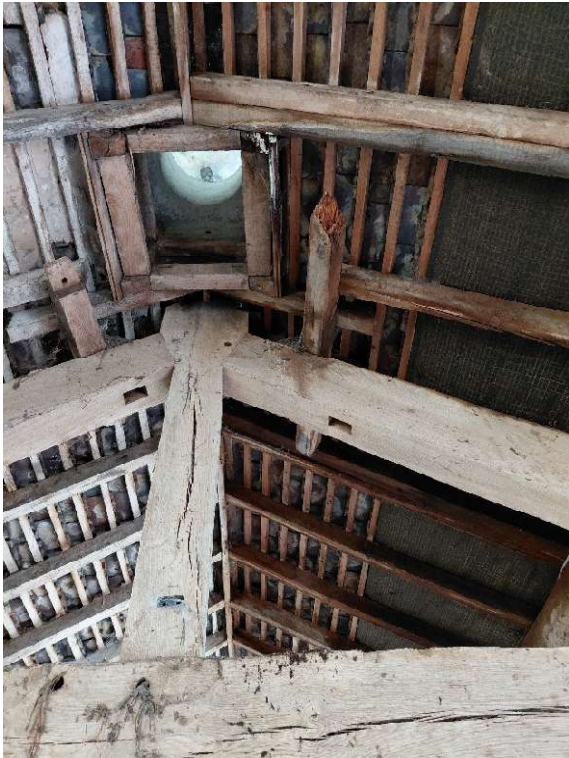
Repurposed truss

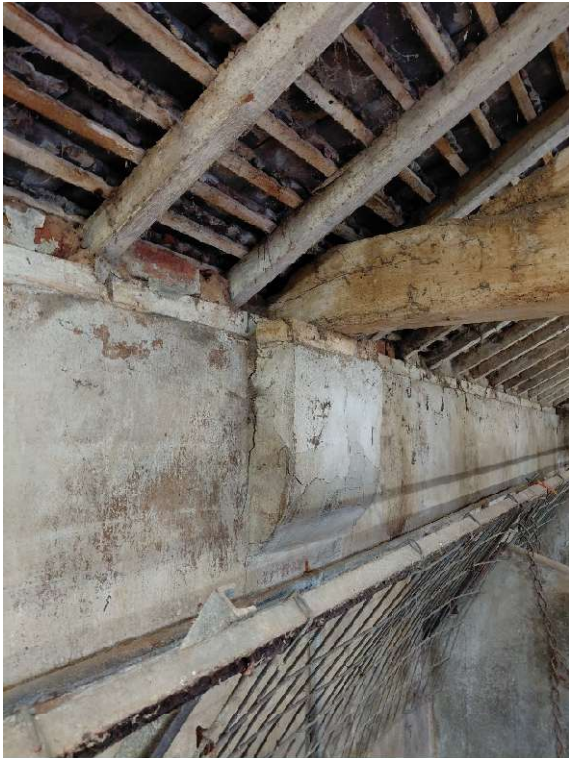
Truss support

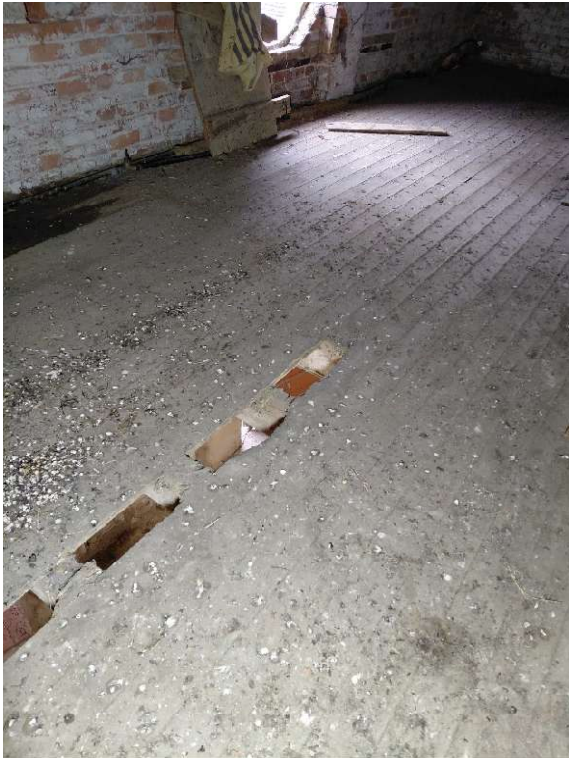
- 3.1.3 Timber lintels are noted on some openings.
- 3.1.4 First floor covering is in poor condition with widespread areas of structural distress and failure.

Damaged first floor

- 4.6 All failed or timber lintels are to be replaced.
- 4.7 Suspended ground floor over lower ground floor is to be replaced.
- 4.8 Due to the observed condition of the first floor, it is recommended that the covering is replaced where necessary. Existing floor joists are to be checked for capacity during detailed design with the appropriate loads considered. It is recommended that the first-floor structure is to be tied back to existing masonry walls to increase robustness.

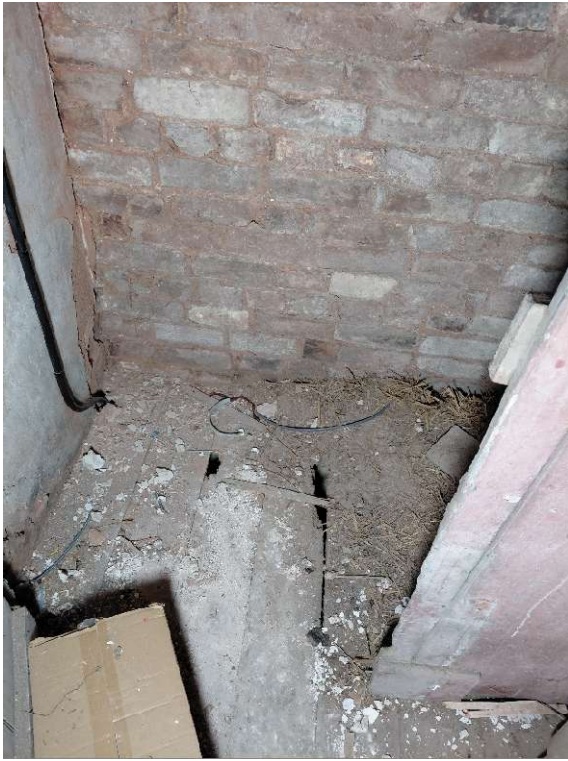
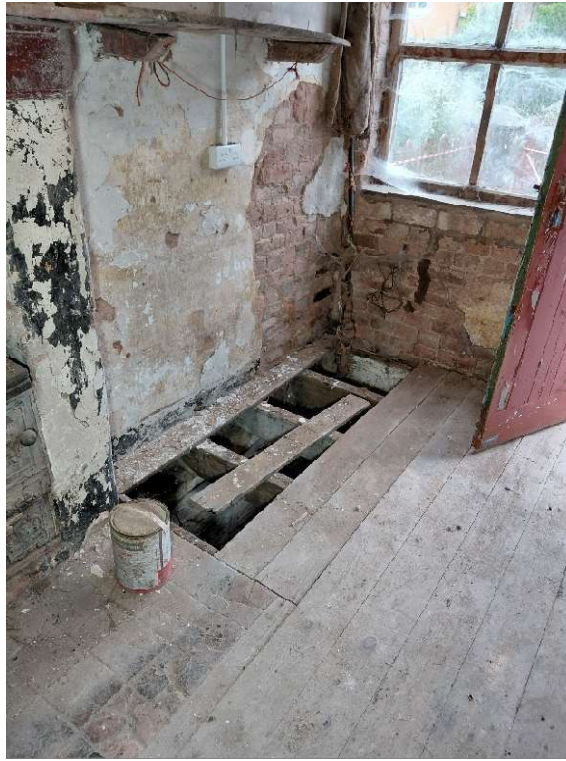
- 3.1.6 Suspended timber ground floor is in poor condition with localised failures and evidence of significant distress.
- 3.1.7 Roof structure observed is generally in poor condition. Failures of structural timber elements was noted in areas accessible.

Damaged GF

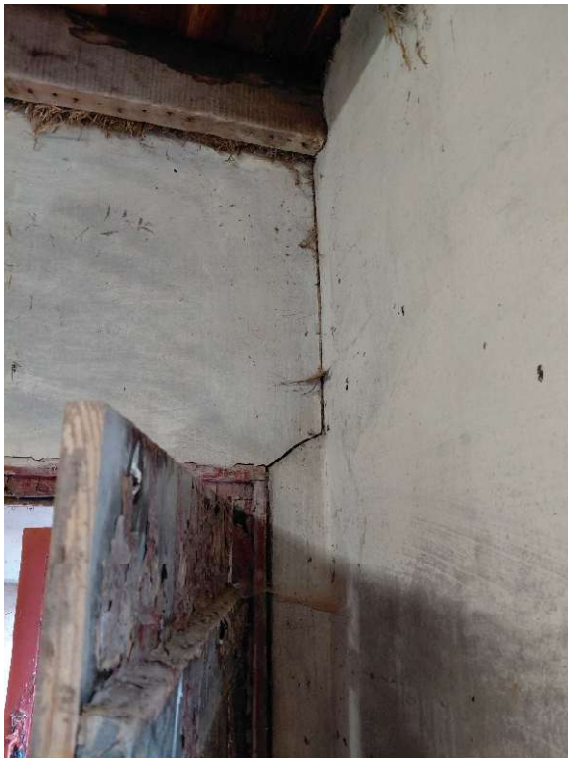
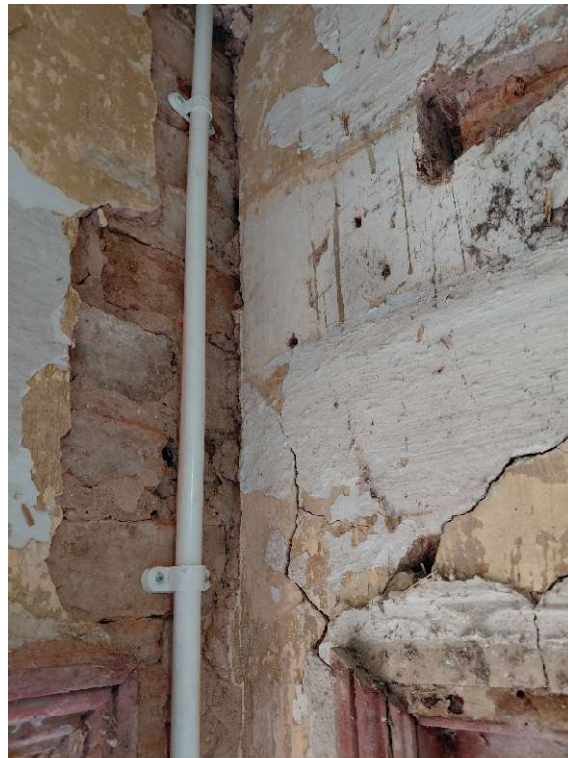
Debonding of buttress walls

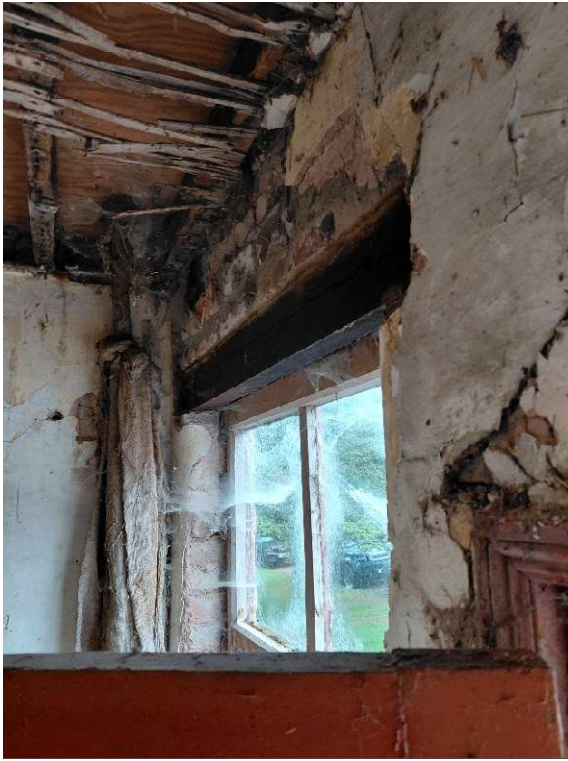
Timber lintels

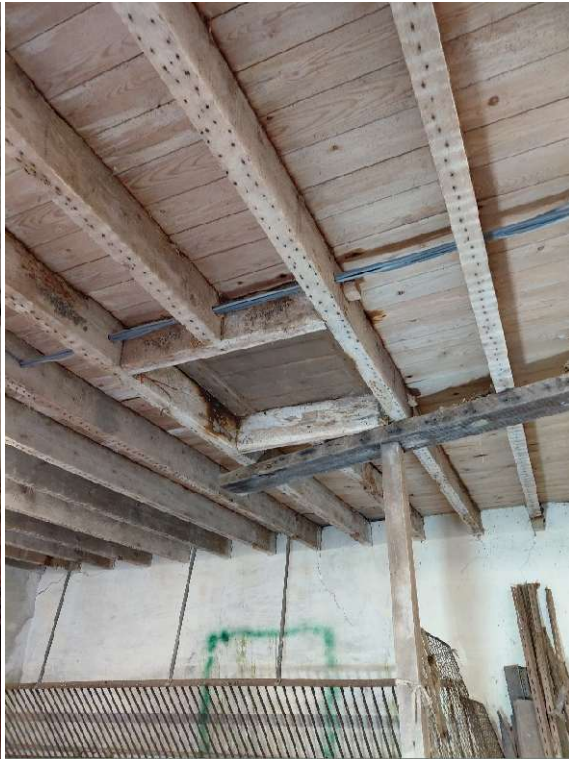
- 3.1.5 First floor joists appear to be repurposed timber although are in fair condition with only minor areas or distress especially in the Northern section. Props are noted.

Repurposed first floor with props

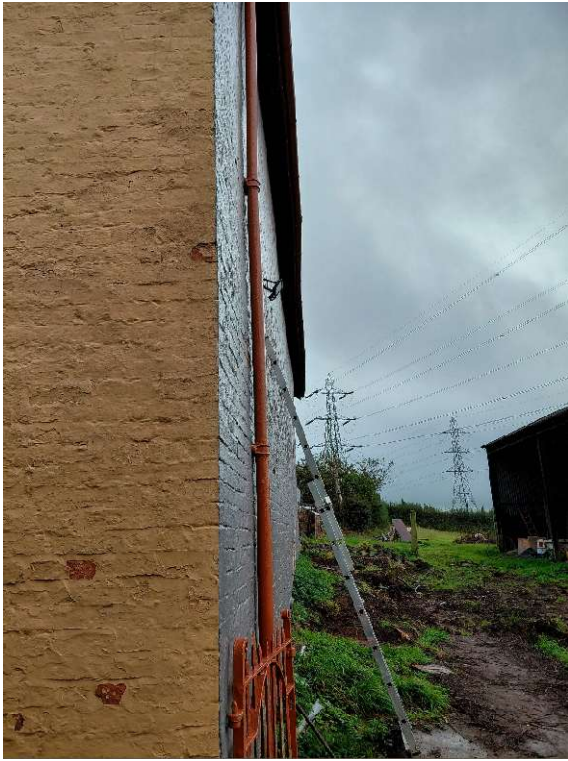
- 3.1.1.5 Slight bulge at eaves on the right hand part of the Western elevation.
- 3.1.2 Roof structure appears appropriate for type of structure and in fair condition.

- 3.1.2.1 Access to fully inspect the two-storey roof was restricted due to safety concerns.
  - 3.1.2.2 Dip in the ridge line to the Southern extent of the ridge that aligns with bulge as noted previously.

Bulge at eaves

- 4.3 The cause of the rotational movement at eaves, combined with the ridge dip, suggests a failure or long-term creep deflection of timber roof supports that will require further investigation and repair or replacement as agreed with a suitably qualified Structural Engineer.

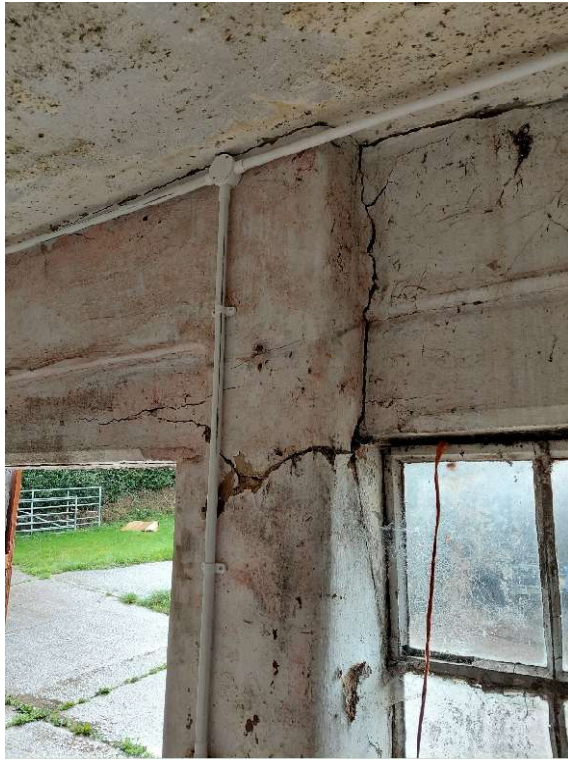
Cracking from lintel
