# Schedule of Repair, Renovation and Alteration Works

00987- Parkfields Farm Cherry Lane Cheadle Staffordshire  
ST10 4QS.

Conversion and alteration of former agricultural buildings to  
form 5no. dwelling houses and associated works.

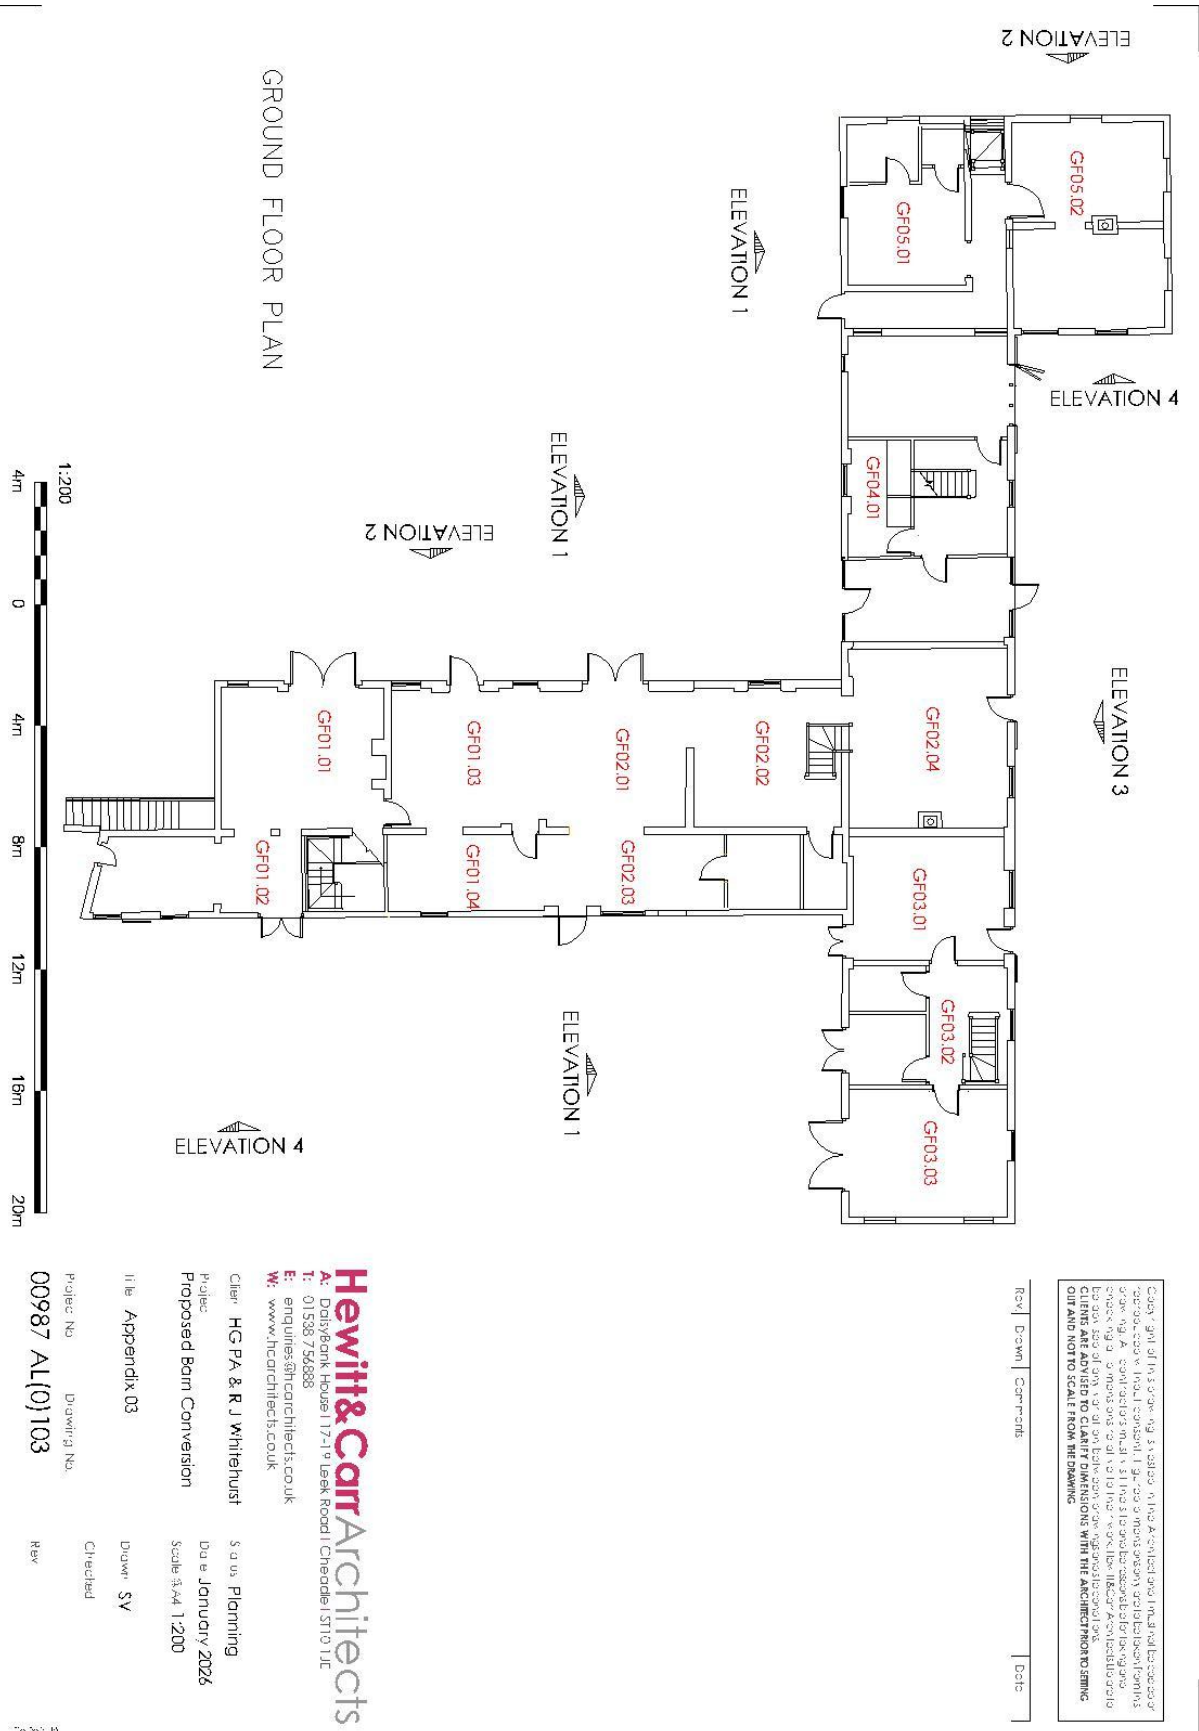
### 6.3 Appendix 3: Ground Floor Plan

Internal ground floors are late C20 non-permeable concrete slabs laid to various falls and troughs to accommodate former livestock and implement housing and agricultural practices. Condition and falls of existing floor are not compatible with conversion works, nor BR compliant, and loss of non-historic building fabric is considered to have a neutral impact to the heritage asset: As such, it is proposed, unless otherwise stated, all ground floors to receive the following treatment:

- Prepare 600x600x400dp trials holes as set out in schedule to determine existing floor construction through building archaeology, ready for safe removal of concrete slab and preparation of ground below to accept new floor construction.

- Concrete slabs carefully removed with particular attention paid around wall junctions to mitigate against damage to wall face and substructure: inspection made at 2m internals of exposed existing footings to mitigate against undermining sub structure; in the event preparations being required below existing footings advice to be sought from a suitably qualified engineer.

- Existing ground compacted with type 2 MOT ready to accept new BR compliant Concrete slab, DPC, Insulation, top screed, and floor finish.
- In the event of previous masonry floor finishes being discovered during the trial hole/ excavation process, slabs/ tiles/ setts should be carefully removed, cleaned and palletted ready for relaying as final floor finish (where practical).

| No | Repairs, Alterations and Renovations |
|---|---|
| GF01.01 | <ul style="list-style-type: none"> <li>• GGFRS</li> <li>• Prior to excavation prepare 600x600x400dp trials hole to determine existing floor construction through building archaeology.</li> </ul> |
| GF01.02 | <ul style="list-style-type: none"> <li>• GGFRS</li> <li>• Prior to excavation prepare 600x600x400dp trials hole to determine existing floor construction through building archaeology.</li> </ul> |
| GF01.03 | <ul style="list-style-type: none"> <li>• GGFRS</li> <li>• Prior to excavation prepare 600x600x400dp trials hole to determine existing floor construction through building archaeology.</li> </ul> |
| GF02.04 | <ul style="list-style-type: none"> <li>• GGFRS</li> <li>• Prior to excavation prepare 600x600x400dp trials hole to determine existing floor construction through building archaeology.</li> </ul> |
| GF03.01 | <ul style="list-style-type: none"> <li>• GGFRS</li> <li>• Prior to excavation prepare 600x600x400dp trials hole to determine existing floor construction through building archaeology.</li> </ul> |
| GF04.01 | <ul style="list-style-type: none"> <li>• GGFRS</li> <li>• Prior to excavation prepare 600x600x400dp trials hole to determine existing floor construction through building archaeology.</li> </ul> |
| GF05.01 | <ul style="list-style-type: none"> <li>• GGFRS</li> <li>• Prior to excavation prepare 600x600x400dp trials hole to determine existing floor construction through building archaeology.</li> </ul> |

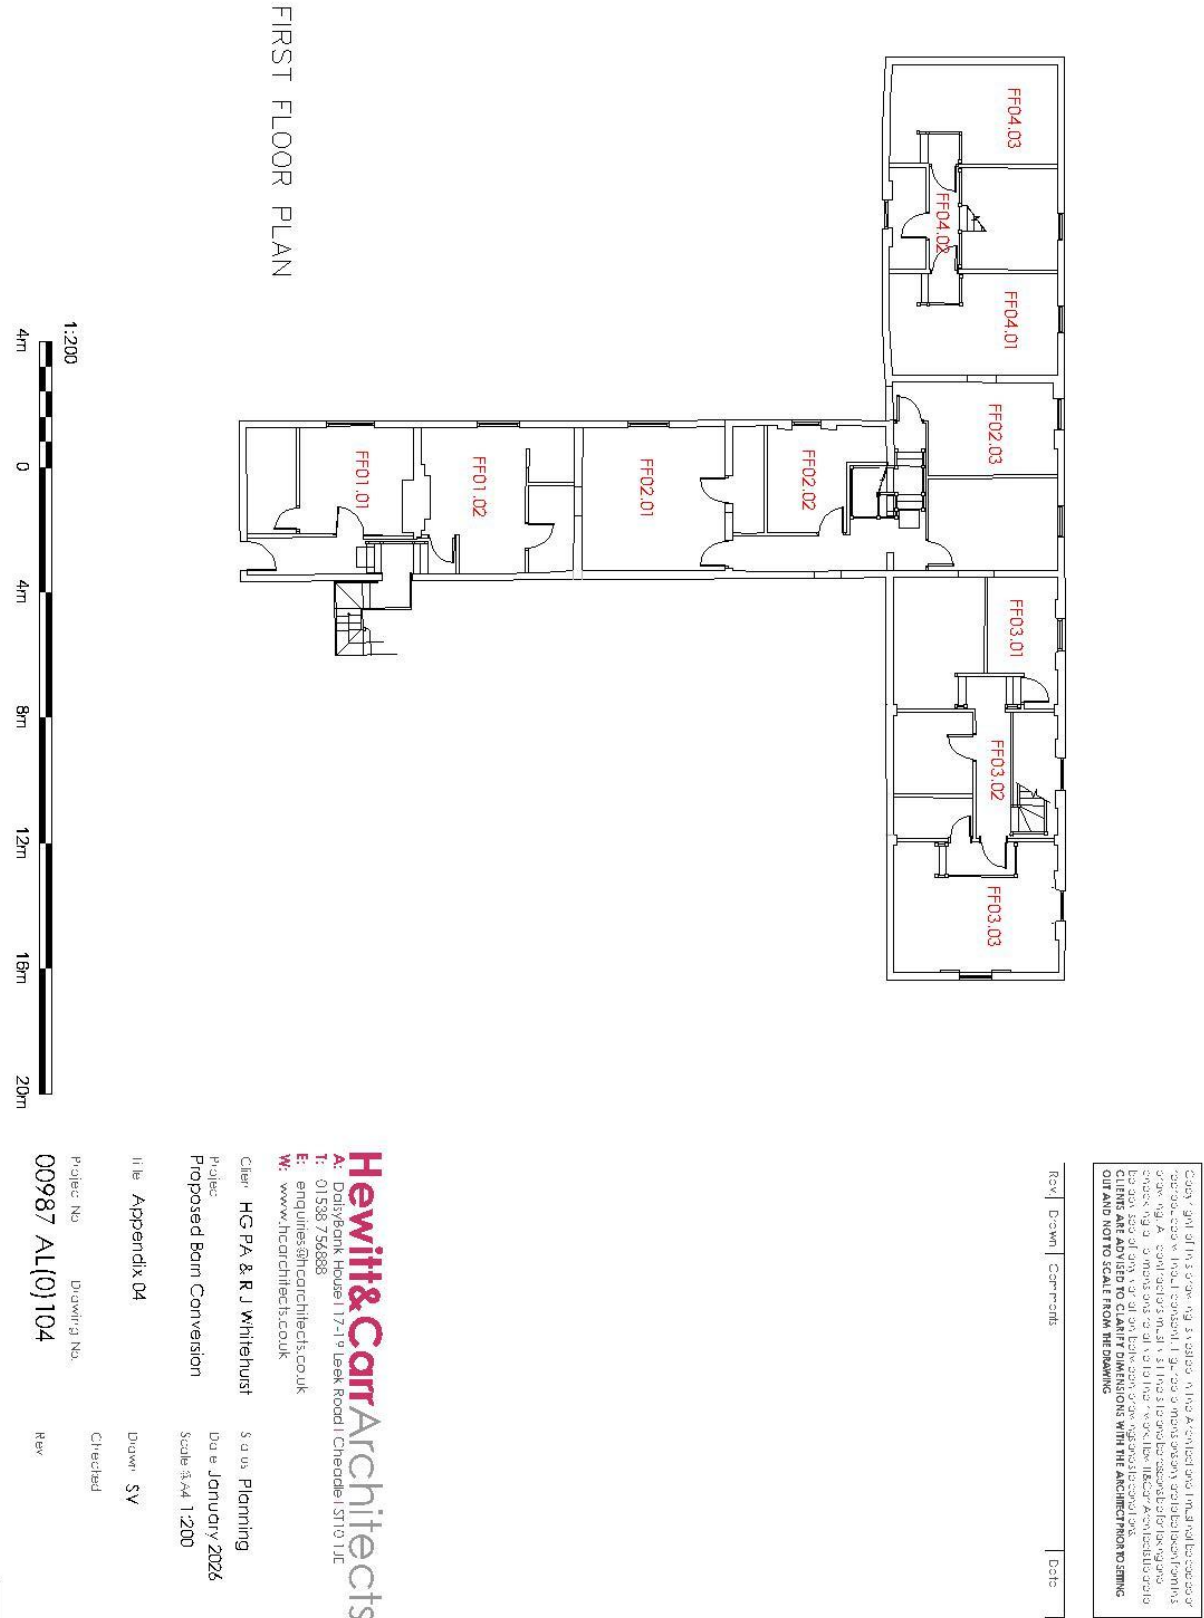
6.4 Appendix 4: First Floor Plan

Due to extensive and prolonged water ingress due to failing roof coverings most timber floorboards and timber joists are now in a poor state of repair with significant deterioration at wall junctions. Various repairs and additional structural supports have been installed during the late 20<sup>th</sup> and early 21<sup>st</sup> century using non-traditional construction methods and materials (largely made up of steels recycled from agricultural vehicles and portal frame buildings). Condition and fabric of existing floor are not compatible with conversion works, nor BR compliant, and loss of non-historic building fabric is considered to have a neutral impact to the heritage asset: As such, it is proposed, unless otherwise stated, all first floors to receive the following treatment:

- Careful removal of all floorboards, joists and steel supports: existing steel and timber joist pockets cleaned and prepared ready to accept replacement structure.
- Install new BR compliant timber floor joists, floor boards and additional supports as needed. Where possible floor joists to span from eaves wall to eaves wall to assist with continued integrity of the building structure.
- Demolition and construction work to be carried out sequentially between loadbearing cross-walls/ walls/ principal timbers and temporary propping utilised to maintain integrity of the building throughout works.
