13<sup>th</sup> June 2025

250561-C2C-XX-XX-LTR-S-C01

**RE: LONDON MILL, LEEK – STRUCUTRAL CONDITION OF EXISITNG TIMBER FLOORS**

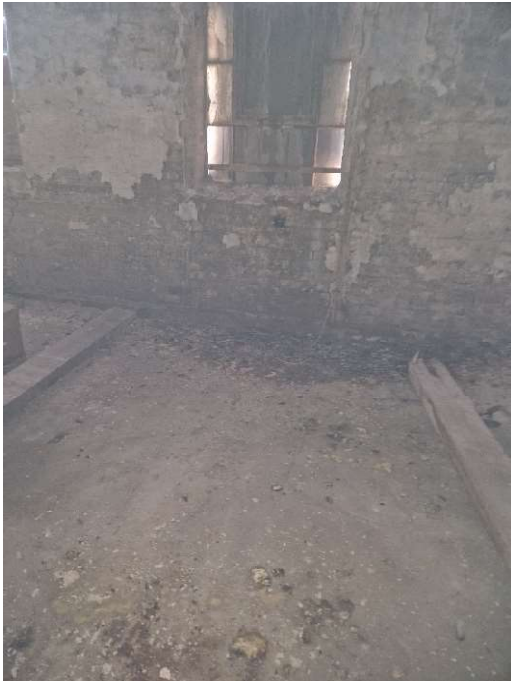
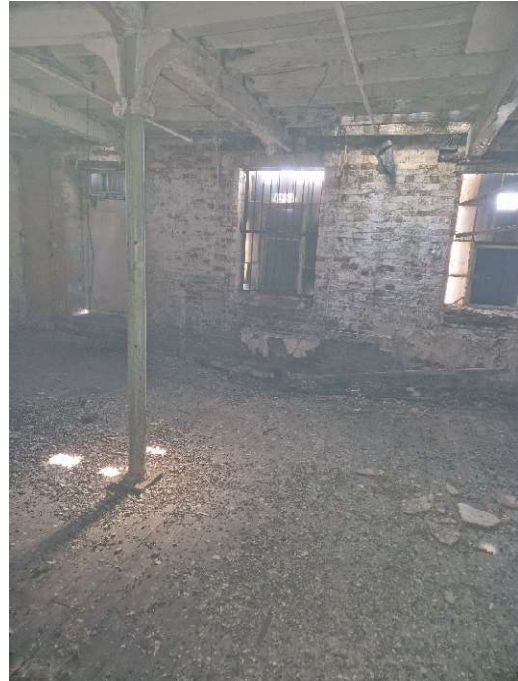
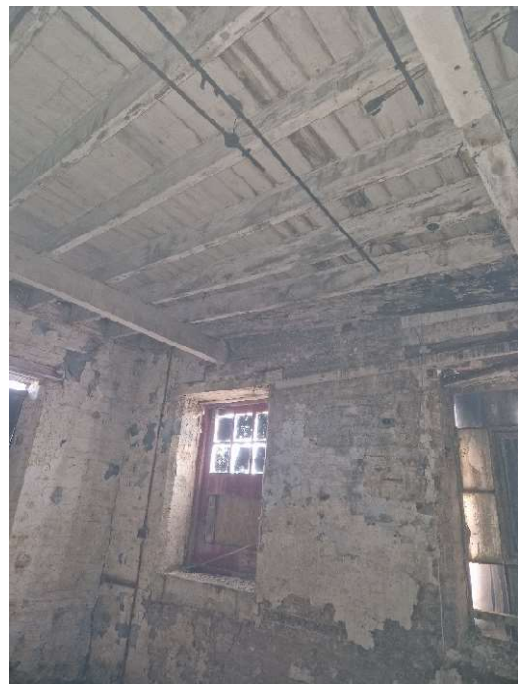
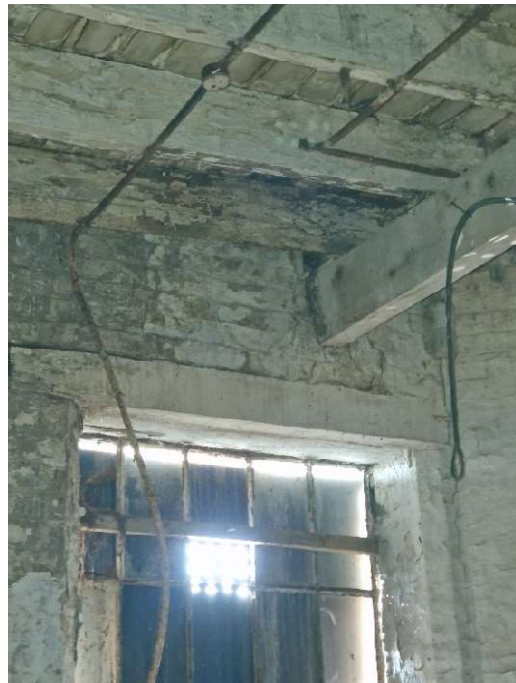
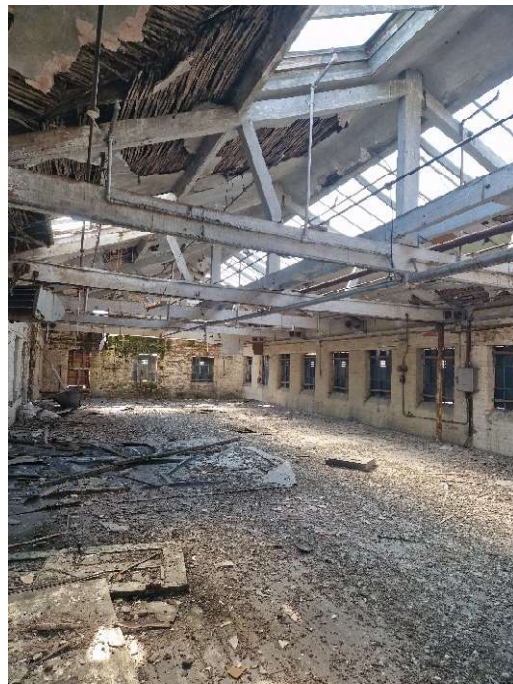
## APPENDIX A

The purpose of the investigation completed by C2C was to determine whether the damaged floor structure adjacent to the western elevation could be temporarily propped and made safe to allow building surveyors to inspect and record the historic interior features of the building at each floor level. The existing floor structure is supported via a series of central cast-iron posts which support a central beam which is scarfed at intervals along its length. This beam then supports timber joists which span from the perimeter walls. During the inspection, it became apparent that the extent of wood rot was significant. At each floor level, the floor structure (timber beams, joists and floorboards) has dropped on the western end of the building. Some of the primary timber beams in this zone appear to have sheared at the support location, others have dropped due to failure of the inner leaf timber lintels. Photographic evidence of the damage described above is provided in Appendix A.

Due to the extent of the current floor deformation and structural damage, a safe method of temporary propping the existing timber floors is not considered feasible. We therefore recommend that the impacted floor area shown in Appendix B is demolished and reinstated in a bottom up approach. With the first floor structure reinstated, remediation works at upper levels may then be completed safely as access can be made via the reinstated floor below. To account for potential instability and disturbance of the damaged floors above, we advise that a crash deck is provided to ensure that any debris from the floors above does not fall on the contractors when completing the construction work at lower levels.

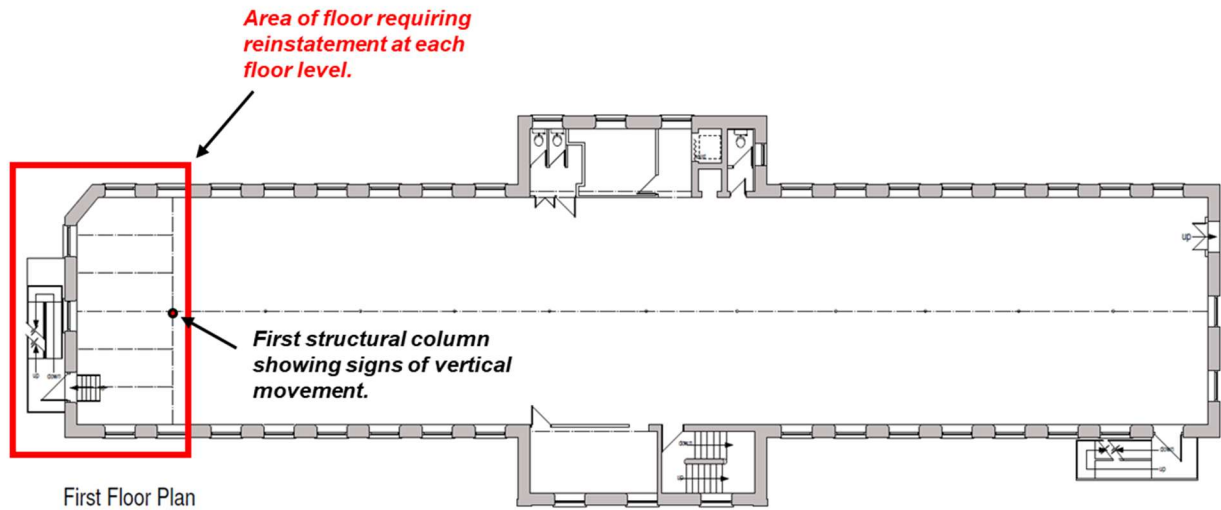
## APPENDIX B

During the inspection, the first central column from the western elevation appeared to have dropped slightly at each floor level (for column location, see Appendix B). Prior to completing any reinstatement works, this defect should be investigated further. As part of the floor replacement work, this central support member may need to be removed and reinstated back to its original position.
