# Building Engineering Evaluation

## Building at Victoria House, Stanley Moss Lane, Stanley ST9 9LR

**Client:** Mr.& Mrs. M. Yates

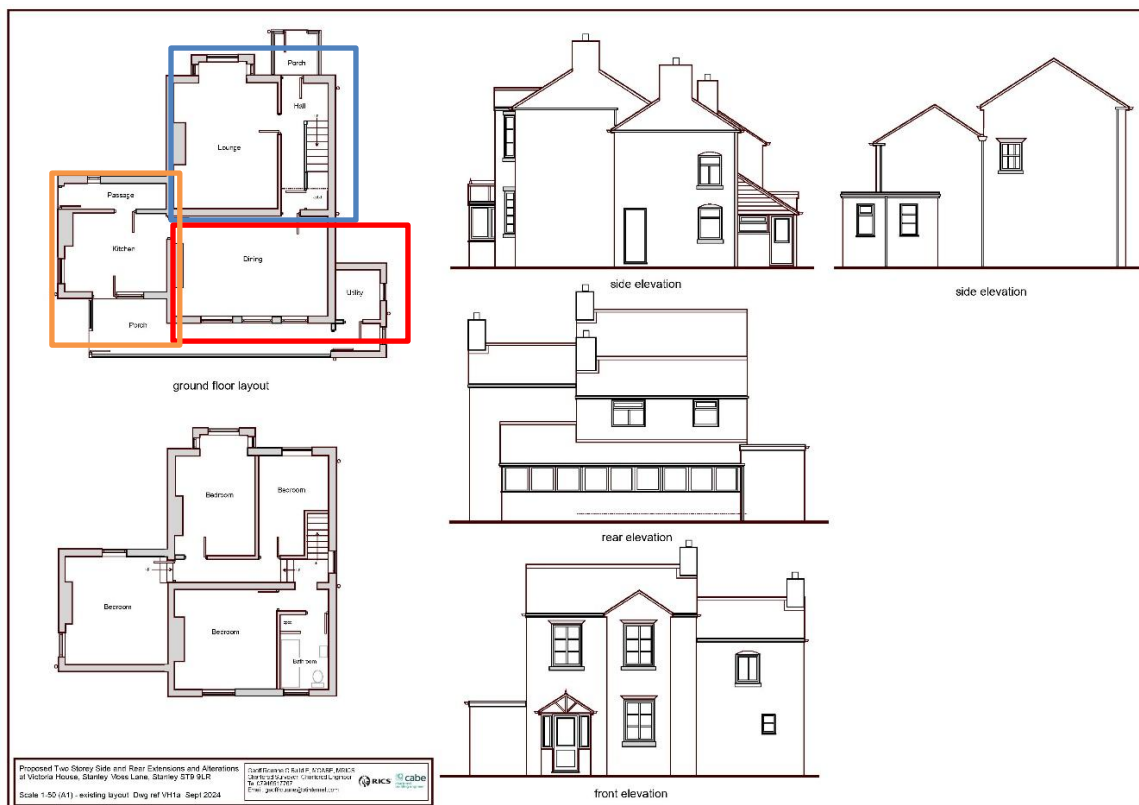
3.2 The project is self-build and is being undertaken directly by the clients. It has been determined following removal of some internal finishes, surfaces and linings, including ceilings, that the building comprises three distinct stages in its development. What was originally considered to be the main and oldest part of the building (ie. the front) is actually the most recent part of the building. The original building being at the back. These three distinct areas and therefore construction methods are shown on the following drawing.

Fig 1 Existing layouts with building phases shown

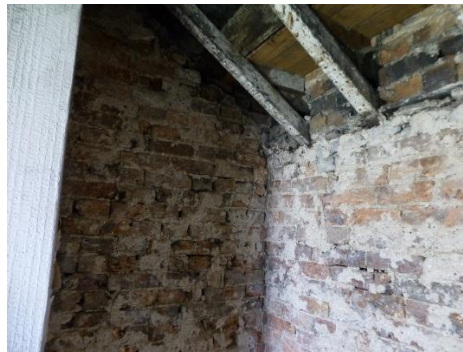
In relation to the proposed renewal of the roof structure; the existing spine wall running the width of the building at the junction of the front pitch and rear pitches of the roof configuration is barely adequate with the inadequate foundation construction now revealed.

Fig.3 Inadequate bonding between external wall and internal loadbearing wall and brickwork built off original timber soleplate

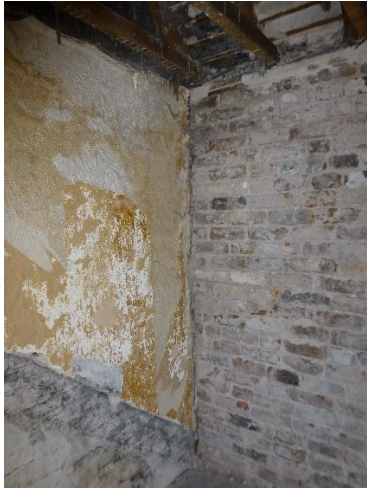
Whilst at first glance the front of the building, highlighted by the blue box in fig 1.0, perhaps appears visually sound, it is actually severely compromised by inadequate bonding between the other two parts of the building with varying floor levels, faulty valley gutters and weak brickwork following years of water ingress behind failing rendering (which has since been hacked off to reveal the defects referred to).

Fig. 4 Inadequate bonding

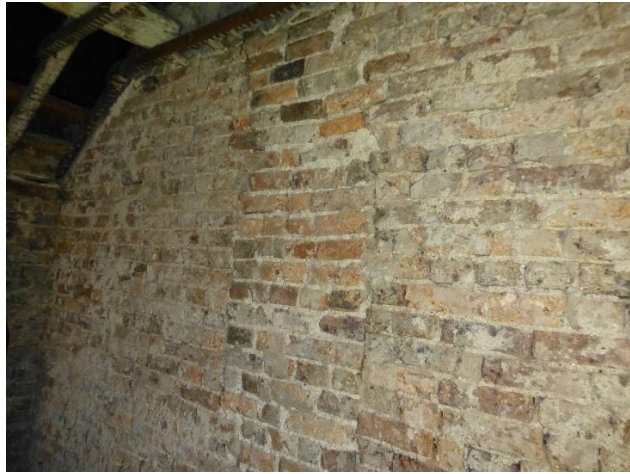
Fig. 5 Previously repaired brickwork without bonding

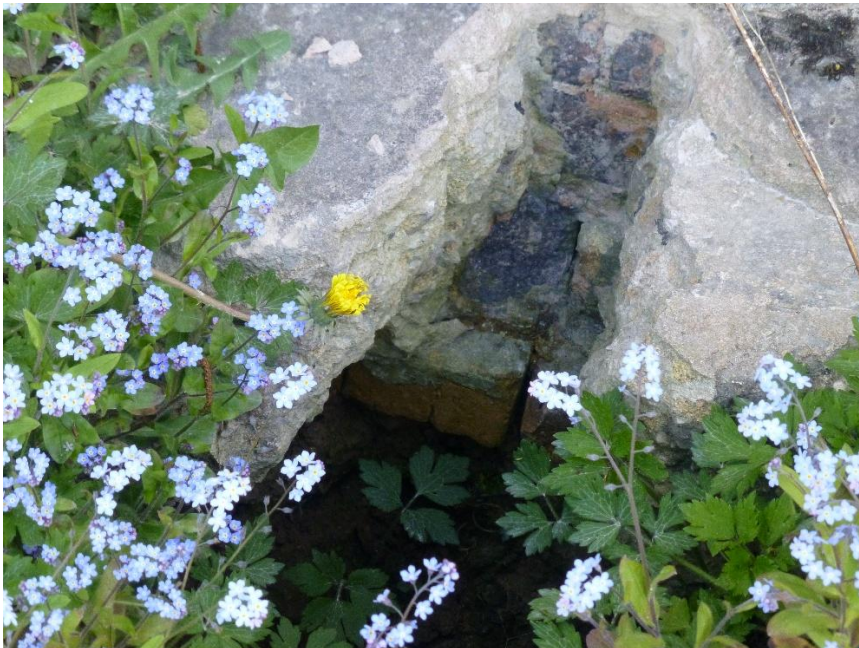
The photograph below shows the below ground conditions of part of the external wall to the second (orange) phase of the original construction. Whilst a spread brick foundation would be fairly typical of a domestic property of this age, Victoria House does not even reflect that and the walls are simply built almost directly off the ground. This type of work (not a foundation) is wholly inadequate and simply not capable of supporting new, additional or altered forces from refreshed or changed superstructure. A system of underpinning is likely to be more detrimental to the stability of the existing fabric.

Fig. 6 Existing below ground brickwork

The building as it currently stands should be removed.
