Structural Appraisal Report on

**The Cottage Building at
Fole Dairy
Uttoxeter Road
Uttoxeter
Staffordshire ST14 5EH**

July 2011

Report No. R11-1860

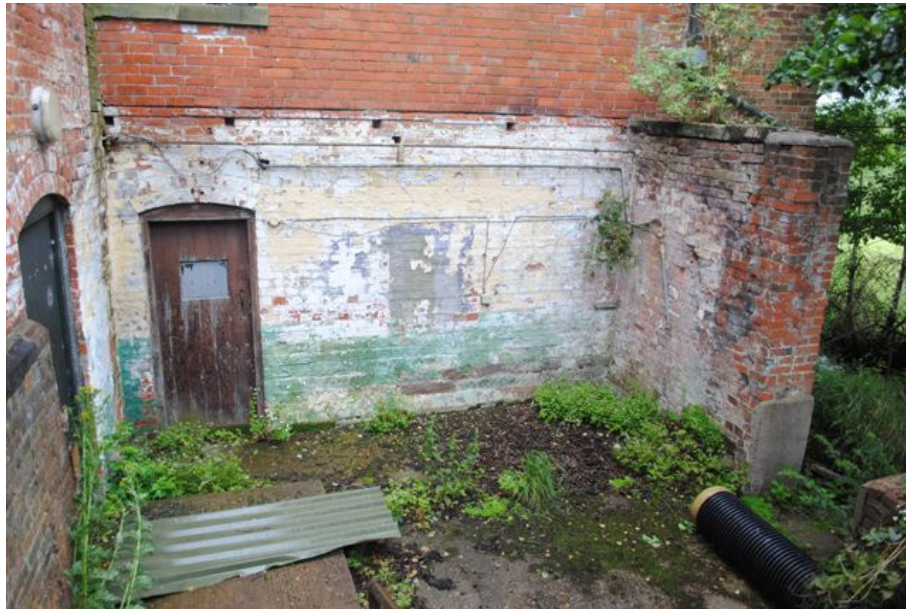
Photograph No. 1: Part View on West Elevation (Lower Level)

- 3.5 **West Elevation:** The lower part of the wall has been painted and there were pockets in the wall that suggest there was a previous building over the small courtyard. The wall also appears to have been extended towards the river. The brickwork is generally poor with numerous frost damaged bricks. The windows and rainwater goods would need replacing.
- 3.6 **Roof:** The roof was inspected by cherry picker with the vehicle on Fole Lane. The ridge lines undulate and there were many dislodged and slipped tiles. Sections of the gutters were blocked.
- 3.7 The two chimneys were reasonably plumb. The capping courses of both chimneys have cracked and there was flaking and missing brickwork. The majority of the flaunching was missing from the top of the west chimney.

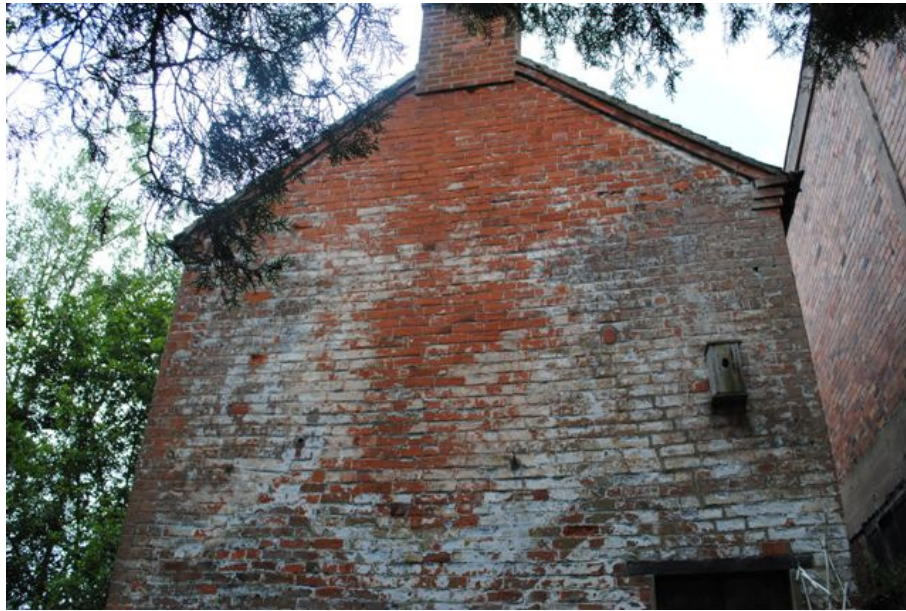
Photograph No. 3: View on East Gable Elevation

- 3.3 **East Elevation:** The wall is in very poor condition with many frost damaged bricks. The lower middle section of the wall has dropped and there was diagonal stepped cracking above the window which has been re-pointed and subsequently re-cracked. There was further cracking in the brickwork to the right hand side of the window cill.

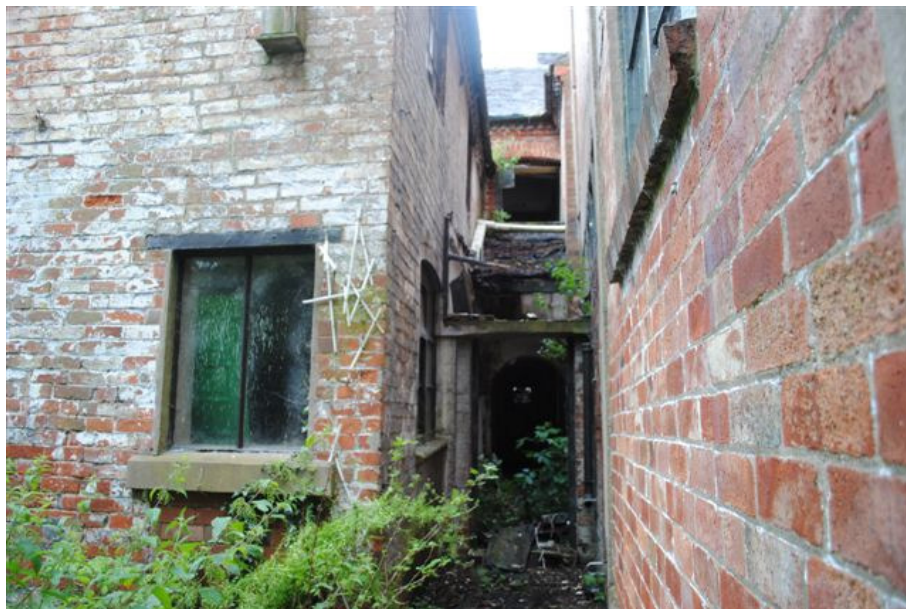
- 3.1 **North Elevation facing the Engineering Stores Building:** The wall was in poor condition with stepped cracking below the ground floor window cill and above the lintel. There is evidence of previous cracks having been re-pointed up to the underside of the first floor window cill. The wall leans outward towards the roof.

- 3.2 The roof of a previously covered narrow section of passageway has partially collapsed and is in a dangerous condition with rotting timbers and failed roof coverings.

Photograph No. 4: View along passageway with North Elevation on Left Side (Note: Collapsed roof covering)

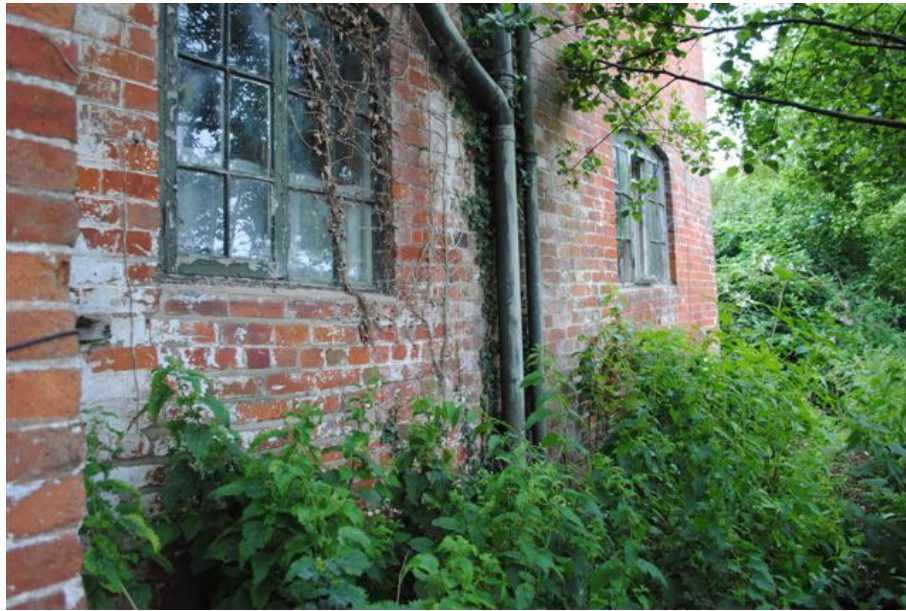
- 3.4 **South Elevation Facing The River Tean:** There is a considerable amount of settlement affecting the wall. The window openings are distorted and the cill brickwork slopes. Parts of the wall bulge outwards and there was stepped cracking at the short corner return and below the ground floor windows. The first floor window lintel has been re-pointed in the past.

Photograph No. 5: Part View along South Elevation (Lower Level)
(Note: Sloping bedjoints and window ledges)

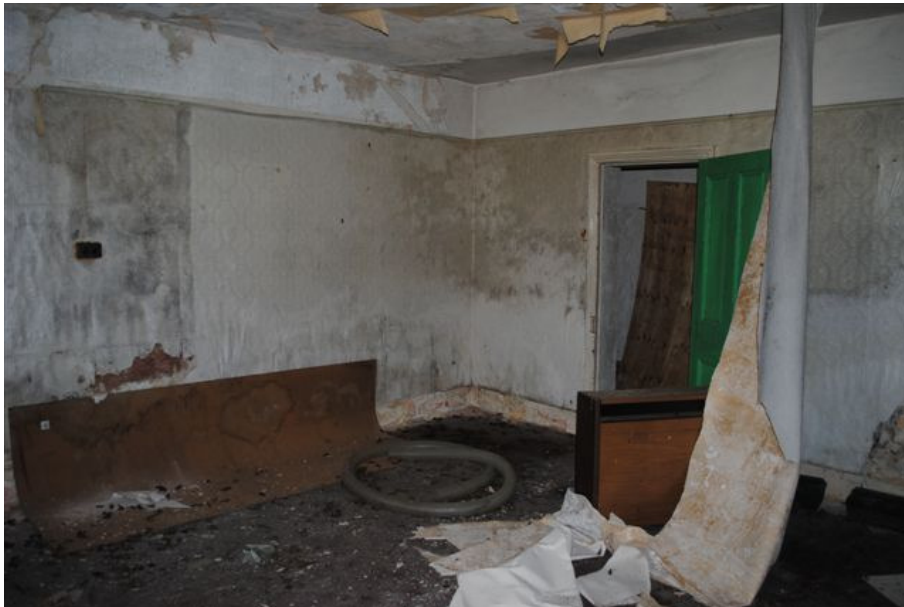
Photograph No. 8: Typical View inside property

4.0 Internal Observations: The interior was generally dilapidated throughout with evidence of significant amounts of settlement and associated structural cracking of walls. The ceilings are collapsing and damp/rainwater was penetrating many parts of the building. The roof space was not accessed due to the potential dangerous condition.

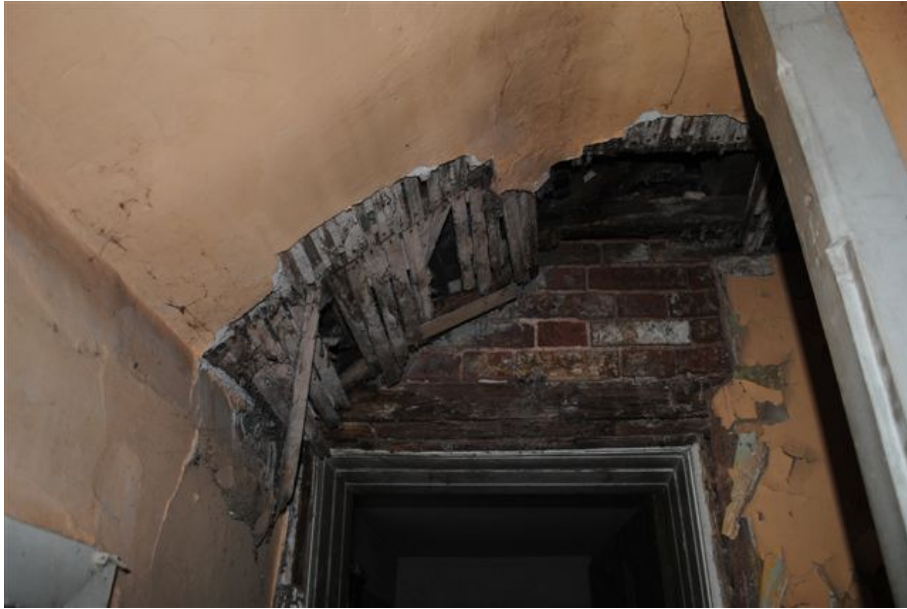
**Photograph No. 9: View on Ceiling at 1st Floor Landing
(Note: Collapsed Ceiling)**
