Property Address	The Talbot 1 Ashbourne Road Leek
Customers	Saxondale Properties Ltd & Premier Inn Hotels Ltd
Our Ref.	P12-290/GRW/JH
Inspection Date	6 August 2012
Report Date	10 August 2012
Prepared by	Giles Ward MA CEng MICE Partner giles.ward@hwa-consulting.com For and on behalf of Howard Ward Associates LLP

Summary

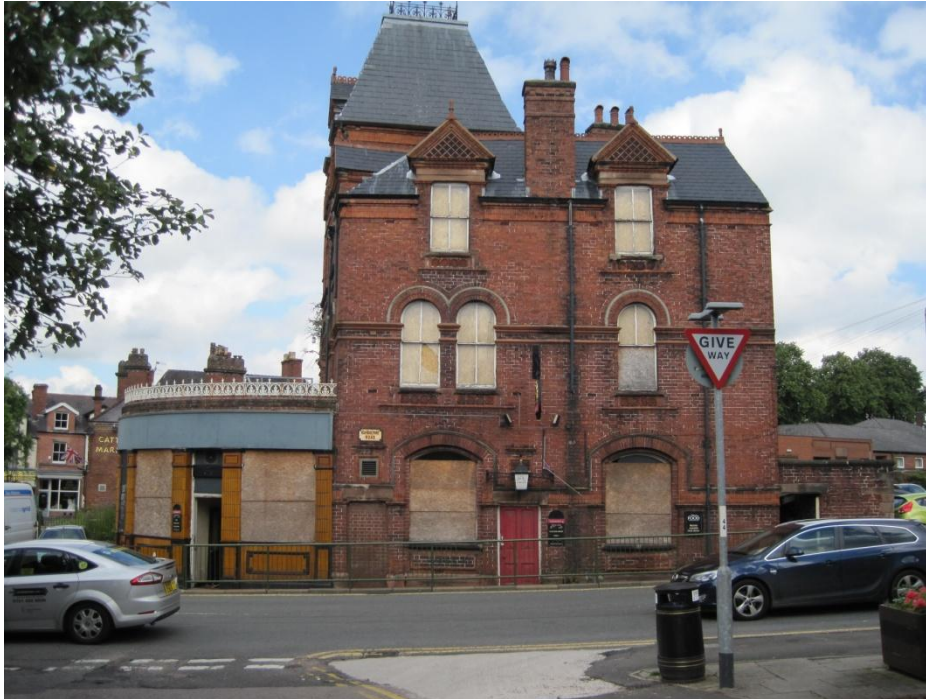
Photograph No. 2
Right elevation – General view

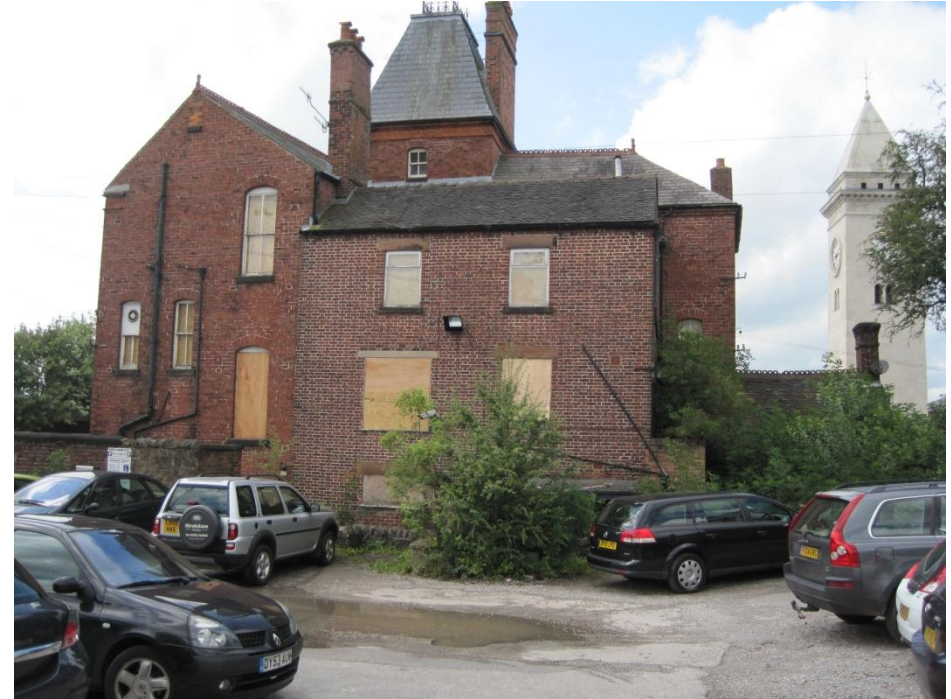
Photograph No. 3
Rear elevation – General view

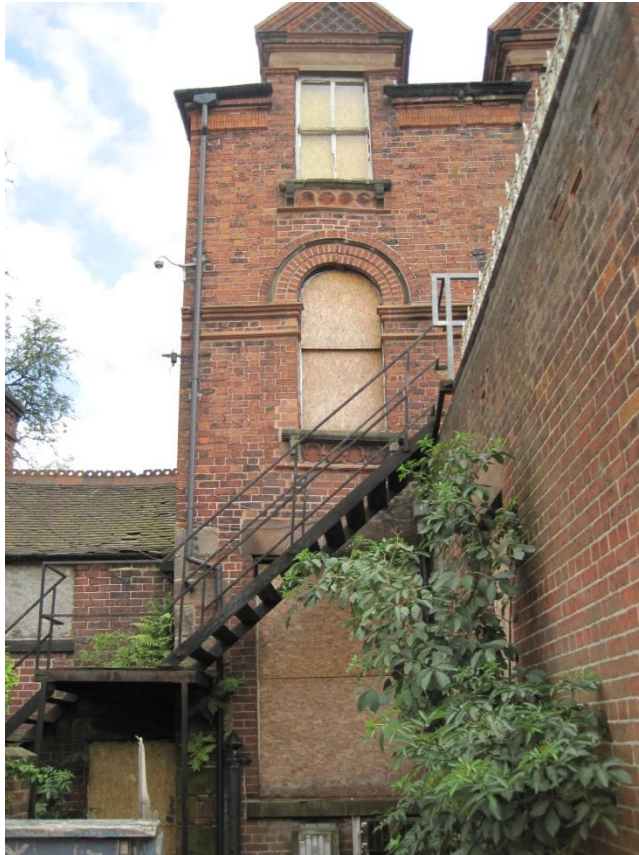
- 3.1 Signs of significant movement are apparent externally in the front elevation of the original part of the property towards its left-hand end. Photographs Nos. 4-8 illustrate.

Photograph No. 4
Original front elevation, left section

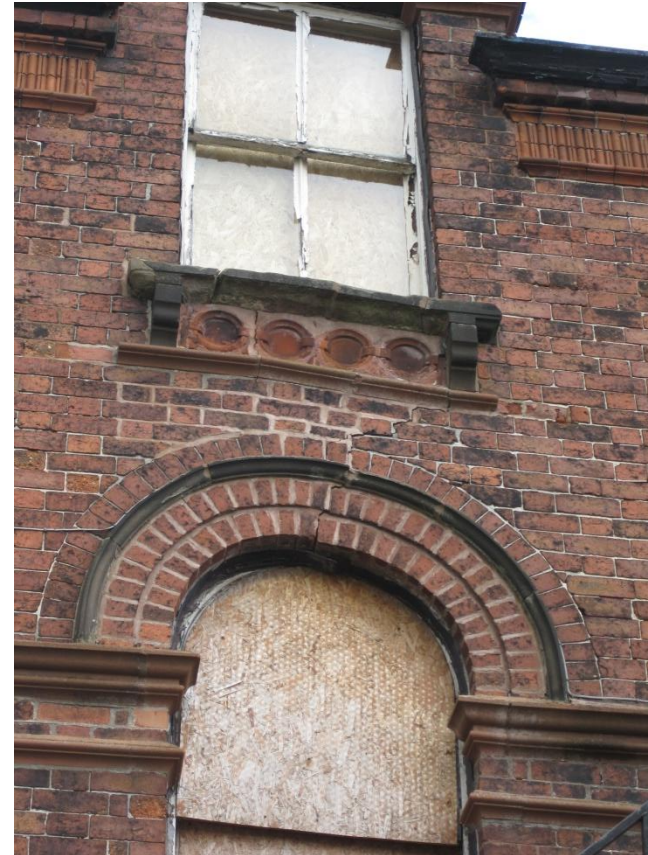
Photograph No. 5
Original front elevation, left section

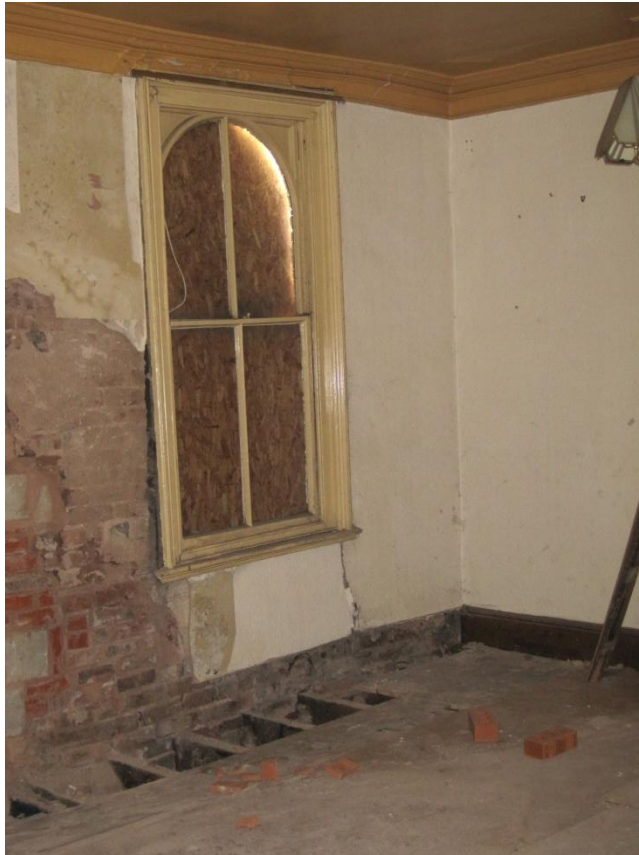
Photograph No. 6
First floor, front left room

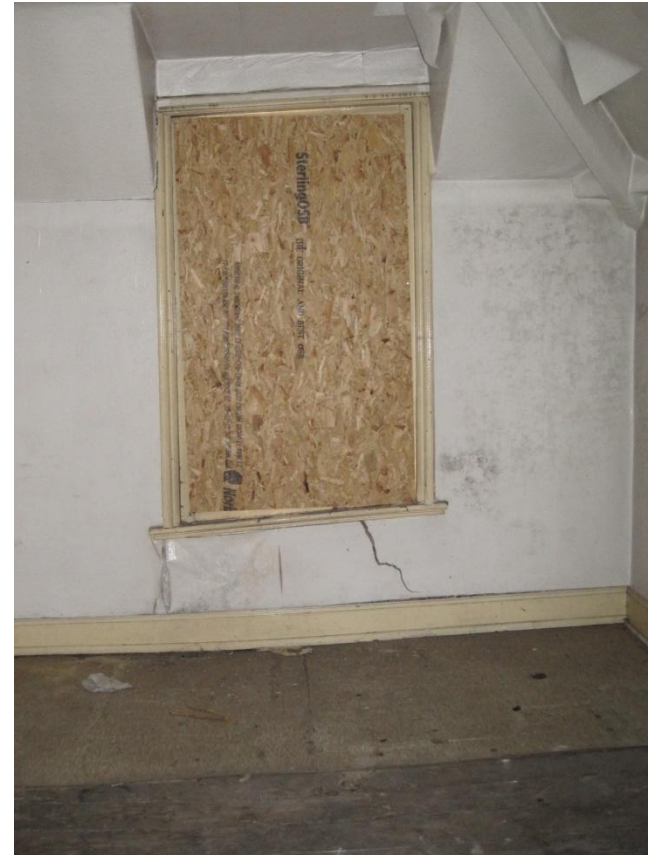
Photograph No. 7
Second floor, front left room

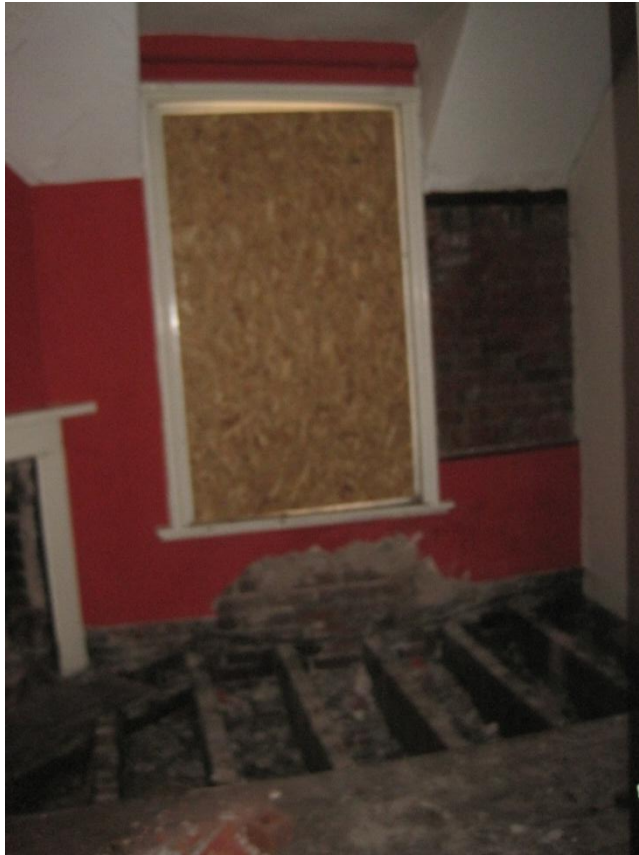
Photograph No. 8
Second floor front room adjacent to left corner

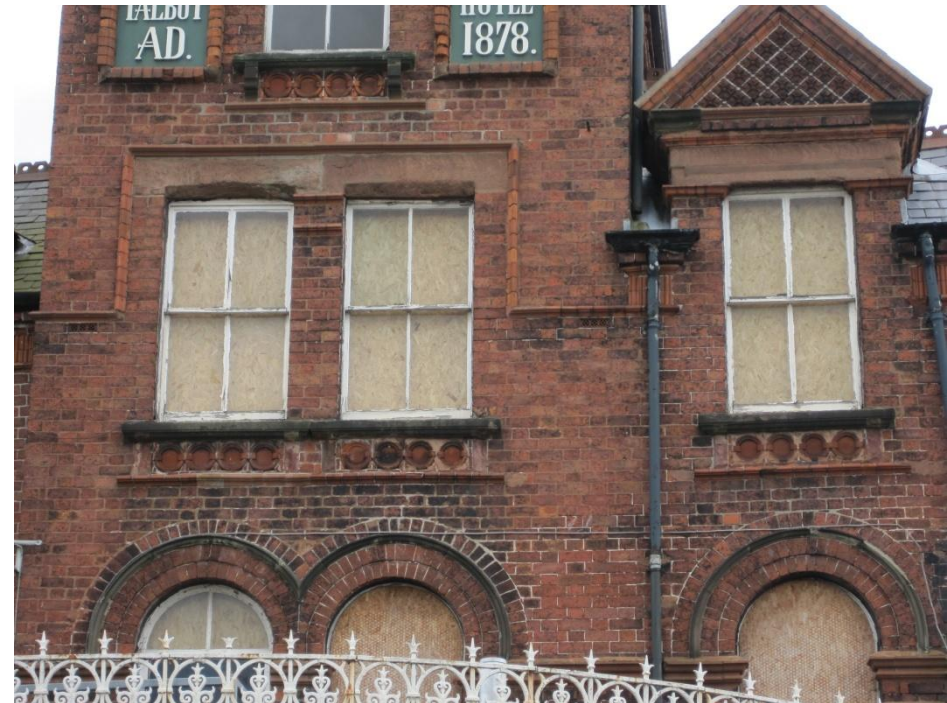
- 3.2 More minor distortions were apparent in the central/right section of the front elevation, as shown in photograph No 9, but these do not appear to have resulted in significant cracking or internal damage.

Photograph No. 9
Original front elevation, right section

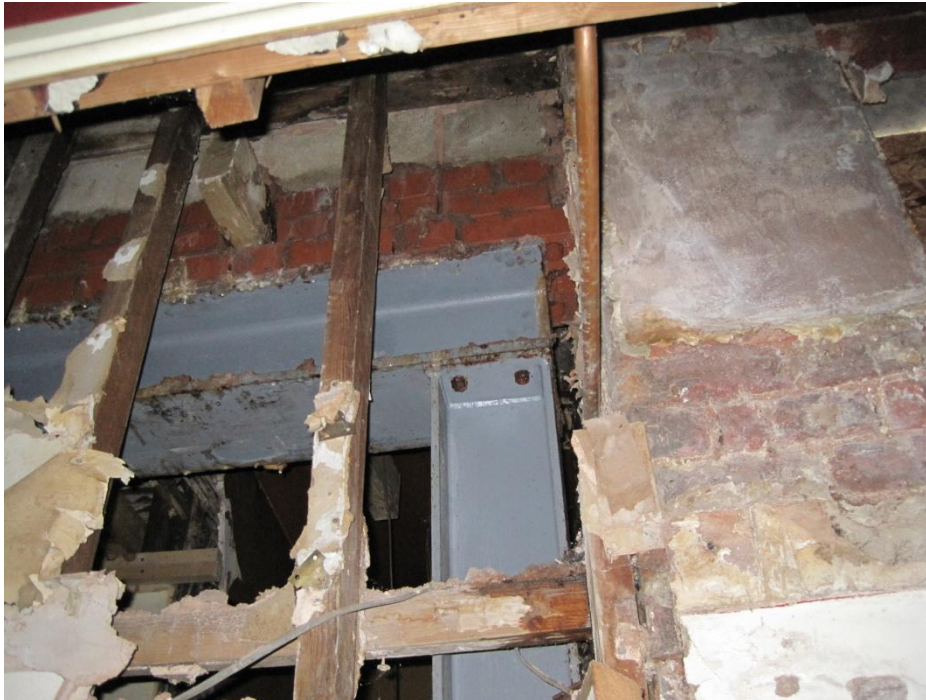
Photograph No. 10

- 3.3 Elsewhere, no signs of significant distortion or cracking to the main brickwork elements of the structure were apparent.
- 3.4 In the ground floor bar area below the most significantly distorted sections of the front elevation, relatively modern steelwork is evident as shown in Photographs Nos. 10 and 11. The original front wall has been removed below the main beam and a significant area of the front wall has been re-built above the beam, the blockwork to the inner leaf being visible on the first floor as shown in Photograph No. 12.

Steel column supporting steel beam in ground floor bar area

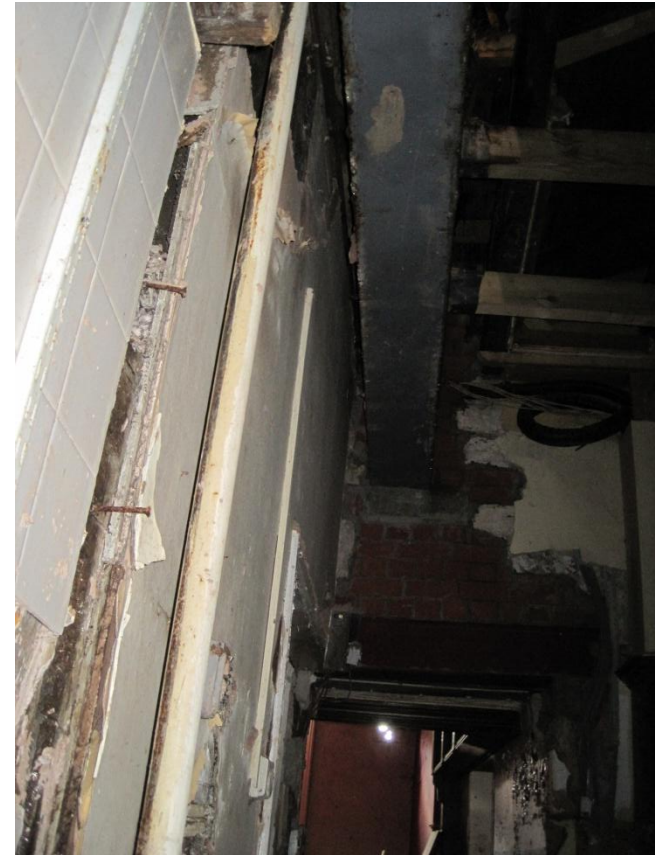
Photograph No. 11

Beam supported via steel lintel, bar area

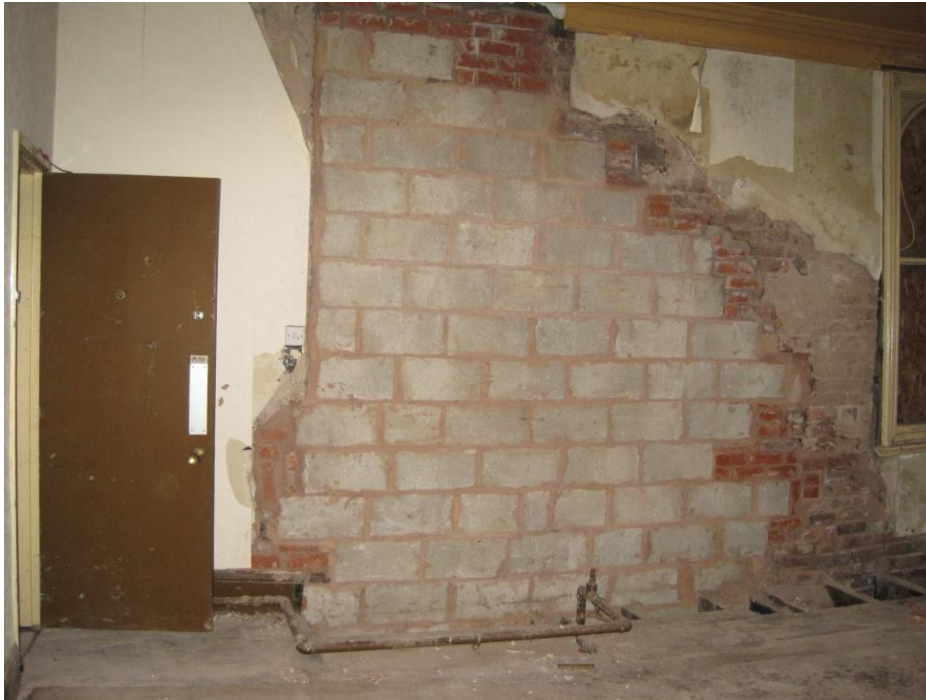
Photograph No. 12

First floor front left room. Front wall rebuilt in blockwork

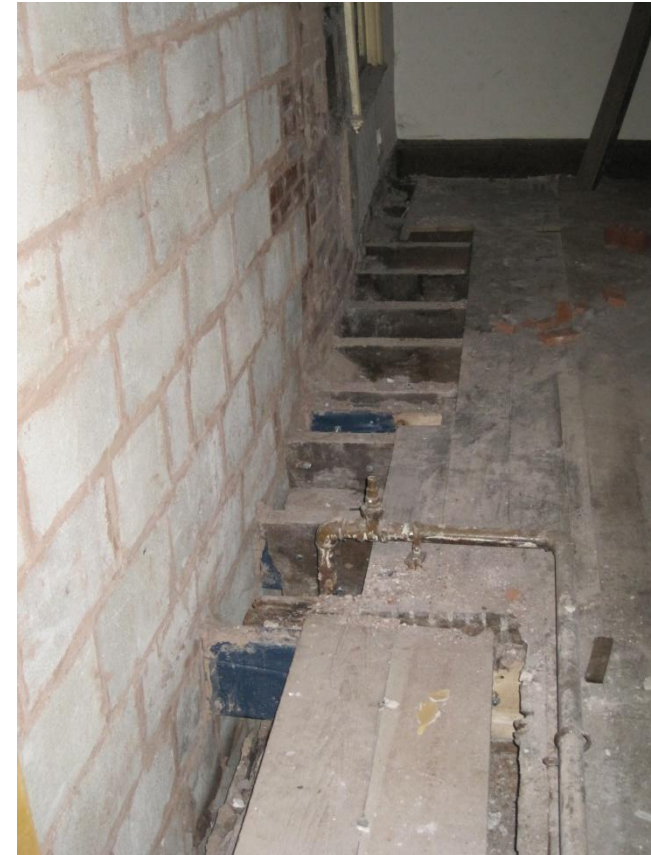
- 3.5 High moisture levels are present in much of the property. A major source of this appears to be in the ground floor bar area, where water was dripping in at the time of our inspection. We assume that the source of the water was an accumulation of rain on the flat roofed extension; although no significant rain fell during our inspection we suspect that there may have been some immediately prior to it. Although dampness in itself is not generally a structural issue, prolonged high levels of moisture are likely to lead to fungal attack on timber and we would strongly suspect that this is occurring, although limited access was available to the main structural timbers such as floor joists. Remedial works to the ends of some first floor joists appear already to have been undertaken, although it is unclear whether this relates to previous damage to the joists or to the installation of the adjacent steelwork. Photograph No. 13 illustrates. A localised area of the ground floor

First floor front left room. Joist ends replaced (bolted to existing)

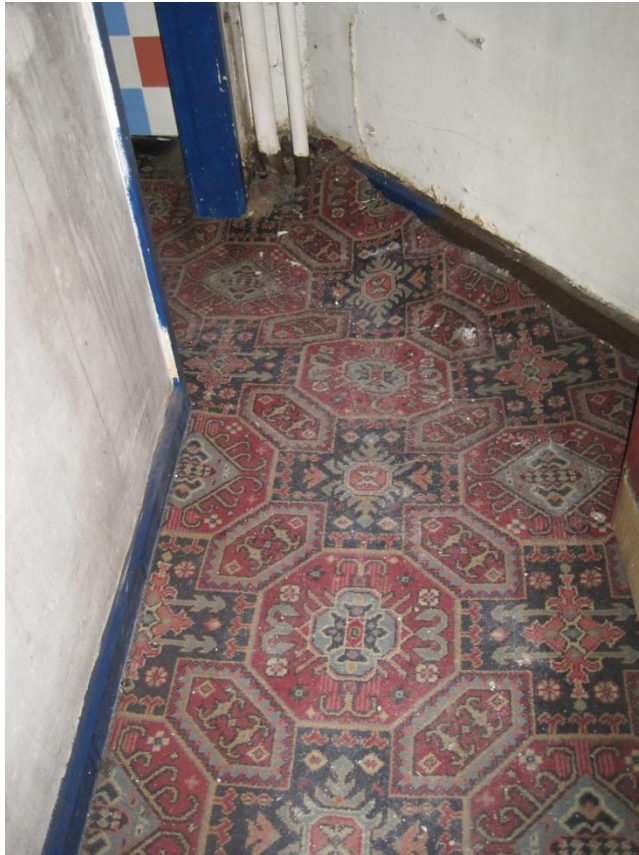
appeared to have collapsed in the rear right section around the entrance to the ladies toilets (Photograph No. 14) although it is unclear whether this is an issue of rot or damage from other sources.

Photograph No. 14
Ground floor rear right. Localised collapsed floor

4.3 As suggested above, we suspect that some structural timber elements within the property, especially in its lower parts, may have been damaged by fungal attack due to the high moisture levels. As a first step, it would be advisable to rectify the sources of moisture ingress, which appear to include defective flat roofing and possibly rainwater goods. A more thorough survey of the timber could then be undertaken, which we suspect would result in a requirement for the replacement of some sections of timber floor joist.

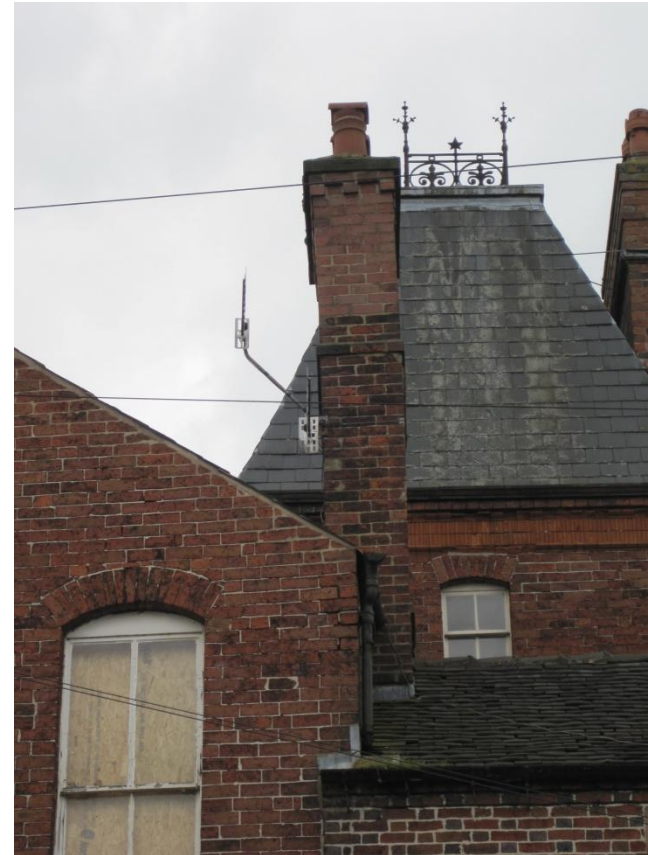
- 3.6 Minor disturbance to the tiling was apparent in the pitched roofed extensions but the slates to the original part of the building showed no signs of significant damage or sagging where visible. Limited access to roof voids was available but the upper section over the tower contained relatively new steelwork and timbers and we therefore suspect, given the consistently good external appearance of the roof, that much of it has been relatively recently renewed. A slight lean was however noted to the rear chimney as shown in Photograph No. 15, although the extent did not appear to be sufficient to warrant any immediate remedial action.

Photograph No. 15
Slight lean to rear chimney
