**Structural Appraisal Report on**

**The Engineering Offices at  
Fole Dairy  
Uttoxeter Road  
Uttoxeter  
Staffordshire ST14 5EH**

July 2011

Report No. R11-1862

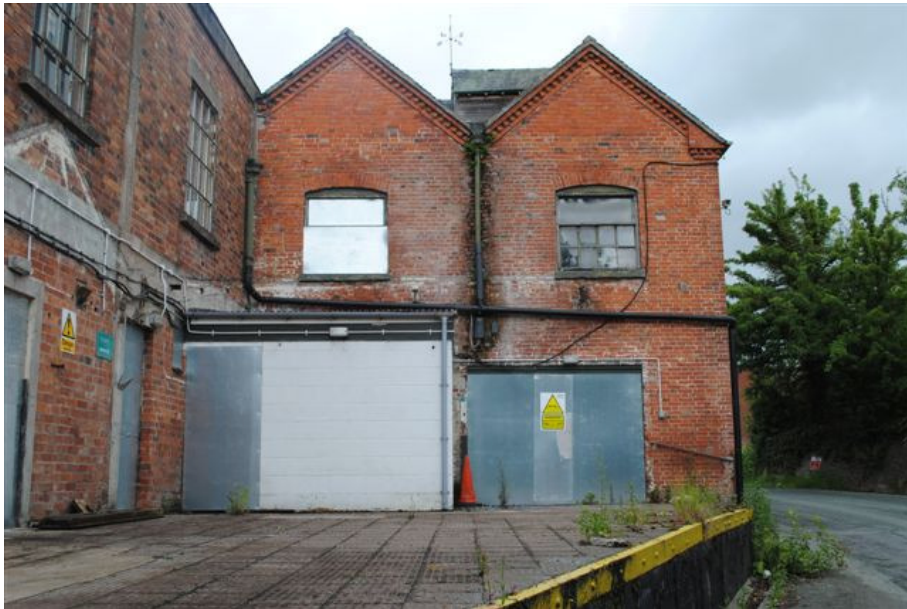
- 3.1 **East Elevation Overlooking the Loading Dock:** The elevation features twin gable walls of solid brickwork with feature brick string course verges. The first floor window openings have brick segmental arches. The timber window frames are decayed. There is an industrial sized door opening at ground floor/loading dock level.

- 3.2 The walls were reasonably plumb with no evidence of any foundation settlement or ground subsidence. There was old stepped cracking in the brickwork from the bottom left corner of the left hand first floor window cill.

- 3.3 The brickwork was in poor condition. There are many frost and impact damaged areas of bricks throughout and the original pointing is poor. Extensive re-pointing has been carried out in the past which does not match the original.

- 3.5 The rainwater goods are a mixture of original and modern plastic pipes. The downpipe and hopper from the valley gutter appear to be original but have been leaking for a long time with vegetation growing out of the brickwork around the

**Photograph No. 2: View on East Elevation of East Building**

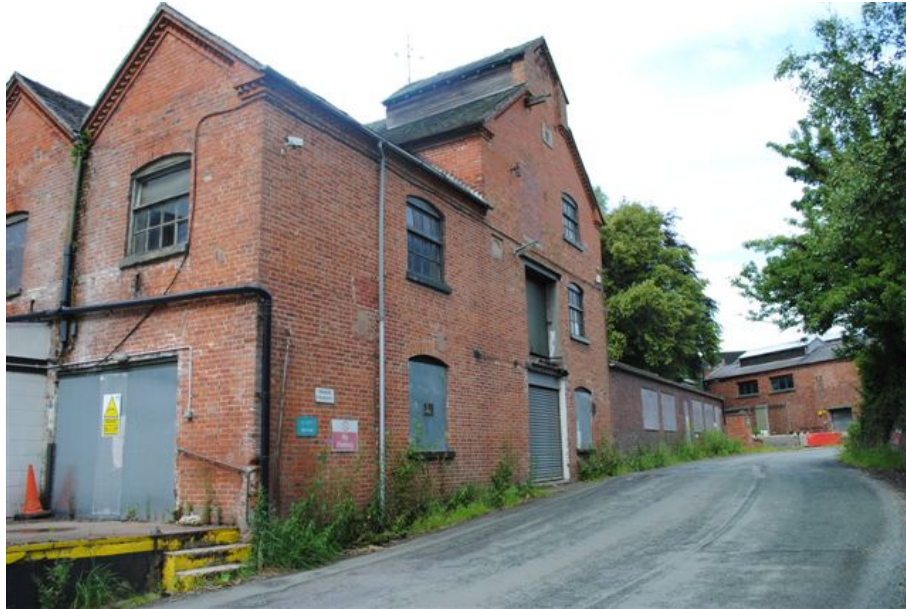
- 3.8 The wall was reasonably plumb with no evidence of any significant structural movement.
- 3.9 There were some frost damaged and patched areas of brickwork and evidence of two former beams having been built into the wall. The pointing was generally poor.

- 4.2 The ground floor loading door was a modern steel roller shutter. The brickwork around the opening was impact damaged and the brickwork above the steel beam lintel was loose and displaced. A previous loading door has been bricked up at second floor level.

- 4.3 The wall was reasonably plumb with no evidence of any significant structural movements but there are several frost damaged bricks and the lower two thirds of the wall has been re-pointed in the past. The upper third of the wall appears to be more recent construction and could have been part of the rebuilding in 1897.

**Photograph No. 3: View on North Elevation of East and West Buildings**

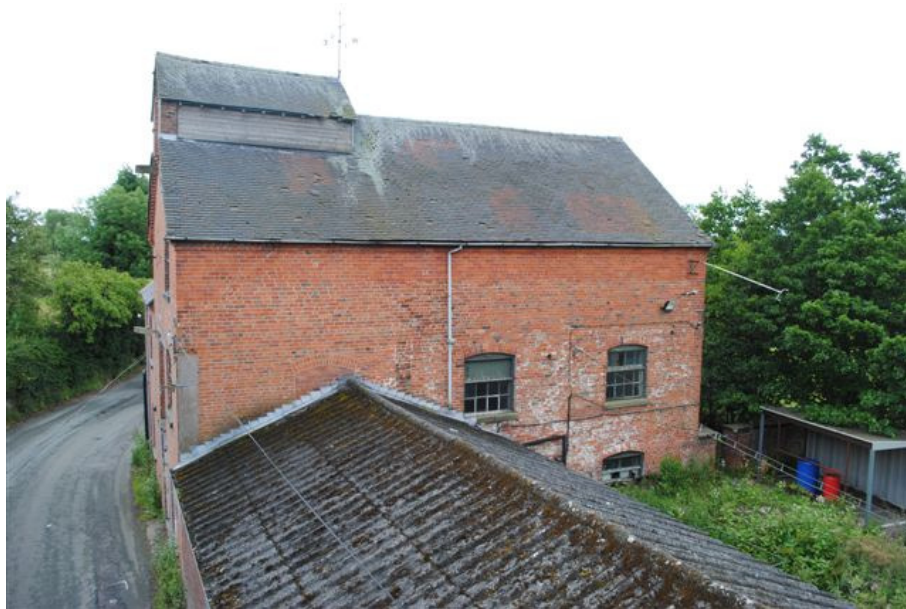
- 4.6 The wall was reasonably plumb and has had a painted finish to parts of the lower areas in the past when it would appear that there was a previous building on the site of the existing Canteen. The lower part of the building wall at the southern end was acting as a retaining wall to the surrounding ground.

- 4.7 The top few brick courses of the wall appear to be more recent construction than the remainder/lower parts of the wall. Again this may reflect that only the upper part was rebuilt in 1897.

**Photograph No. 4: View on West Elevation and Roof of West Building**  
(Note change in brickwork below eaves)  
(Note canteen building roof in the foreground)

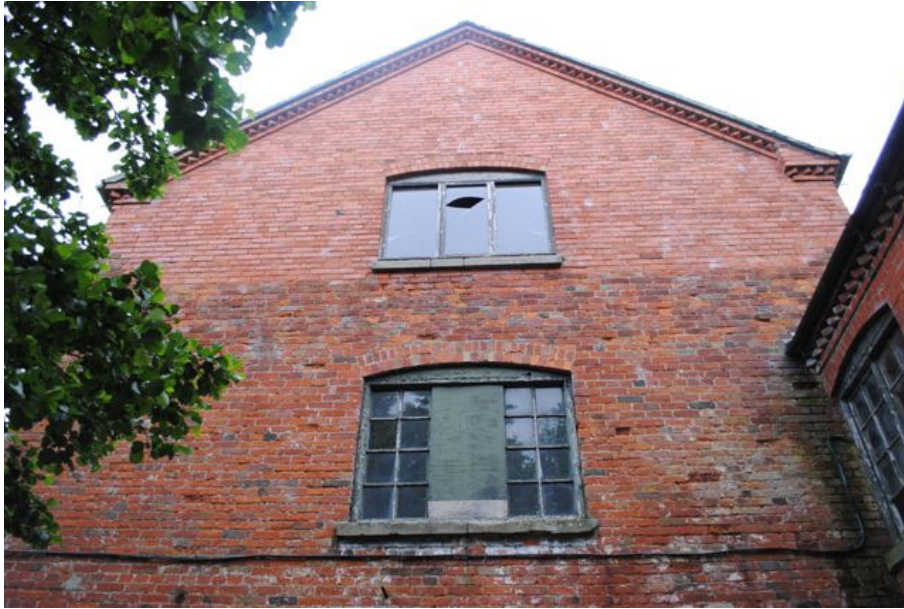
- 4.10 The brickwork above the first floor window cill up to the verge appears to be more recent construction similar to the west and north walls. Again this may reflect that only the upper part was rebuilt in 1897.

**Photograph No. 5: Part View on South Elevation of West Building (Upper level)**  
**(Note change in brickwork above first floor window cill)**

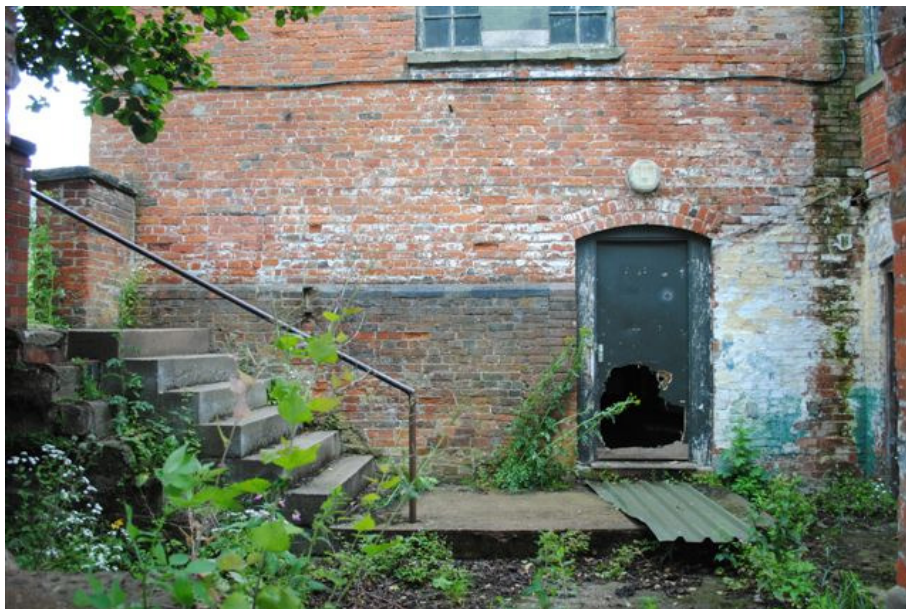
- 4.11 The lower part of the wall is thicker than the upper parts and has a splayed capping. The mid to lower parts of the wall have been painted previously and appear to have been the internal wall of a previous building within the present courtyard. The brickwork was in poor condition with many frost damaged bricks and weathered pointing.

**Photograph No. 6: Part View on South Elevation of West Building**  
**(lower level)**

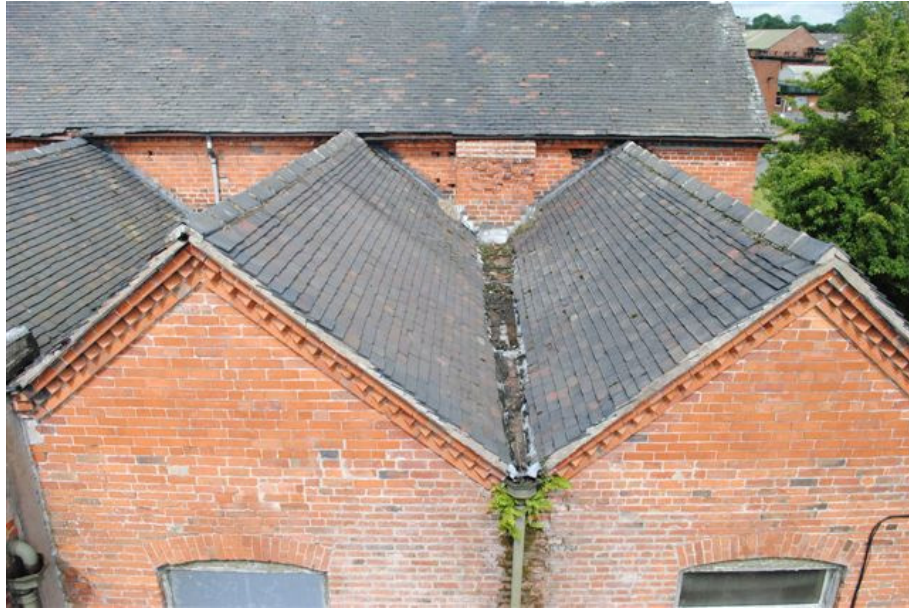
- 4.4 **East Elevation Overlooking the Roof of the East Building:** Only small triangular sections of the wall are visible. There were some frost damaged bricks and the pointing was poor. There is no evidence of any significant structural cracking or movement.

**Photograph No. 7: Part view on East Elevation of West Building in the background**

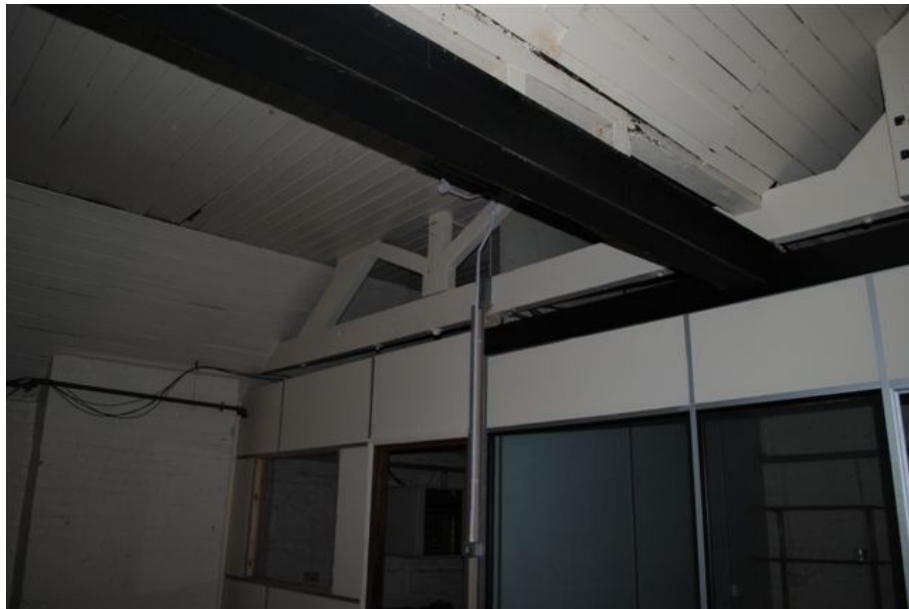
- 5.3 Lower parts of the timber roof trusses were exposed within the office area which are supported at the valley positions by steel beams. No structural defects were observed.

- 5.4 There was some damp penetration through the under-drawn timbered ceiling and timber decay where the eaves meets the passageway to the Cottage and also adjacent the concrete frame to the Engineering Workshop Building.

**Photograph No. 8: Part View on underside of roof to the East Building**

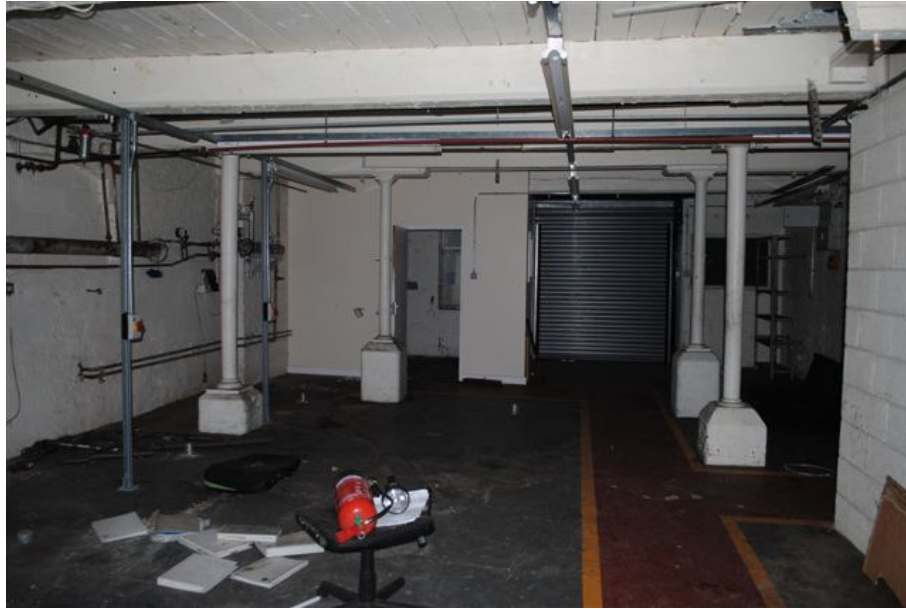
6.3 Four circular cast iron/steel columns on raised plinths support the first floor primary timber beams where alterations to the floor have taken place in the past. The remainder of the first floor is supported on primary timber beams. There is a longitudinal split in one of the beams at the north end.

**Photograph No. 9: View inside Ground Floor Room of West Building  
(Note columns supporting first floor beams)**

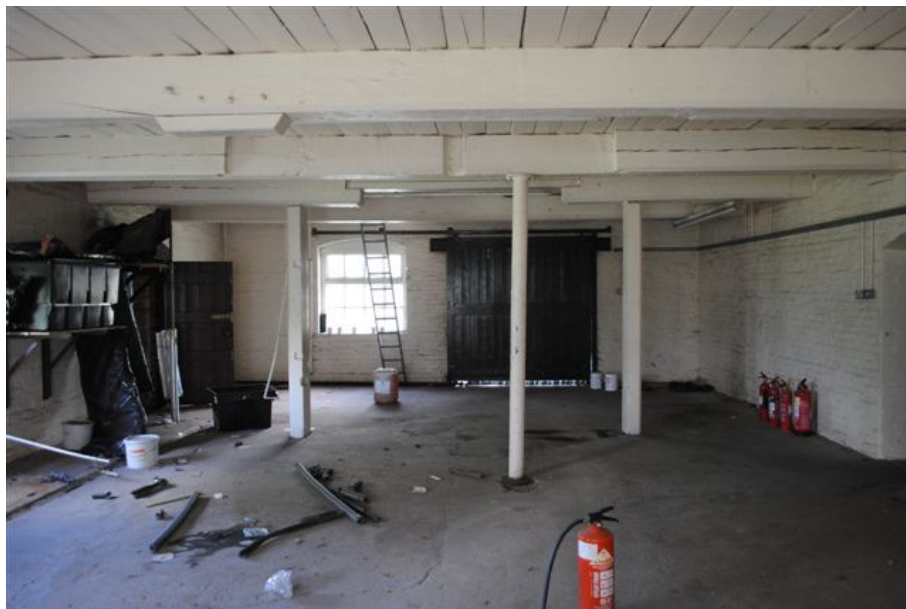
6.5 **First Floor Room:** The floor has a cement based wearing screed on top of timber boards which span onto primary timber beams. There were two timber posts and one circular cast-iron/steel column supporting two of the second floor primary timber beams. The central section of one beam is missing and replaced

with timber boards. The second beam has had the side cut away reducing the width of the beam and a circular column has been installed. One of the beams has been scarf jointed and bolted and there appears to have been a column/post removed from beneath the joint. There were longitudinal splits in the sides of some of the primary timber beams. Also the circular column was loose and not fixed at the base.

**Photograph No. 10: View inside First Floor of West Building  
(Note columns/post and cut outs in face of primary timber floor beam)**

- c) Carry out repairs to primary timber floor beams and re-fix column/post supports
- d) Repair cracks to brickwork and replace all frost and impact damaged bricks

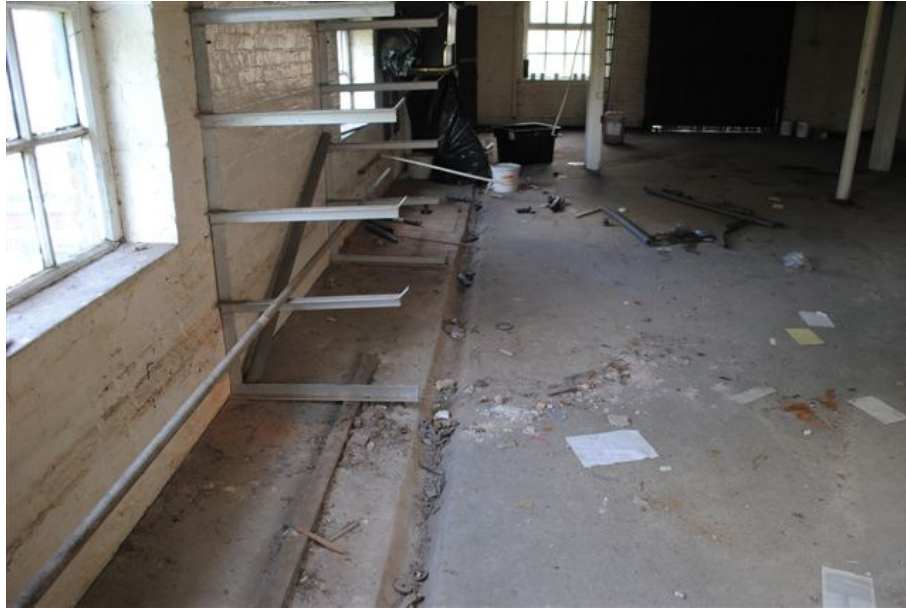
**Photograph No. 11: Part View on First Floor of West Building  
(Note cement based screed and open drain channel)**

- i) Remove cement based screeds from timber floors and clean timber boarding
- j) Break out and replace the concrete ground floor and service duct and include damp proof membrane and insulation as necessary
- k) Replace all windows and doors to suit future use of building
- l) Provide insulation to all external and party walls
- m) Re-point external brickwork with a lime based mortar

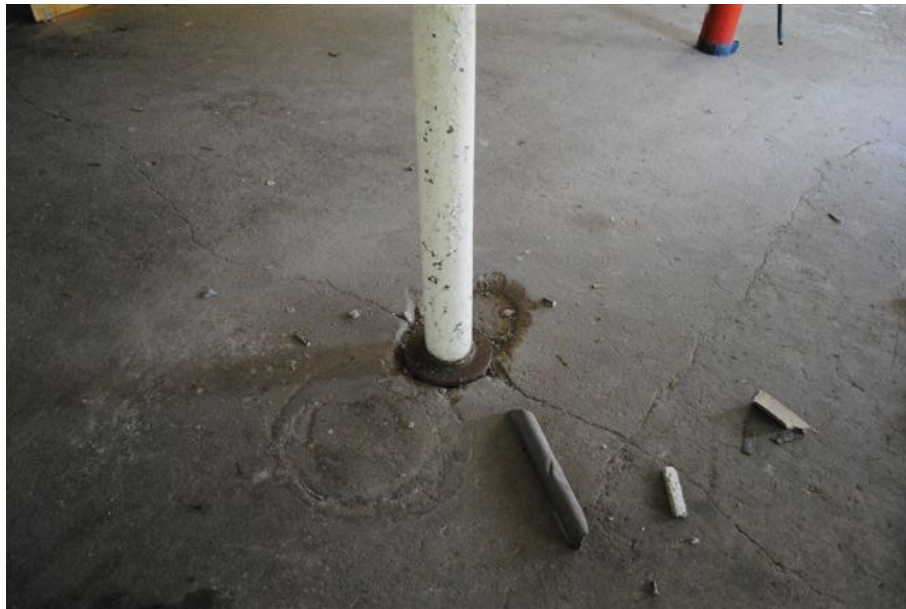
**Photograph No. 12: Part View on First Floor of West Building showing screed failure and unfixed base of steel post**

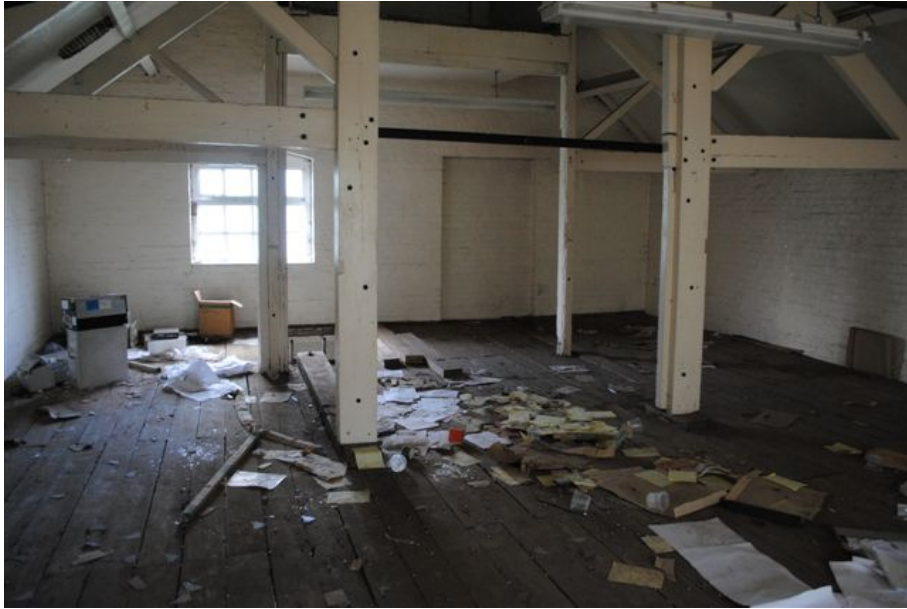
6.7 At the northern end there are two built up timber frames which support the extended loft. These frames have been structurally altered with the central horizontal rail having been replaced with a loose fitting metal strap in one case and one of the horizontal rails removed in the other. The northern most frame has different sized posts; one being a single piece of timber and the other made up of three separate pieces of timber. The cross beam/rail has little or no support/bearing onto the post.

**Photograph No. 13: View inside Second Floor of West Building showing timber framework to Loft**

- b) Carry out a measurement survey and structural assessment of all roof timbers in the West building and carry out structural repairs to the timber frameworks and loft extension

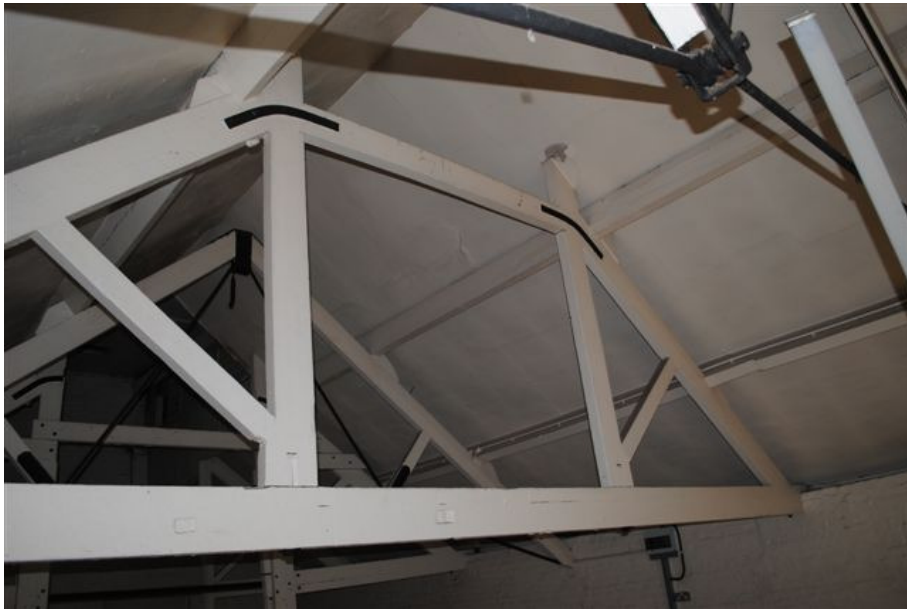
**Photograph No. 14: Part View of Roof Truss to West Building**

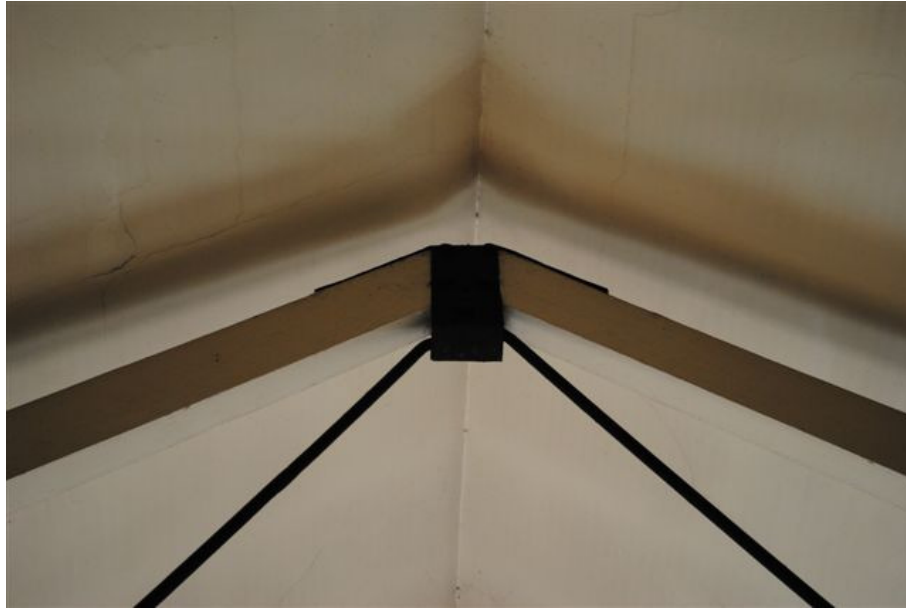
- 6.9 Several of the timber purlins have deflected between the timber trusses causing the splice joints to rotate and open.
- 6.10 The main roof trusses appear satisfactory but the apex of the composite trusses do not extend up to the ridge and may have been retrofitted to provide additional support to the deflected purlins.
- 6.11 The extended loft could not be inspected but there was evidence of damp penetration.
- 6.12 There is diagonal cracking in the painted brickwork at the bearing of the fourth truss on the north wall and evidence of previous cracking at other truss bearings, which have been painted over.

**Photograph No. 15: Part View on Composite Roof Truss to West Building  
(Note gap between apex and underside of ridge)**

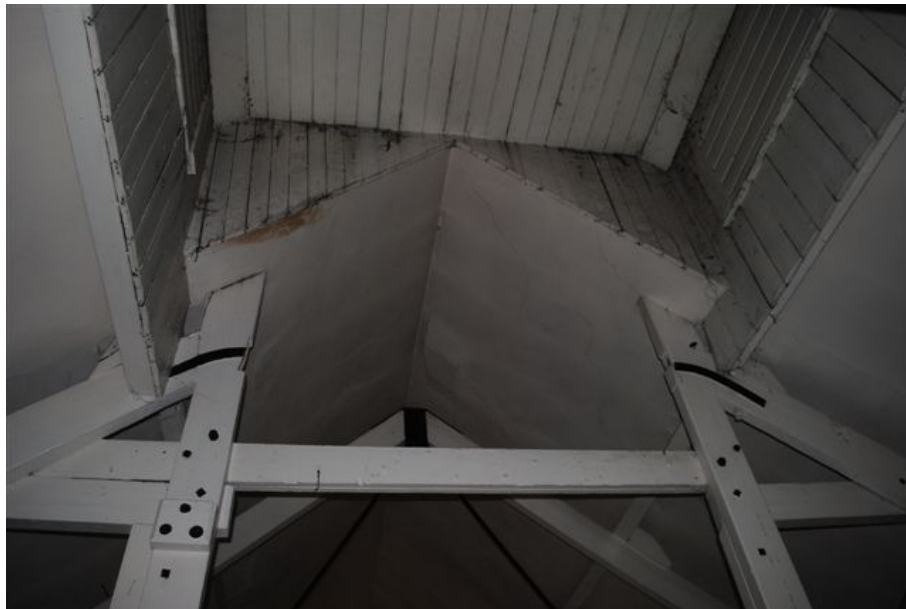
6.8 The timber frame posts of the second frame in from the northern elevation are not positioned directly above the primary beam of the floor. The loads have been

transferred from the posts to the beams by installing additional timber spreaders laid on top of the floor and bolted down where possible.

**Photograph No. 16: View on Timber Framework to underside of  
Loft in West Building**

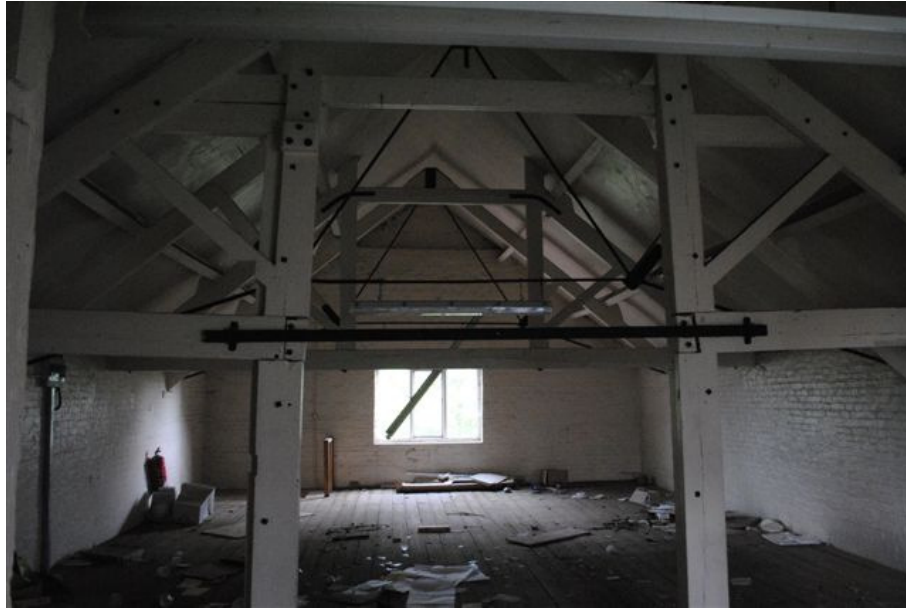
**Photograph No. 17: View on Timber Framework supporting Loft in West Building  
(Note metal horizontal tie bar)**

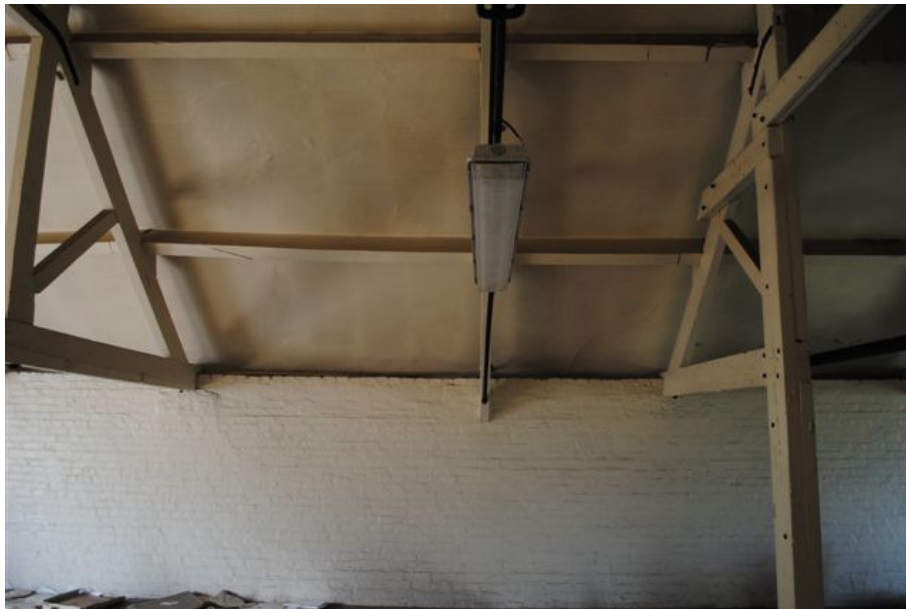
**Photograph No. 18: View on underside of roof slope to West Building  
(Note deflection in purlins)**

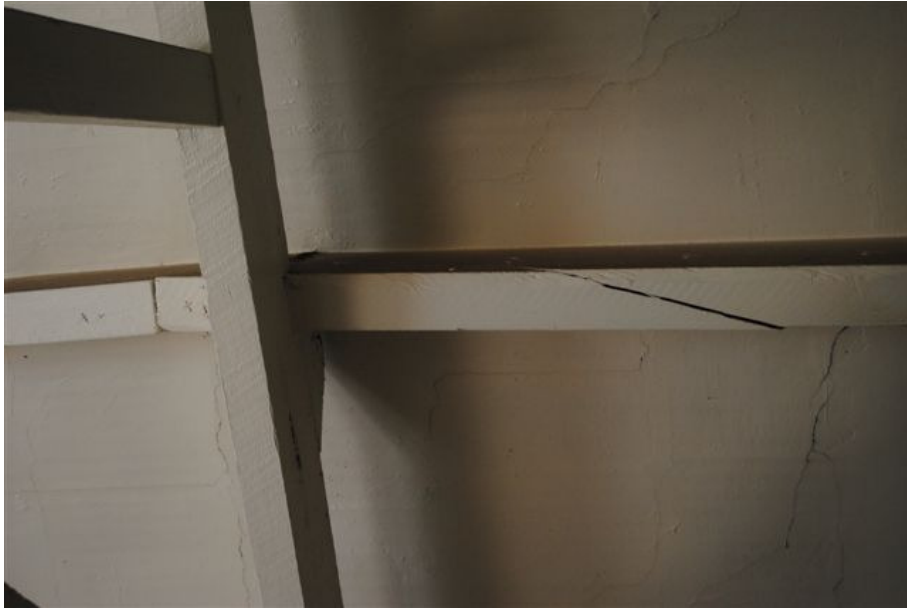
**Photograph No. 19: View on roof purlin to West Building showing displaced joint**
