## ASBESTOS DEMOLITION /REFURBISHMENT SURVEY REPORT

Popular Garage  
Mill Street  
Leek

Prepared for  
Nechcol Ltd

REC Report MAN/12S/1058

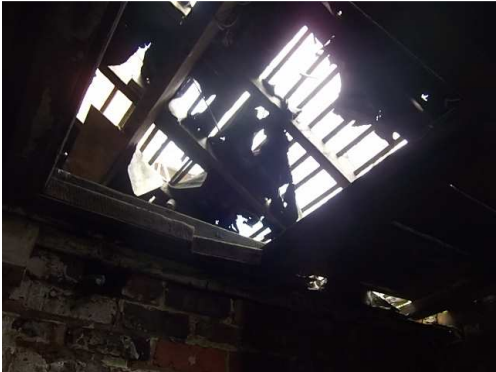
Building Name / Number		Popular Garage	Room	00/01
Location / Description		Garage, roof felt		
Sample No	01	Material Assessment Score		0
Product Type	Roof felt	Comments / Recommendations	No Action	
Asbestos Type	NAD			
Extent	30m2

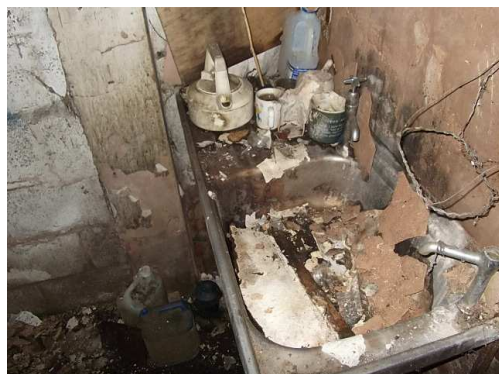
Building Name / Number		Popular Garage	Room	00/02
Location / Description		Kitchen, Sink pad		
Sample No	02	Material Assessment Score		0
Product Type	Bitumen	Comments / Recommendations	No Action	
Asbestos Type	NAD			
Extent	<1m2

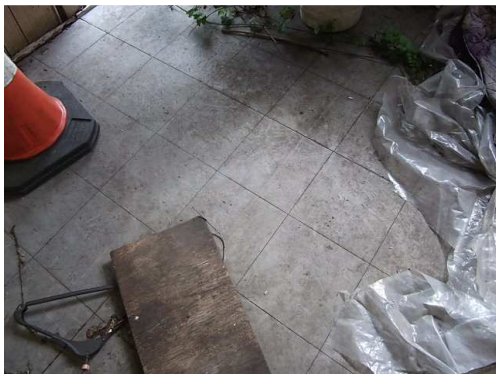
Building Name / Number		Popular Garage	Room	00/04
Location / Description		Portacabin, Floor tiles		
Sample No	03	Material Assessment Score		0
Product Type	Floor tiles	Comments / Recommendations	No Action	
Asbestos Type	NAD			
Extent	15m2
