PHASE I GEO-ENVIRONMENTAL SITE ASSESSMENT

**Land off Congleton Road
Biddulph
Staffordshire**

**E3P Report: 10-047r3
Issued: September 2014**

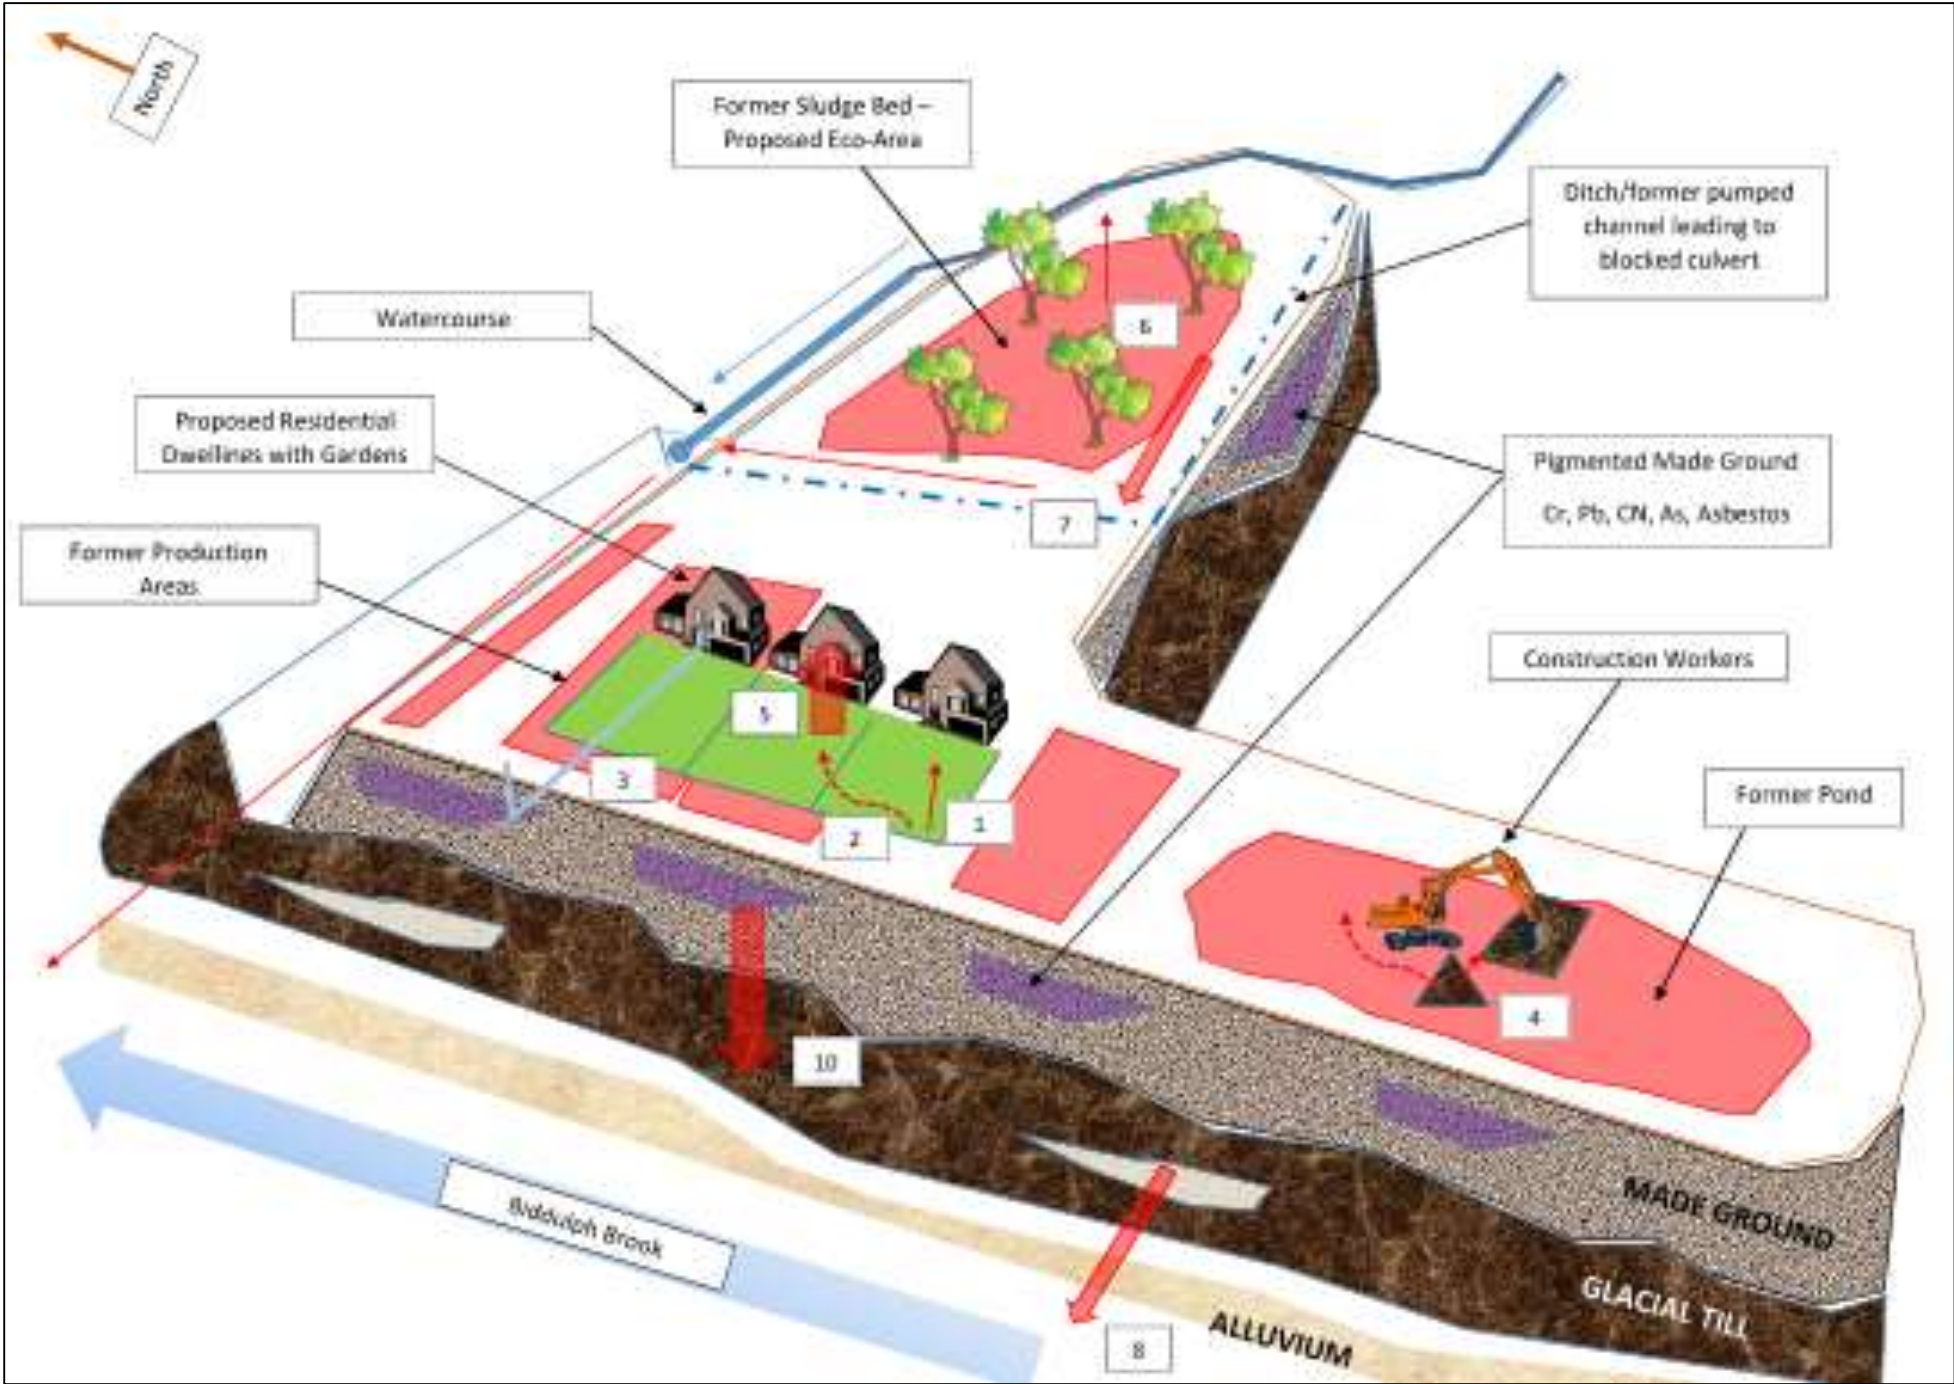
Drawing 003
Initial Conceptual Site Model

Source	Exposure Pathways	Potential Receptors
Human Health		
[1] Metal Compounds – Cr, As, CN, Pb, Sr	Dermal Contact Ingestion	Residential End Users - Gardens
Discussion Elevated metal compounds have been recorded throughout the Made Ground, typically associated with vibrant pigmentation that is considered to have arisen through historical spillages and site practices. The metal compounds identified as part of previous investigations typically pose a risk to human health through dermal contact and ingestion such as would occur if impacted soils were encountered while gardening etc.		
[2] Asbestos Containing Material (ACM)	Dust Inhalation	Residential End Users - Gardens
Discussion Chrysotile sheets have been identified within the north of the site and further fibres may be present within the Made Ground though fibre testing on the Made Ground has not taken place to date. Asbestos fibres pose a risk to human health through the inhalation of microscopic crystals that become airborne as a result of mechanical disturbance. Such disturbance could occur in a residential scenario through digging in dry soil that is impacted with ACM.

Discussion Ground gas monitoring undertaken as part of the previous ground investigations has not identified any significantly elevated concentrations though monitoring to date would not necessarily comply with the requirements of CIRIA 665 to enable a detailed assessment. Furthermore, the chemical analysis has identified the presence of certain compounds such as CN which under certain, low likelihood, conditions could generate potentially hazardous vapours. Gases and chemical vapours could migrate through permeable strata or service entries and accumulate within sub-floor voids or wall cavities and pose a risk to future occupiers through inhalation.		
[6] Metal Compounds – Cr, As, CN, Pb	Dermal Contact Ingestion	Residential End Users – Eco Area
Discussion Part of the scheme in the North East comprises a proposed Eco-Area that will be landscaped or left 'wild' to encourage wildlife and enhance biodiversity. This area is known to have historically comprised a sludge bed and while there has been only limited investigation, elevated concentrations and vibrant pigmentation has been identified during previous ground investigation. As the area will be adjacent to a residential development, it is feasible that the area will be utilised by residents who may come into contact with exposed impacted soils or dust or ponded water.

Controlled Water / Ecology		
[7] Metal Compounds– Cr, As, CN, Pb Ammonia (NH4)	Lateral migration via culvert	Adjacent Brook
Discussion The site inspection completed by E3P has identified what is considered to be the bricked up outfall to the culvert. The brickwork is stained blue and the small discharge noted, tainted by an ochrous coloration. The colouration of the stream is evident to the point where the adjacent brook converges with Biddulph Brook. Previous testing has taken place which does not indicate any significant impact but the sample points are not known.		
[8] Metal Compounds– Cr, Ni, Ammonia (NH4)	Lateral migration via permeable Made Ground & permeable natural strata	Adjacent Brook / Biddulph Brook
Discussion Testing of the shallow perched groundwater has identified elevated concentrations of ammonia, chromium and nickel. These may pose a risk the adjacent watercourses through lateral migration within permeable strata. The likelihood of lateral migration may be limited by the fact that the sand horizons within the Glacial Till are confined by low permeable Clay horizons. However consideration as the effect that below ground structures may have on the local groundwater will need to be considered, particularly if these are to be removed as part of the proposed development, in-particular the former effluent chambers along the northern boundary. Shallow groundwater analysis has identified significantly elevated concentrations of ammonium (NH4). Ammonia comprises two principal forms: the ionised ammonium ion (NH4+) and un-ionised ammonia (NH3). The toxicity of ammonia to fish is attributable mainly to the un-ionised NH3 molecule. Therefore, based on the results to date ammonia may not present as significant a risk as it first appears but further work will be required to confirm this.

[9] Metal Compounds– Cr, Ni, Ammonia (NH4)	Vertical Migration	Secondary A Aquifer
Discussion Testing of the shallow perched groundwater has identified elevated concentrations of ammonia, chromium and nickel. Assessment of the underlying Clay stratum as part of previous ground investigations suggests that vertical migration has not taken place.

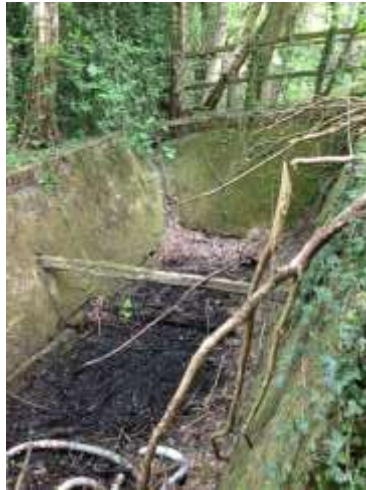
A series of concrete chambers are present along the northern boundary adjacent to the watercourse [Plate 1]. These are considered to represent historical effluent treatment chambers. A number of the chambers appear to have been in-filled as they are flush with the surface. Where they do not appear to have been in-filled, pipework is evident running east and siphons are present to the north indicating where these might have once discharged to the adjacent brook [Plate 2].

Plate 1 – Concrete Chambers At Northern Boundary

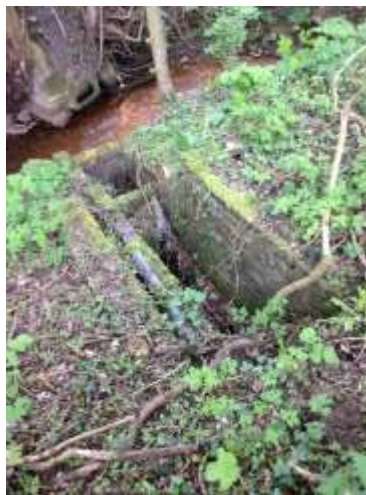
**Plate 2 – Infilled Concrete Chambers with
view of Siphon Down To Adjacent Brook**

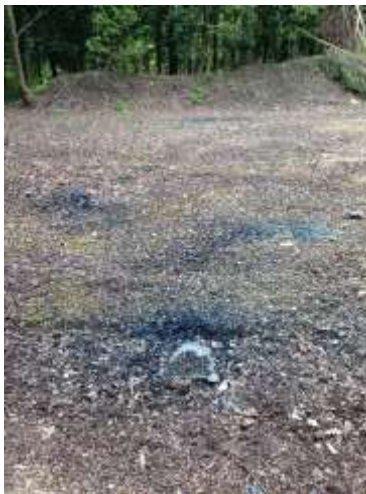
Plate 3 – Blue Staining At Surface

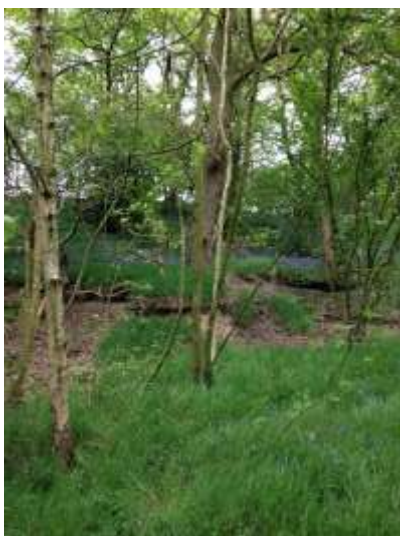
Plate 4 – Slope Along North Of Former Sludge Bed

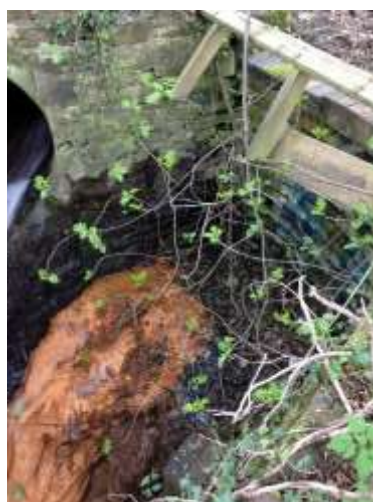
Plate 6 – Presumed Bricked Up Culvert Outfall

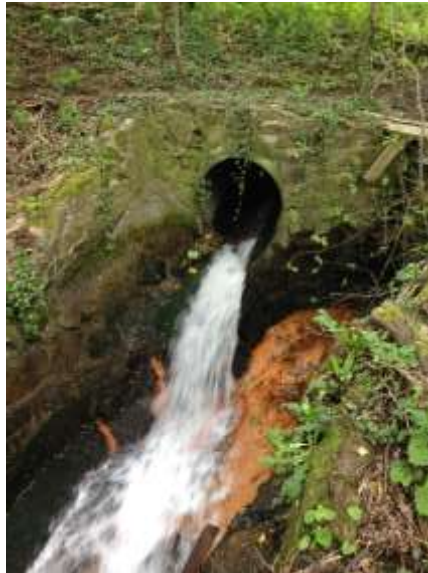
Plate 7 – Ocre From Culvert And Clear Water From Main Outfall

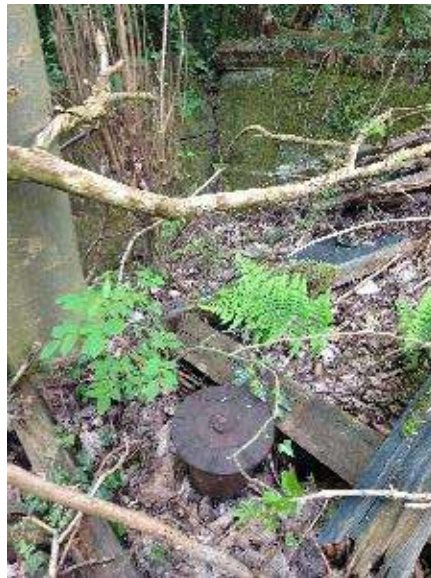
Plate 8 – Former Sumps and Presumed Pumps To Former Reservoir and Culvert

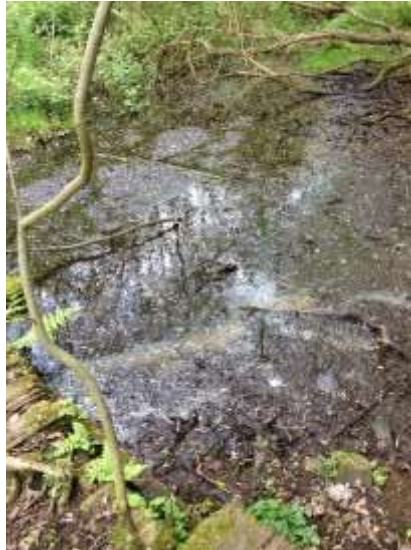
**Plate 9 – Water Logged Ground In North East Sector –
Presumed Former Reservoir Or Poorly Drained Land**
