**ARBORICULTURAL
IMPLICATIONS ASSESSMENT**

**ST JOHN'S SCHOOL, WETLEY ROCKS,
STAFFORDSHIRE**

Report Number: RT-MME-109232-02

March 2011

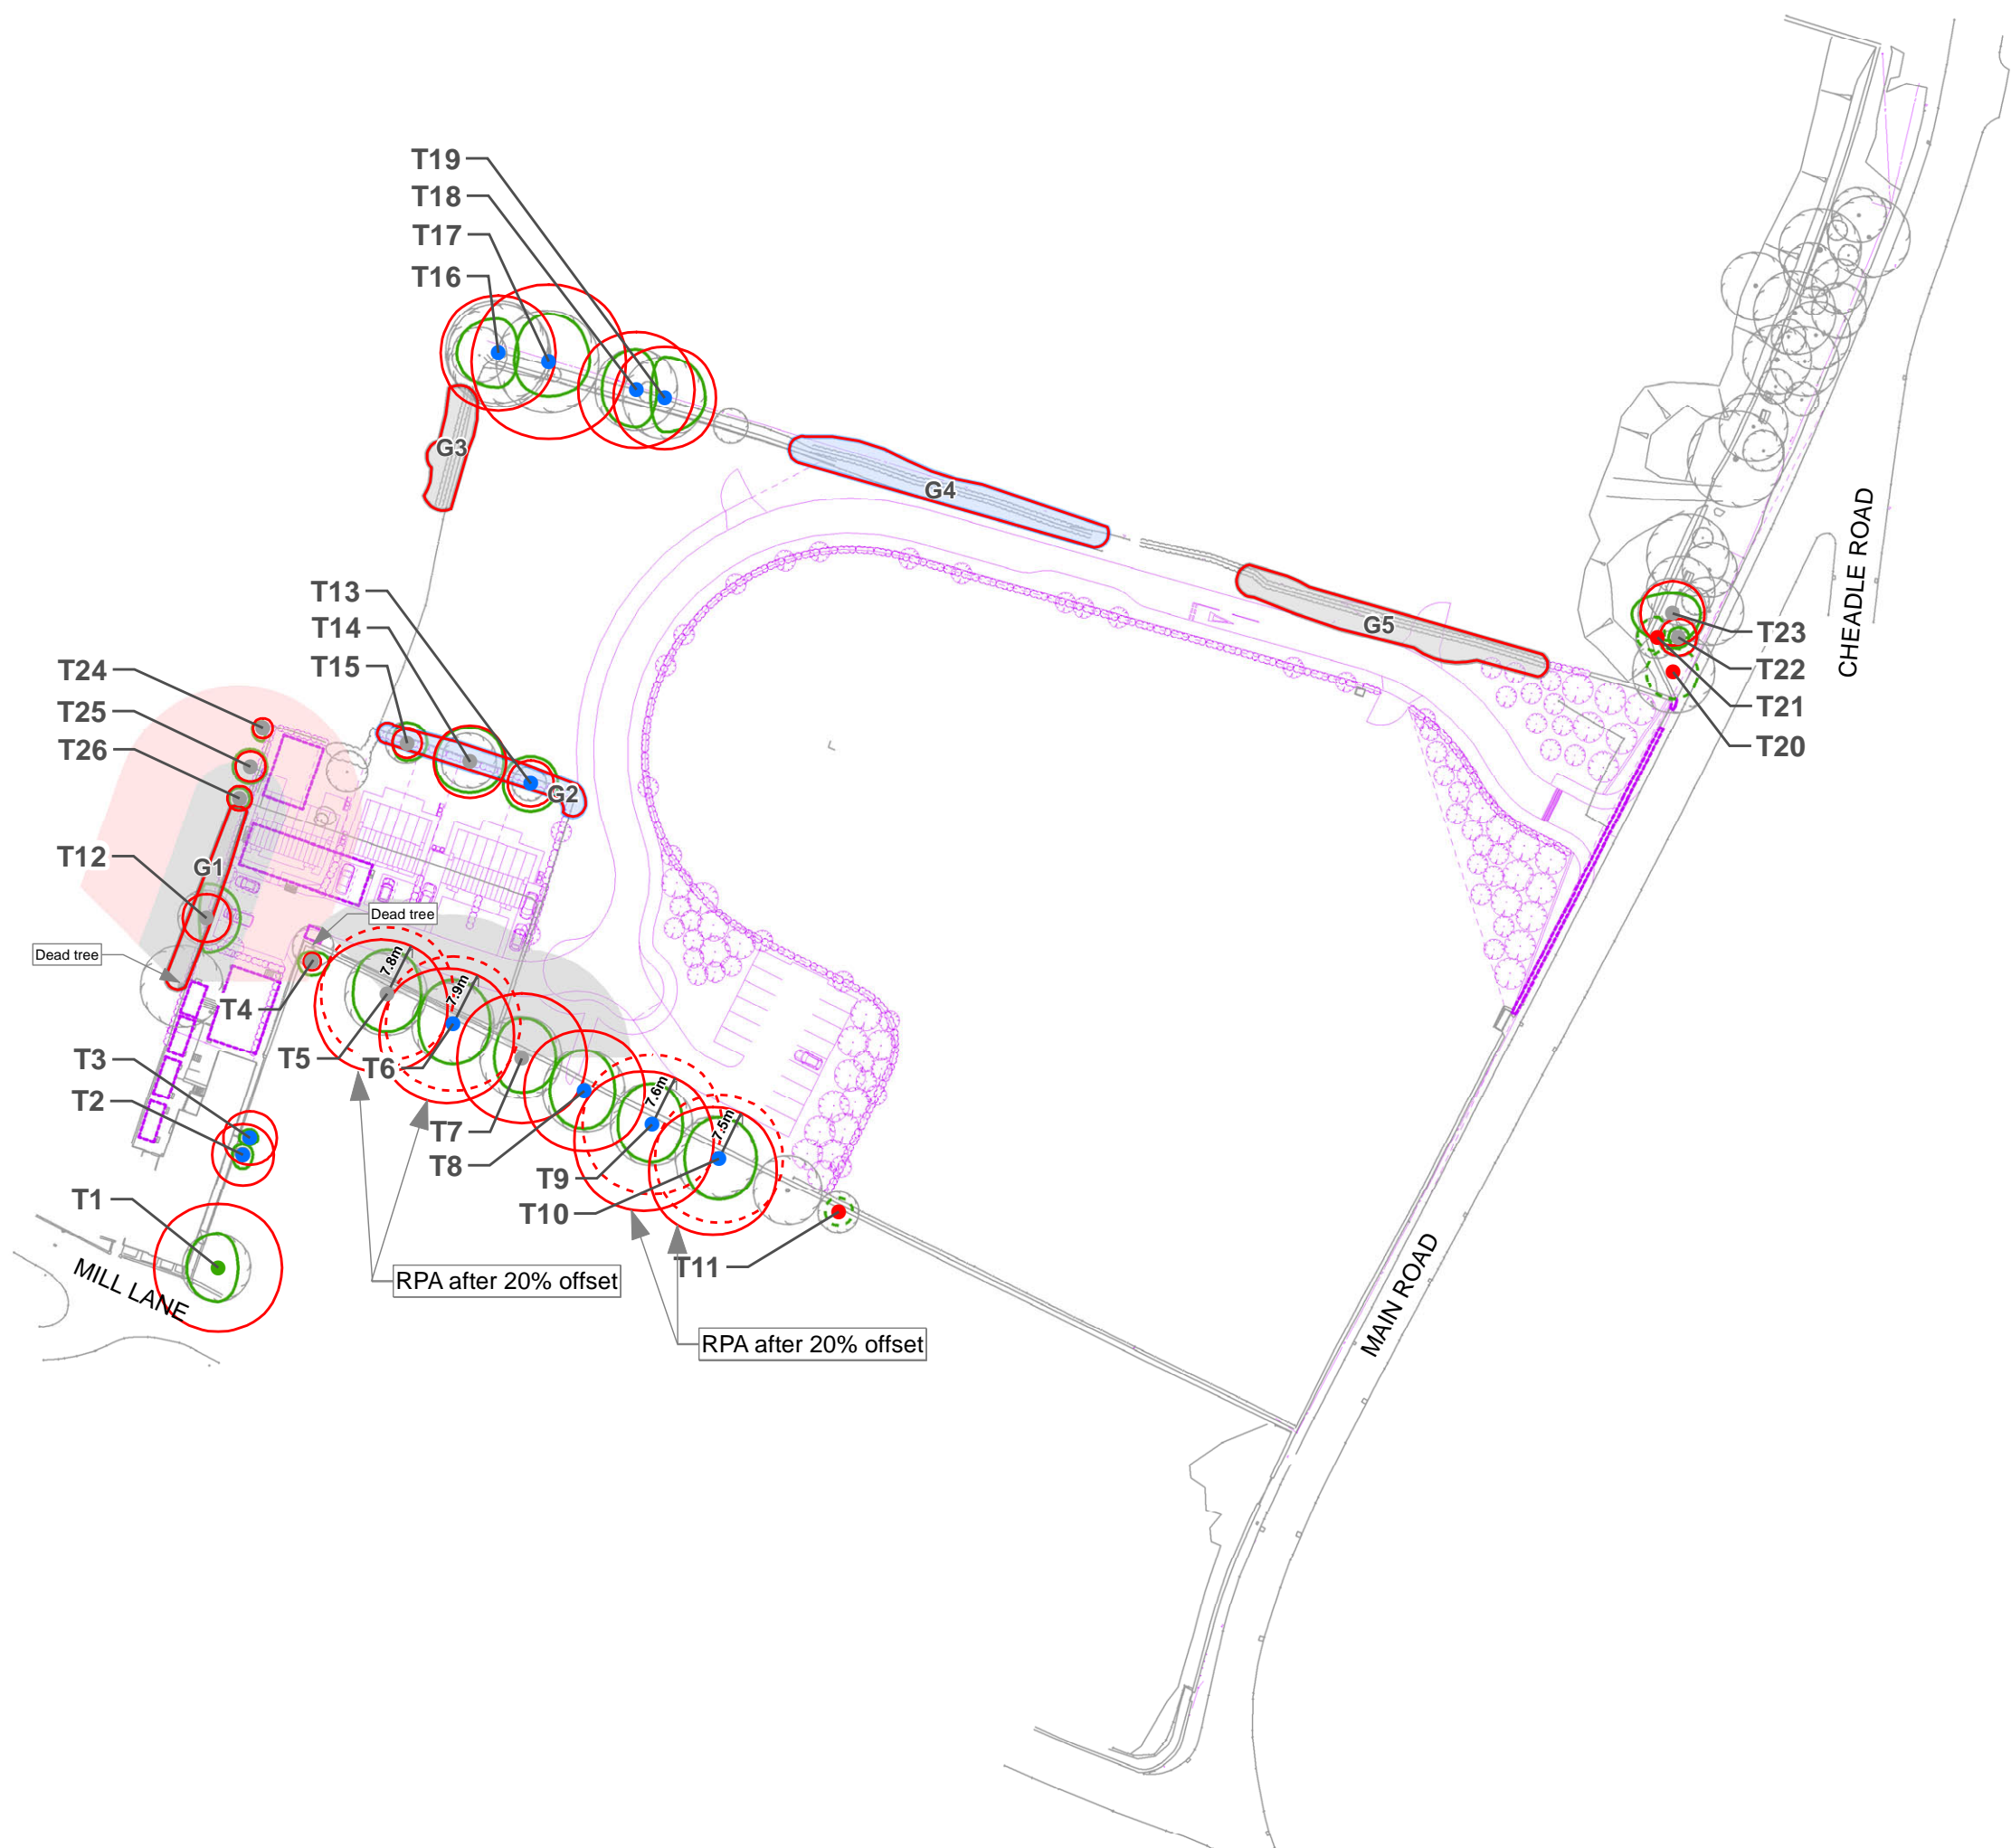
Tree Constraints Plan
Middlemarch Environmental Drawing Number C109232-02-01

A single Category R Holly (T11). This tree is situated within the adjacent churchyard. The tree is a multi-stemmed early mature specimen. The canopy is currently in decline with approximately 50% dieback. As the tree is located on adjacent land, permission will be required by the legal landowner to perform any arboricultural works.

Two Category R Norway maple (T20 and T21). These trees are located to the north of the existing and proposed entrances to the site. Both trees have significant bark delaminating on the basal areas of the trees. As the trees are located on adjacent land, permission will be required by the legal landowner to perform any arboricultural works.

Two dead trees. Located adjacent to the western boundary of the development site in third party ownership are two mature dead trees. It is essential that the legal landowner is contacted to remove the trees. (Illustrated on Middlemarch Environmental Ltd Drawing Number C109232-02-01, Appendix 1).

One dead tree. The tree is located adjacent to T4. It is essential that the legal landowner is contacted to remove the tree. (Illustrated on Middlemarch Environmental Ltd Drawing Number C109232-02-01, Appendix 1).

Utilise the existing surface levels within the RPAs of Trees T5, T6, and T12. If existing surface removal is required no reduction in levels of the underlying soil should occur. It is recommended that the areas of hardstanding within the RPA of the retained trees on or adjacent to the site should be constructed using a permeable surface treatment This will allow water and oxygen to penetrate the surface and reduce the chance of carbon dioxide build up causing problems with root function.

The pathway highlighted to the south of the turning circle that is proposed to access the churchyard adjacent to T8 should be relocated to avoid the RPAs of retained trees on or adjacent to the site.
