**CHOLPESDALE FARM,  
ABBAY GREEN ROAD, LEEK**

**PRE-DEVELOPMENT  
ARBORICULTURAL SURVEY**

Report No: RT-MME-120983-02

Date: March 2016

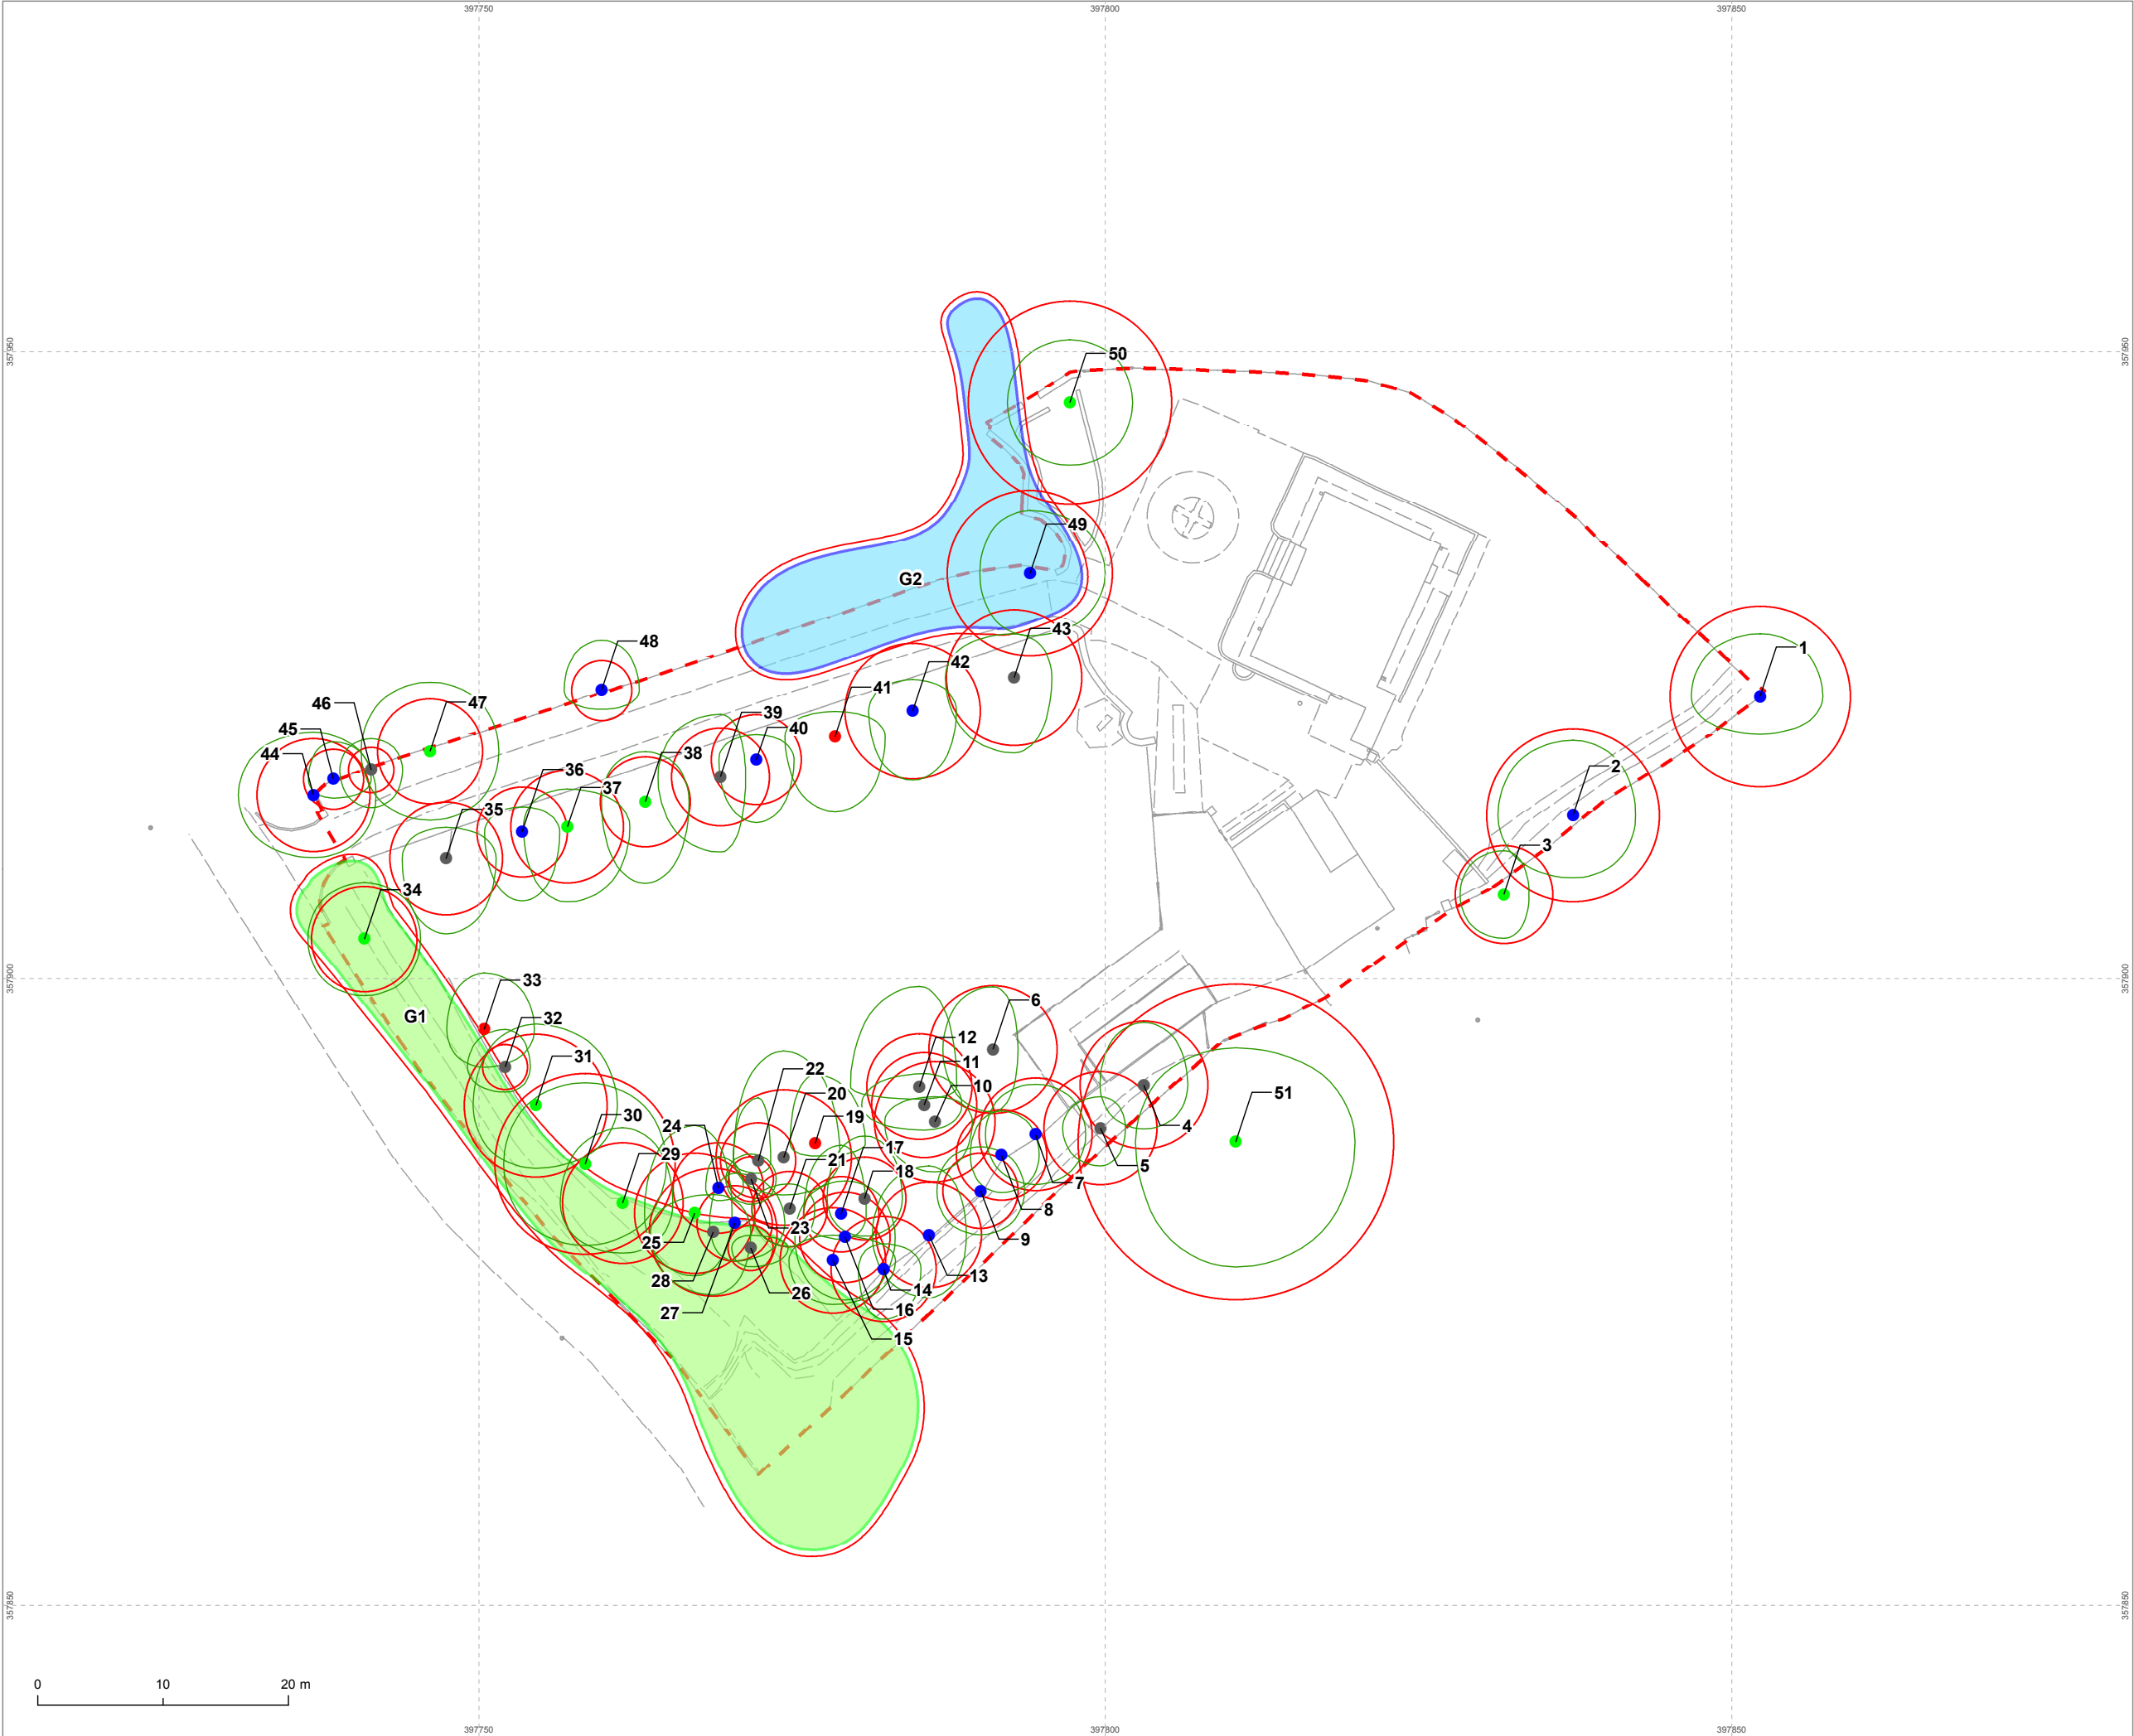
Drawing Number C120983-02-01 – Tree Constraints Plan

The Tree Constraints Plan (Drawing Number C120983-02-01 in Section 7) is designed to show the influence that the trees have upon the site by virtue of their size and position. The plan seeks to act as a design tool that shows both the above and below ground constraints presented by the trees. The plan shows the initial RPA which may be modified dependent on site conditions.
