**Coal Mining Risk Assessment
Report
For A
Proposed Residential Development
On Land Adjacent To
Ash Lea,
Barnfields Lane
Kingsley**

On Behalf of Stubb Brook Developments Limited

Date: August 2016
Report No. 359-R-01
Paul Palgrave BSc (Hons) ARSM MSc C.Geol FGS

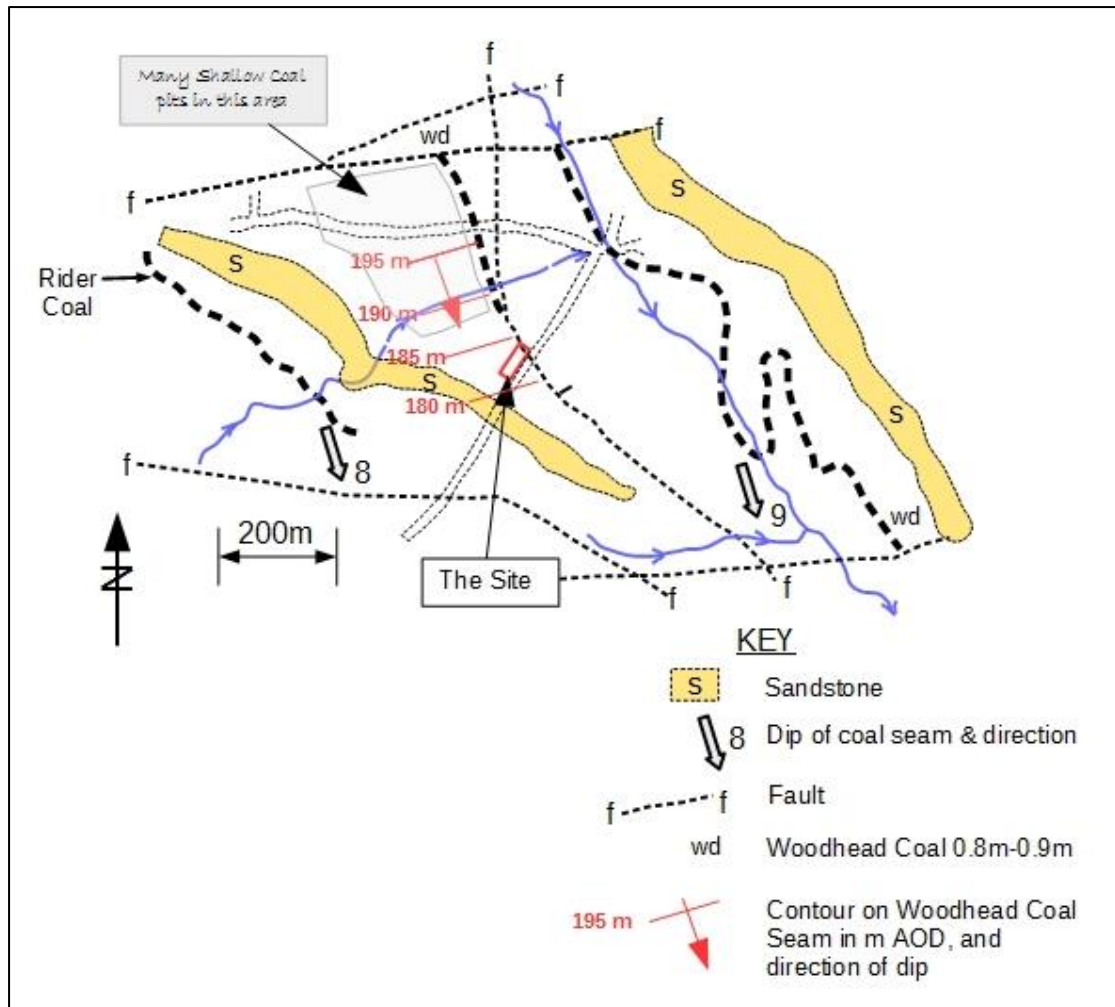
Figure 1: Summary Extract from BGS Sheet SK 04 NW 1:10,560

The key features from the BGS mapping are summarised on the plan presented over-page. This shows the site to be located within a fault bounded block of Carboniferous 'Westphalian A' (Coal Measures) strata, which includes coal seams and thick sandstone units.

The nearest coal seam outcrop to the site within the fault bounded block is the Woodhead seam, recorded as being 0.8m to 0.9m thick, and locally with a thin seam beneath, named the Ouster coal. The Woodhead seam outcrops to the north of the site and dips at a shallow angle south-south east towards the site. A dip measurement on the 'Rider' coal seam within the fault bounded block to the west of the site shows a dip of 8 degrees to the south-south-east.

The inferred outcrop of the Woodhead seam to the north of the site intersects the 195m contour, and, at the point the coal seam crosses the stream, the 190m contour is intersected.

These two points of known elevation on the seam confirm that the seam dips in a southerly direction, which concurs with the dip shown on the geological map.

However, based on the intersection of the seam with the ground contours, a shallow dip of around $3\frac{1}{2}$ degrees is calculated.

Strike lines on the coal seam (shown in red on Figure 1), when extended to the south, show that the seam would lie at around 185m AOD at the north eastern end of the site, which is approximately 15m below the ground surface at that point, deepening across the site.

For a seam of 0.8m to 0.9m worked thickness, a competent bedrock cover above the seam of 10 metres minimum is desirable to prevent voids from the collapse of workings from reaching the underside of shallow foundations, hence the bedrock cover may be sufficient in this respect.

The BGS geological map shows an area of 'many shallow coal pits' to the north west of the site, to the immediate west of the coal seam outcrop (as shown on Figure 1). This area is not shown to extend to the site, which indicates that the seam became too deep to work from shallow 'bell pits', and 'adits' driven into the seam from outcrop.

There is a fault shown clipping the north eastern corner of the site, and it is recommended that the proposed foundation excavations are inspected to ensure that faulted and/or broken ground does not extend beneath proposed building foundations. Foundations should avoid spanning across faults or fault zones, in order to avoid subsidence issues associated with poor ground associated with rock faulting, or movement of the fault line.

However, the true dip of the coal seam is likely to vary between the outcrop to the north-north west and the site, and the precise location of the seam to the north is not proven, hence boreholes are recommended to confirm the geological sequence beneath the site, and to demonstrate that there is adequate competent rock cover above the coal seam.

However, it is recommended that three rotary open hole boreholes are drilled across the site to confirm the geology and demonstrate that there is sufficient cover of rock above any coal seams of workable thickness. As a precaution, the boreholes should be extended to 20m to 25m below rockhead to be sure that there are no thicker seams within that depth range, although this is considered unlikely.

The foundation excavations are not considered likely to impinge on the line of the fault as shown on the geological mapping. However, it is recommended that foundation excavations are inspected to confirm the absence of broken or faulted ground. Alternatively, trial pits may be undertaken ahead of the construction works to demonstrate the absence of such features within the vicinity of the proposed building foundations.
