**Land off Badgers Rise  
Leek, Staffs  
ST13 8YF**

Nickolson Estates Ltd

## TREE SURVEY REPORT

Land off Badgers Rise, Leek

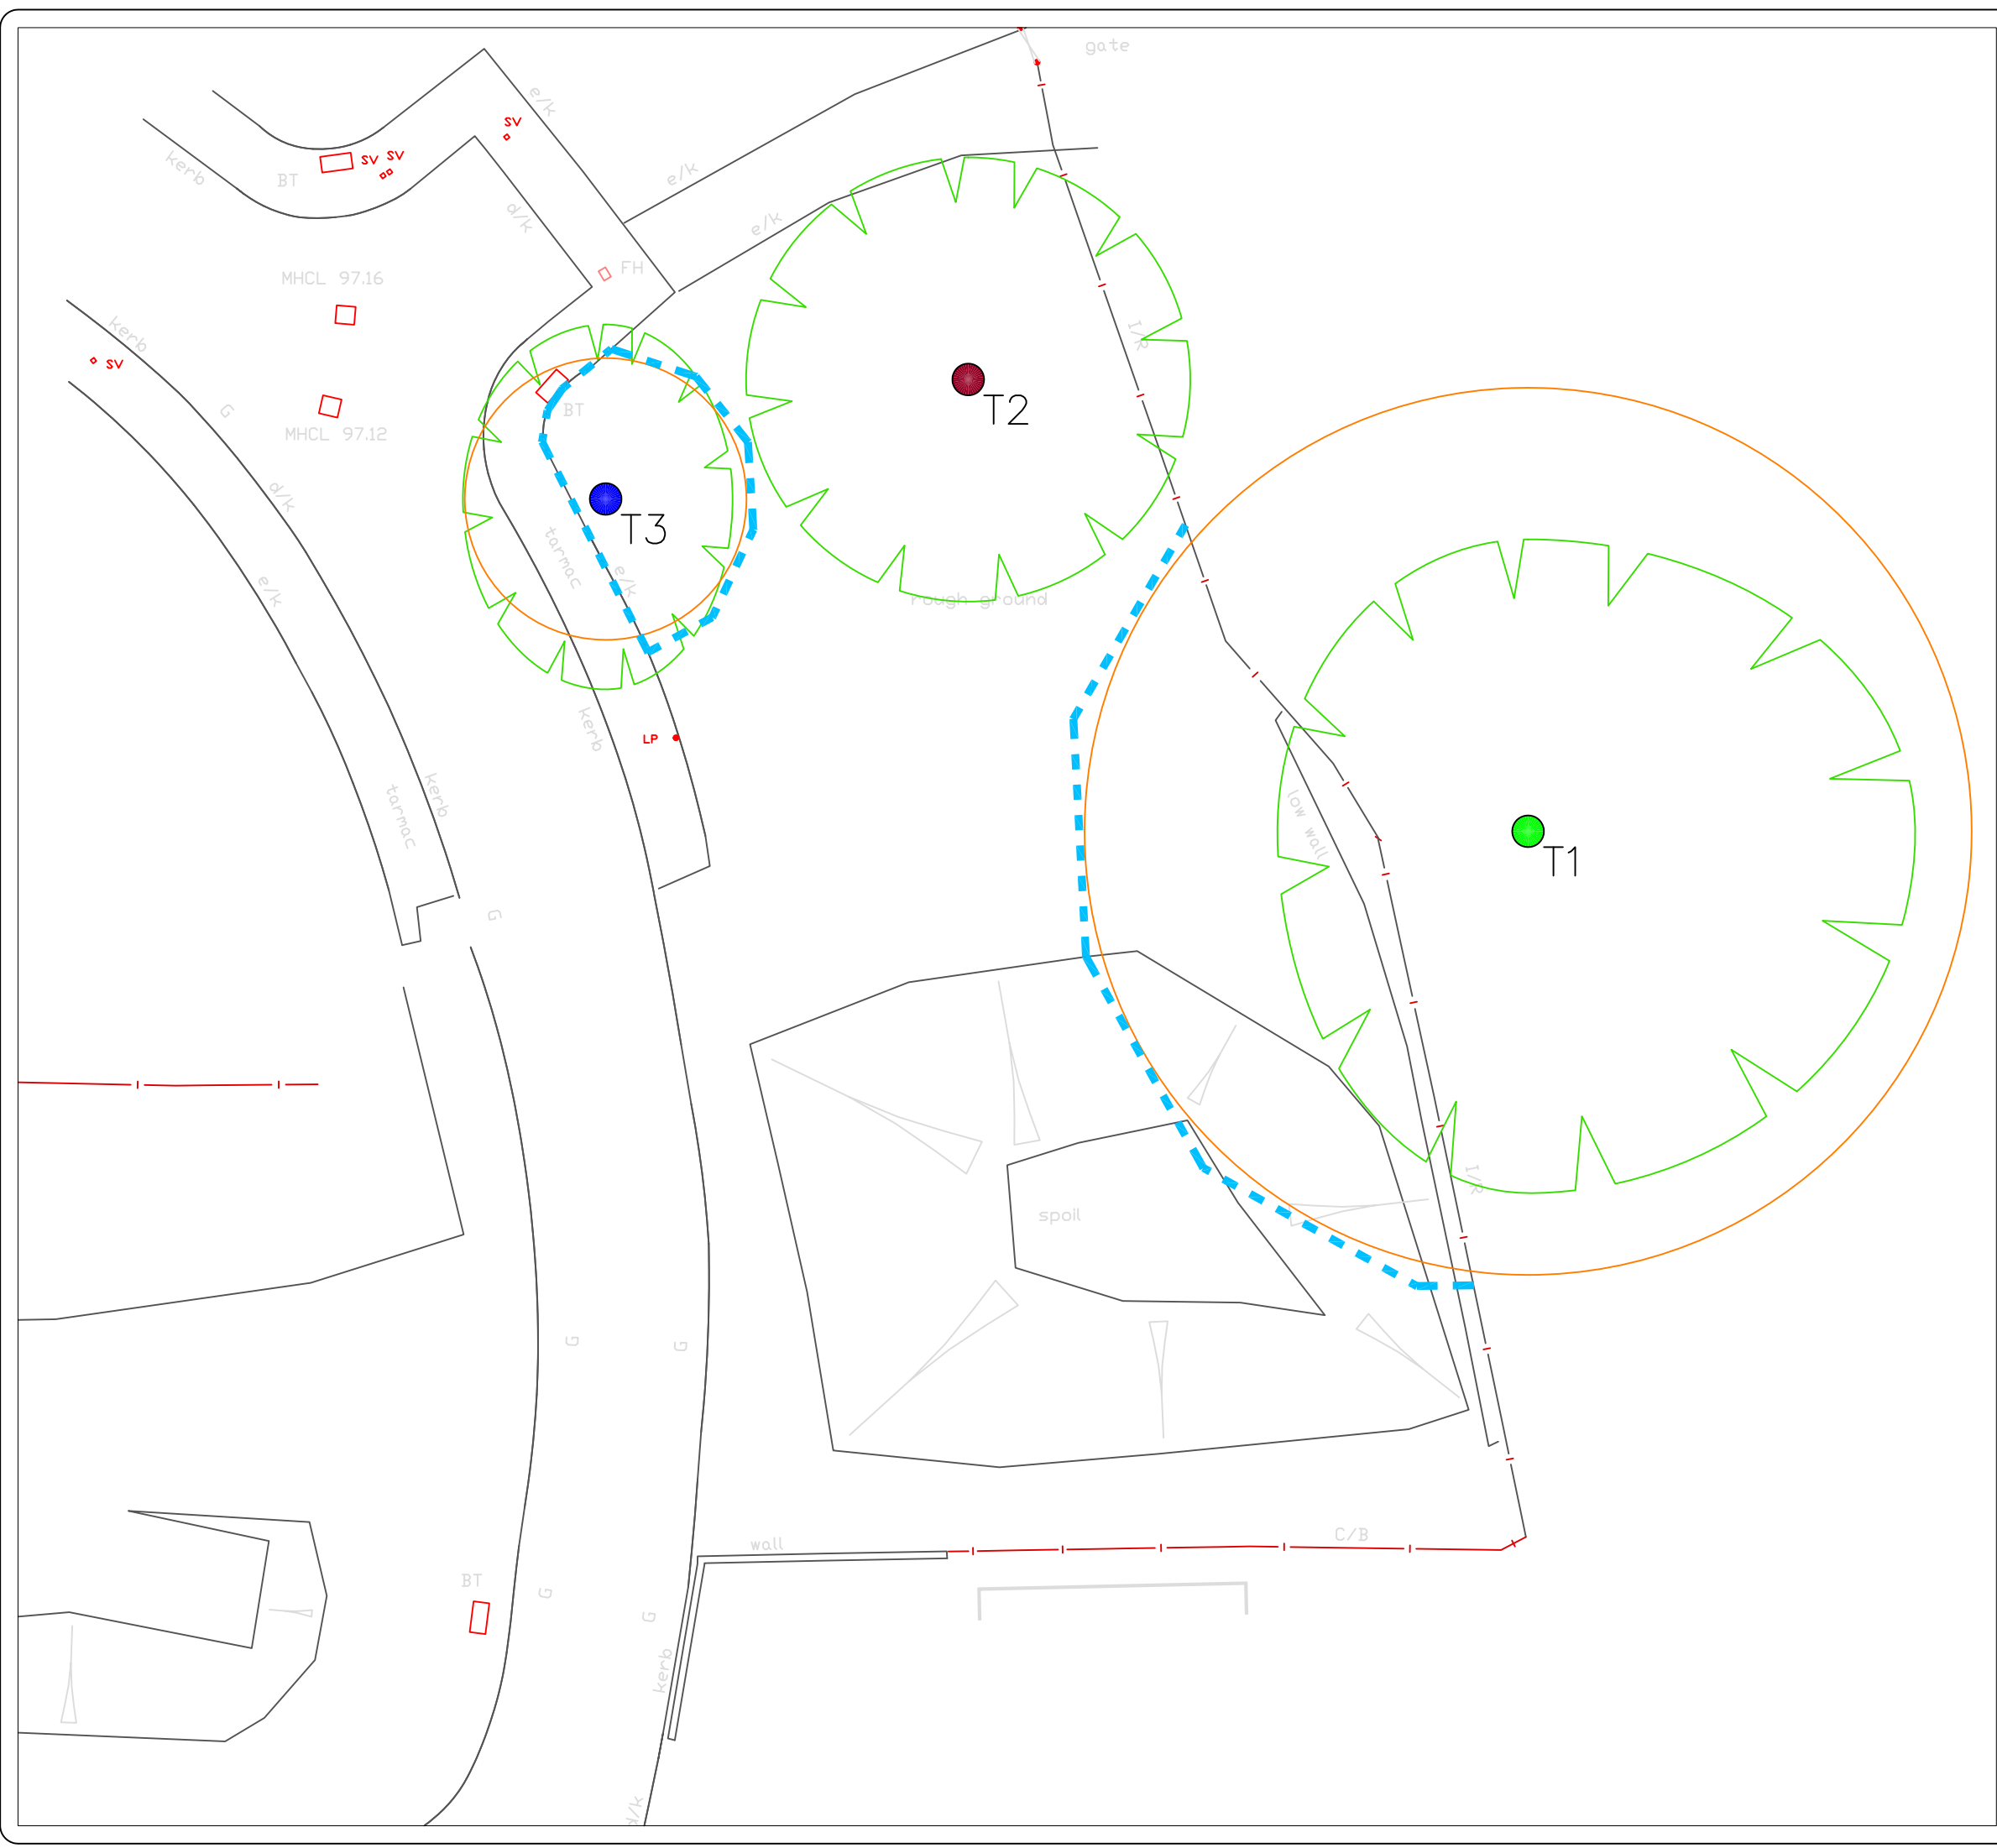
Scale: 1:200	Paper Size: A3	Date Created: 13/07/2011
Drawing Number: THL/BW21	Drawing Revision: 1

- 9.1 T1 is a large mature Copper Beech tree within the local park. The tree is in good condition and a prominent feature within the local landscape. T1 has a large root protection area as shown on plan THL-BW21, care should be taken not build or store equipment within this area.
- 9.2 T2 is a Sycamore in good physiological condition but poor structural condition. The tree has a weak main fork which is likely to fail. There is also some fire damage within the crown and a small cavity on the main stem. This tree should be felled on the grounds of safety.
- 9.3 The exact position of the Tree Protection Barriers should be discussed on site with the agreement of the LPA Tree Officer. It is essential that they are erected before any work starts on the site.
