**LAND AT BEE COTTAGE,
UTTOXETER ROAD, ALTON,
STOKE ON TRENT**

**PRE-DEVELOPMENT
ARBORICULTURAL SURVEY**

Report No: RT-MME-120301-02

Date: August 2015

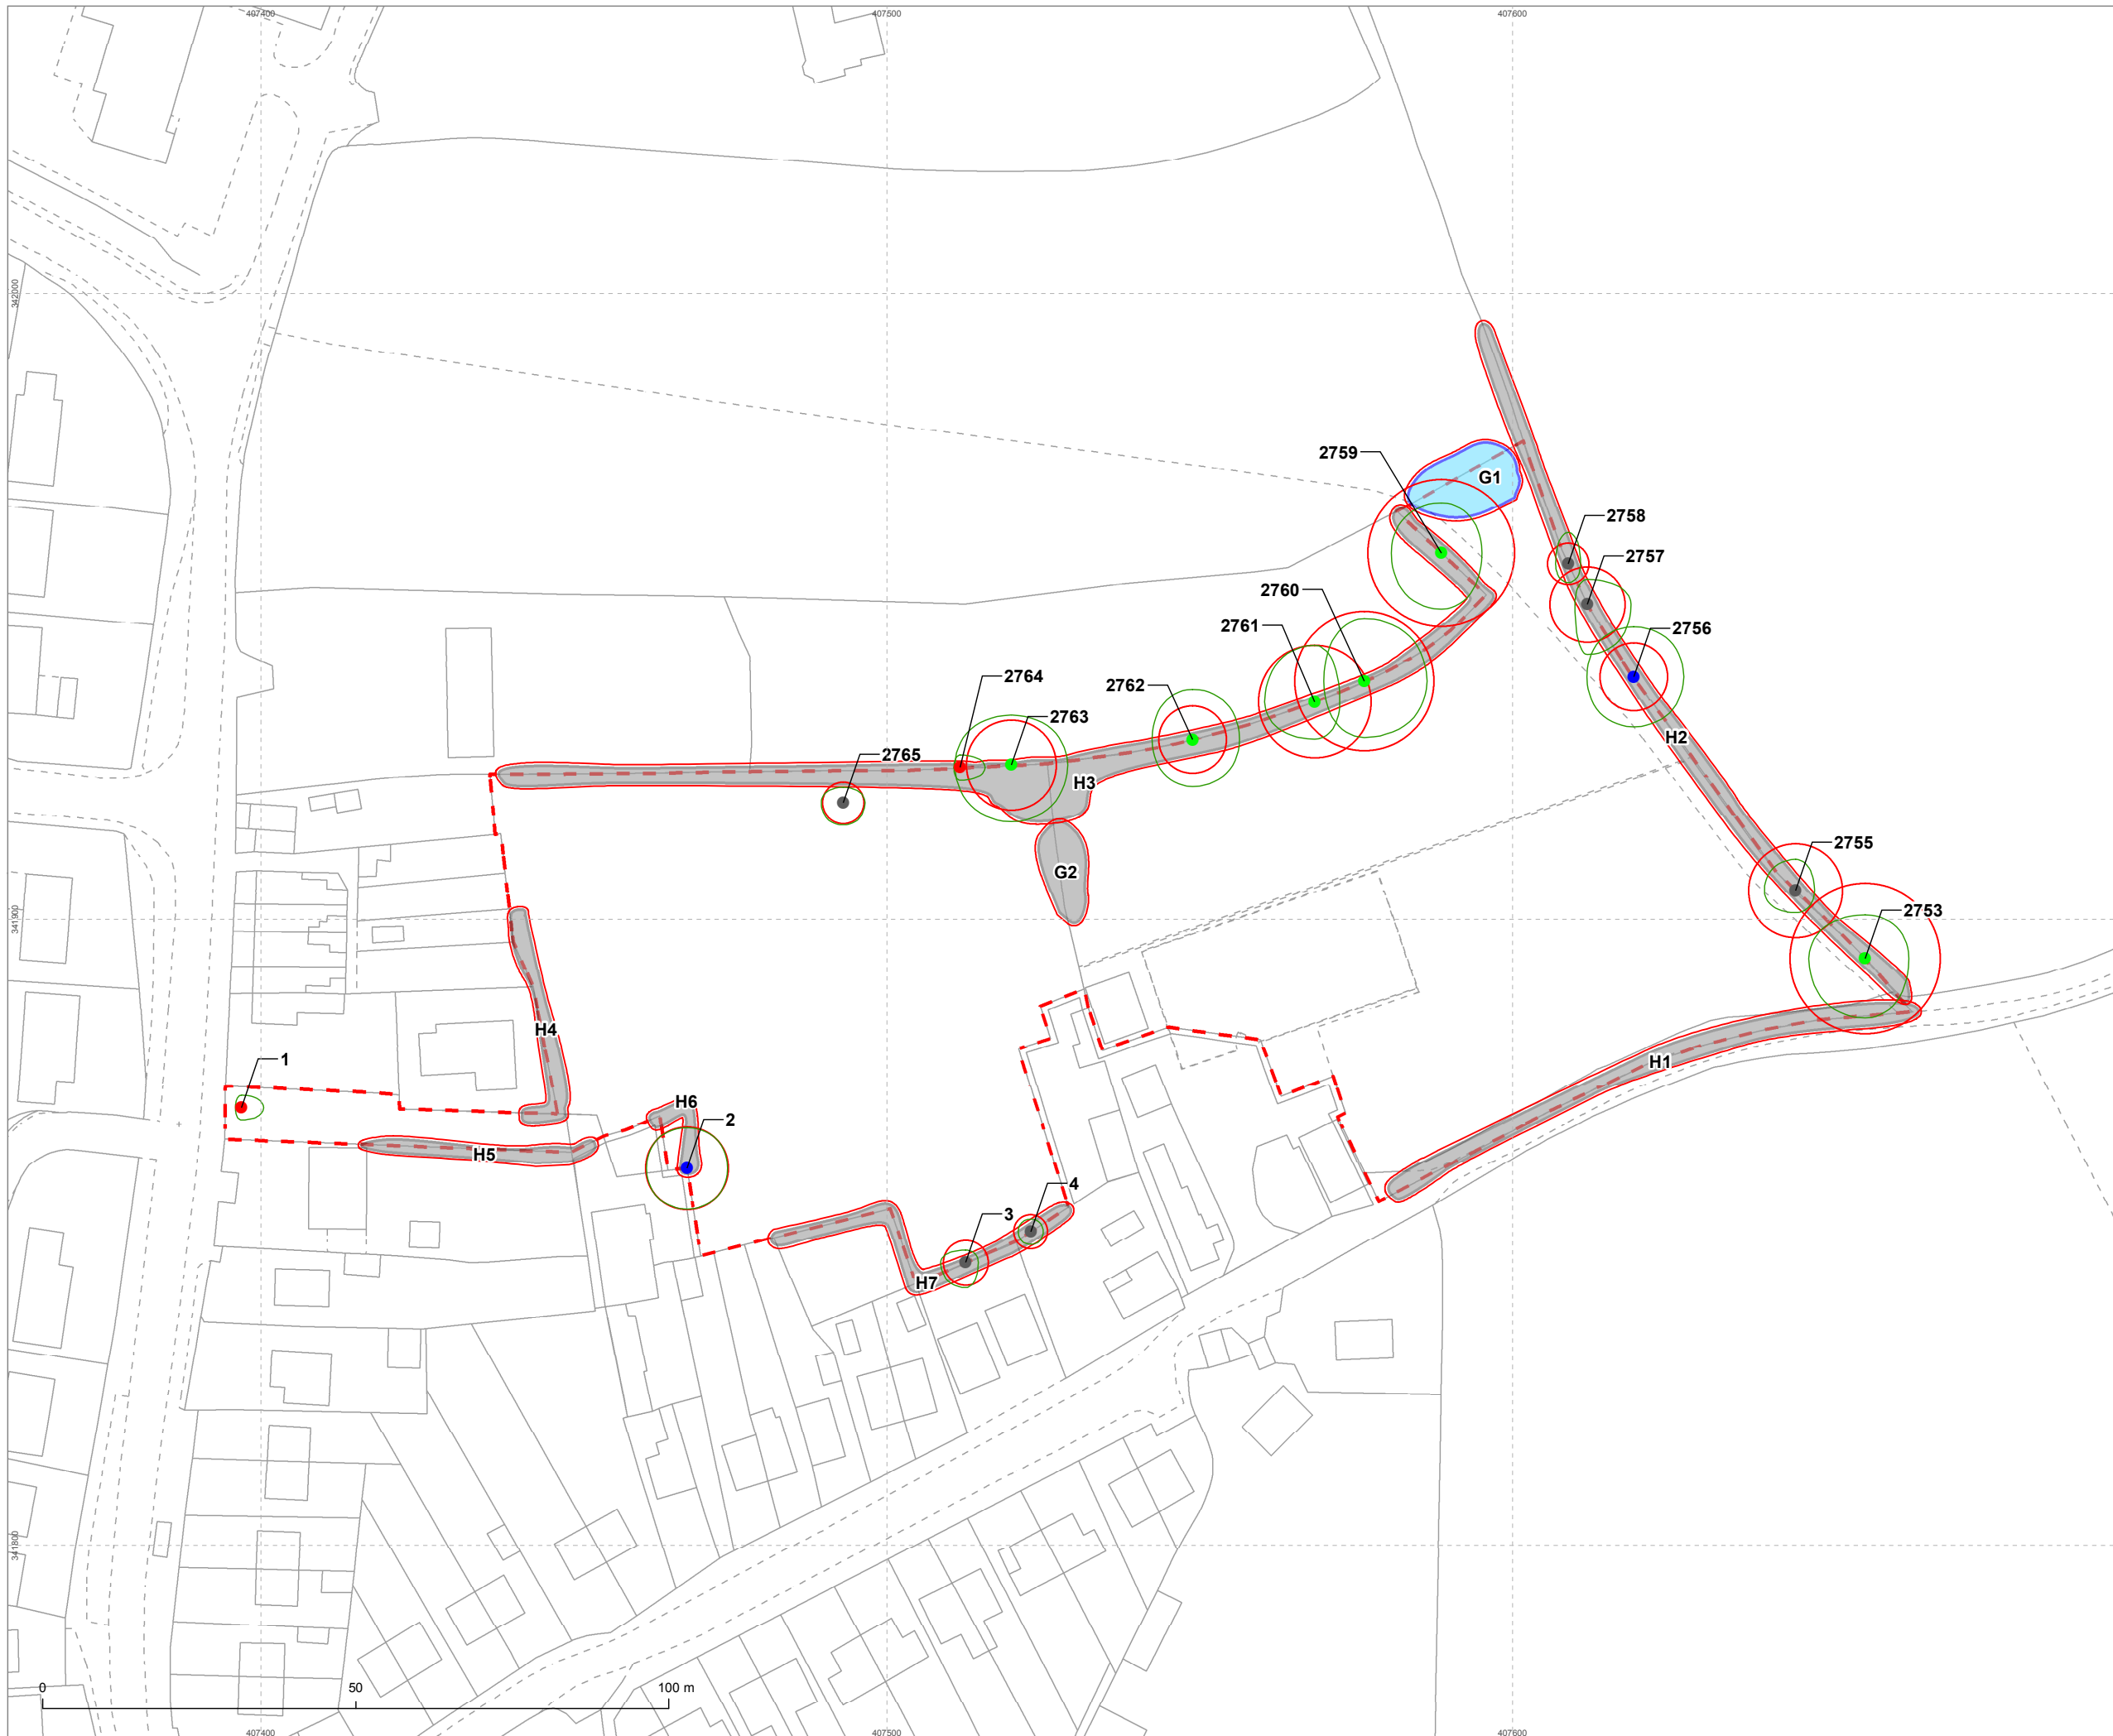
Drawing
Tree Constraints Plan

Sixteen trees, two groups and seven hedgerows have been surveyed. The location of the trees surveyed can be found on Middlemarch Environmental Ltd Drawing Number C120301-02-01, contained within Section 7 of this report.
