Ref: C069

18 December 2016

**ADDENDUM TO EXTENDED PHASE I AND BAT SURVEY REPORT
LAND OFF HARRISON WAY, CHEDDLETON**

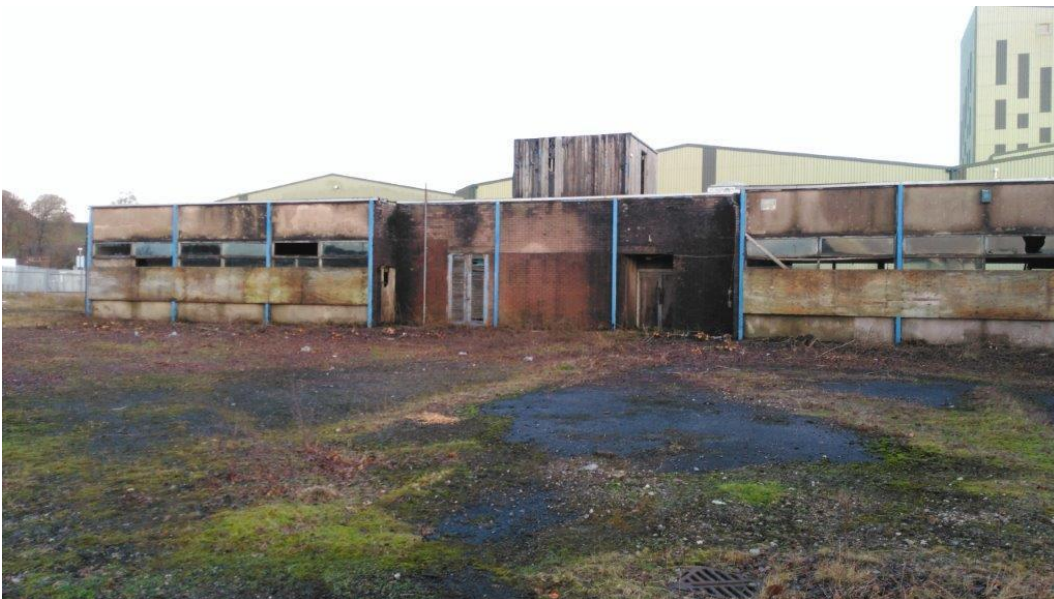
The main change observed in the site's habitats was the removal of scrub and young trees on site (Plate 1 & 2).

Plate 1: West side of building showing scrub removal

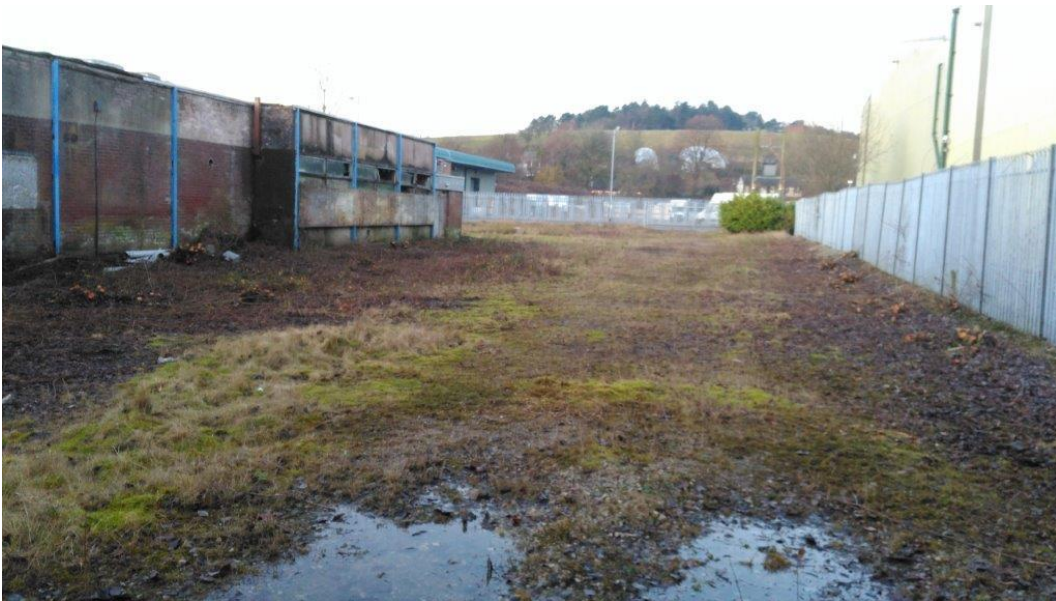
Plate 2: East side of building showing removal of young trees

There is only one remaining tree on site, as the scrub and young trees have been removed. The building itself may support nesting birds between March and August inclusive. It is therefore recommended that the building is demolished outside of this time, or be subject to a check for breeding birds by an ecologist, immediately prior to demolition. If any active nests were found, work would have to be delayed until fledglings have left the nest.

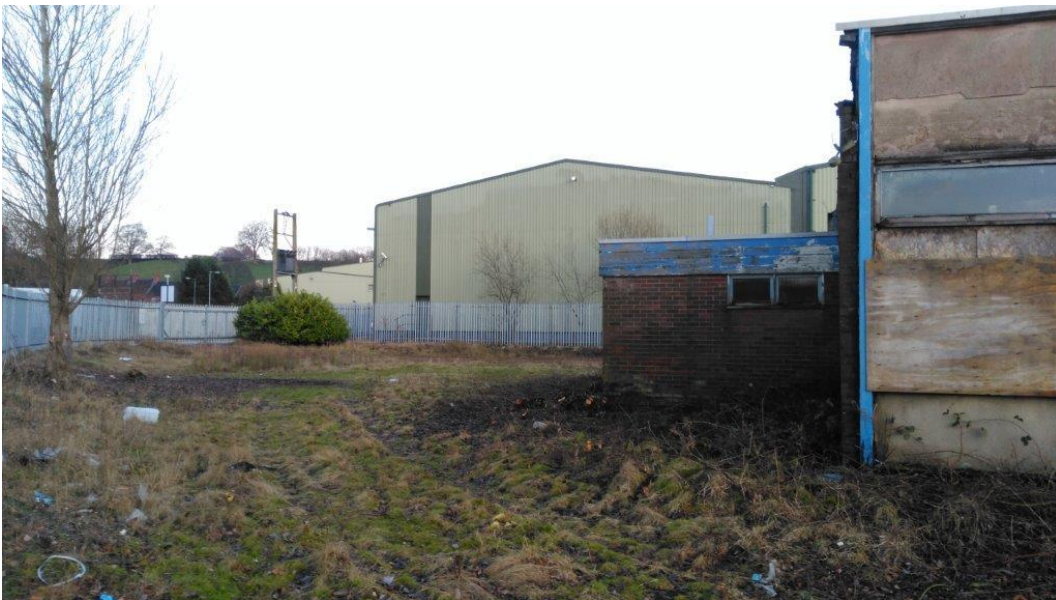
The building was in a similar damp and dilapidated state as in 2014, with internal ceilings falling in, and broken windows around the outside of the building. The north extension was more accessible, with wooden fascia boarding around the edge, but no gaps were noted underneath the fascia boards (Plate 3).

Plate 3: South side of building showing extension with painted fascia boards

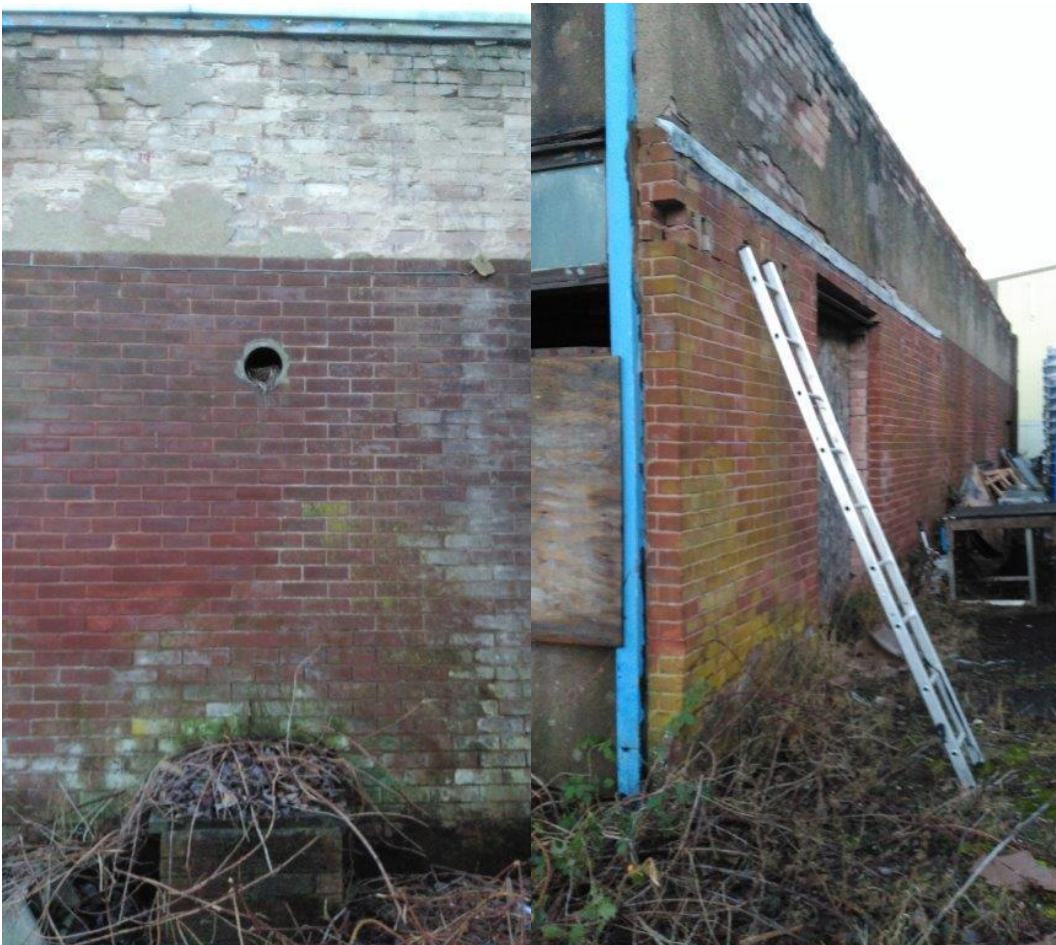
An old bird's nest was noted on the east side of the building (Plate 4).

The southern cavity wall was inspected using an endoscope (Plate 4). No bats or droppings were noted, although it was not possible to see fully down to the bottom of the cavity. It was noted that the cavity was relatively wide (5cm) and draughty, which may reduce potential for bats to use this feature in future.

Plate 4: Birds nest in east wall (left) and endoscope survey of south cavity wall (right)

The endoscope survey found no evidence of roosting bats in the southern cavity wall. The cavity appeared draughty and is considered to be of low potential for roosting bats. However, as opportunistic use of such features can never be ruled out, it is recommended that as a precaution, the wall is carefully broken into at the door edge to allow a check inside with a torch, before full demolition.

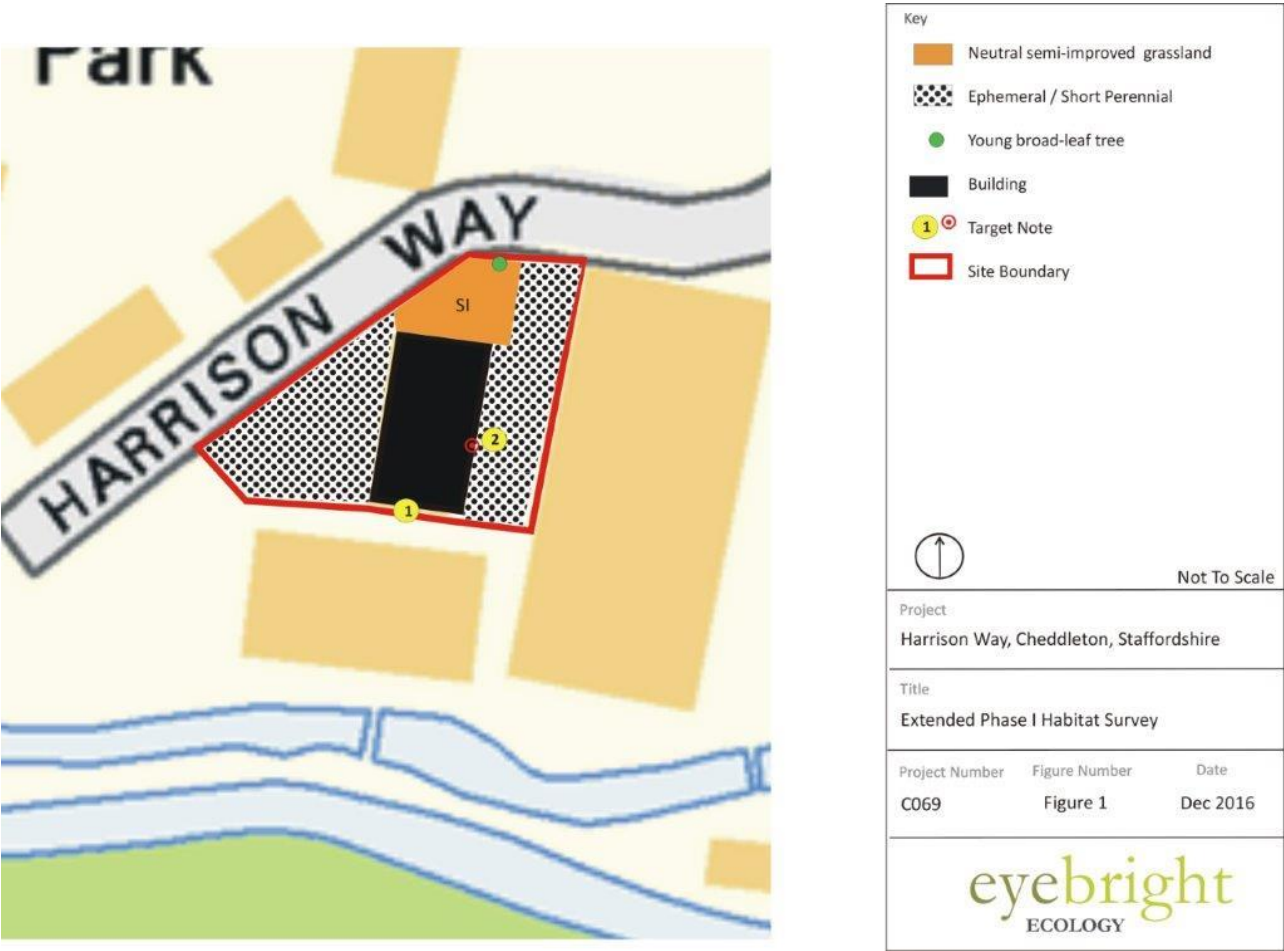
Figure 1: Updated Extended Phase I Map

Number	Target Note
1	Southern wall where endoscope survey took place, no evidence of bats was found.
2	Old bird's nest in circular cavity in wall
