**Heath House Farm Cottage, Ostlers Lane, Cheddleton, Staffordshire, ST13 7DQ**

Further to your recent instruction, we undertook a preliminary bat roost assessment of a metal outbuilding at the above property (SJ968512). The following is a summary of our actions and findings.

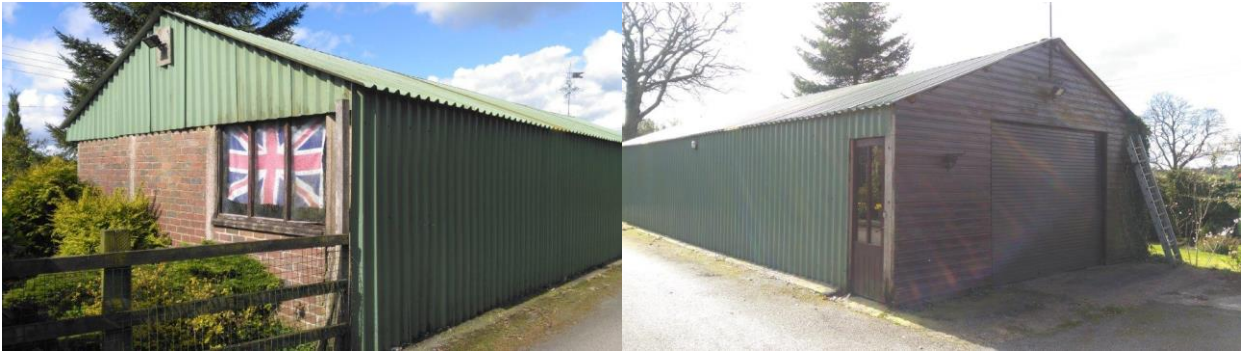
No evidence of bats was found inside the building, or externally. There were very few potential roosting crevices present. On the southern wall there were some gaps under the corrugated metal; however these gaps were heavily cobwebbed and unlikely to be thermally suitable for roosting bats.

There were also gaps present which could allow bats to access inside the building – under the metal ridge covering and along the gable ends. However, as no bat evidence was found inside, it appears unlikely that bats have gained access to the building.

Plate 1: South end of building (Left); North end of Building (Right)

No further bat survey is deemed necessary prior to demolishing the building.

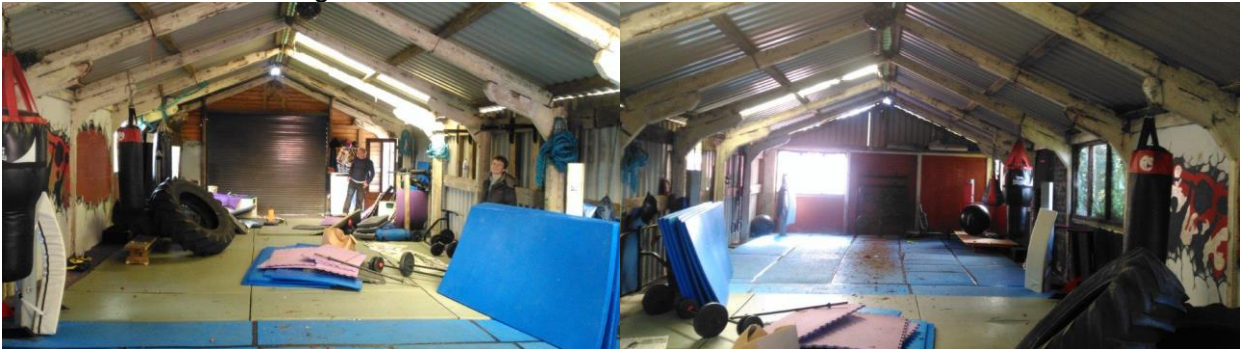
Given the lack of evidence and few roosting crevices present, the building is assessed to be of negligible potential to support a bat roost.

Plate 2: Inside of building
