Mine Entry Interpretive Report

LAND TO THE SOUTH EAST SIDE OF, TONGUE LANE, RIDGEWAY NORTON, STAFFORDSHIRE

Our reference:
 51001473239001

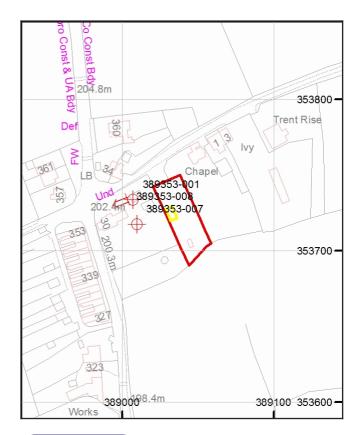
Enquiry boundary

If coal mining subsidence was to occur because of ground movement due to the mine entry, the entire property (as shown on the plan) is outside the area likely to be affected. Our opinion takes into account the thickness of the superficial deposits, the potential difference between the actual and the plotted positions of the mine entry and its diameter/maximum width.

In our opinion, the entire property (as shown on the plan) is not at risk of coal mining subsidence damage from the subject mine entry. This is because it is not within the area of possible ground movement.
