**DAYTIME BAT SURVEY &
ECOLOGICAL SCOPING SURVEY AT
LAND OFF BROOK STREET,
BROWN LEES, KNYPERSLEY,
STAFFORDSHIRE**

JULY 2017

RACHEL HACKING ECOLOGY

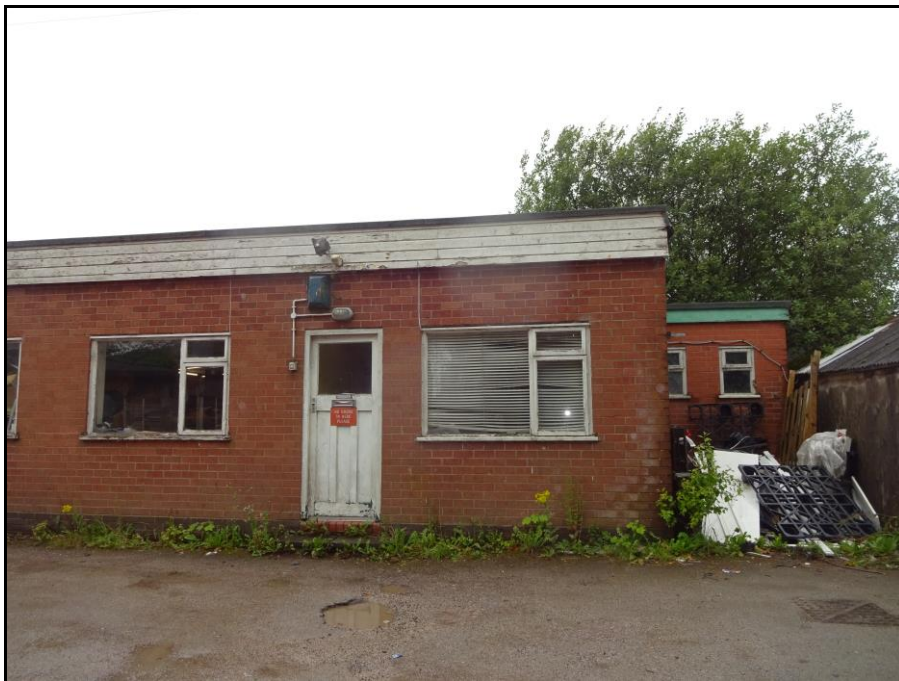
- 3.1 The main workshop is a single-storey brick-built warehouse with a flat roof (see Photograph 1 and the front cover of this report). It has been extended to the northern elevation. The external brickwork is in good condition, with no missing bricks or damaged mortar. The wooden windows and doors are in good condition. These are flush with the brickwork, heavily cobwebbed and do not provide potential bat access points into the building or a suitable bat roosting cavity. The roof of the building is constructed of corrugated metal panels and roofing felt. The roof appears to be in good condition, although the view was limited. The edges of the roof are well-sealed, particularly on the corrugated pitched roof which has been sealed with mortar beneath the eaves, preventing any bat access opportunities.

Photograph 1 showing the brick built workshop

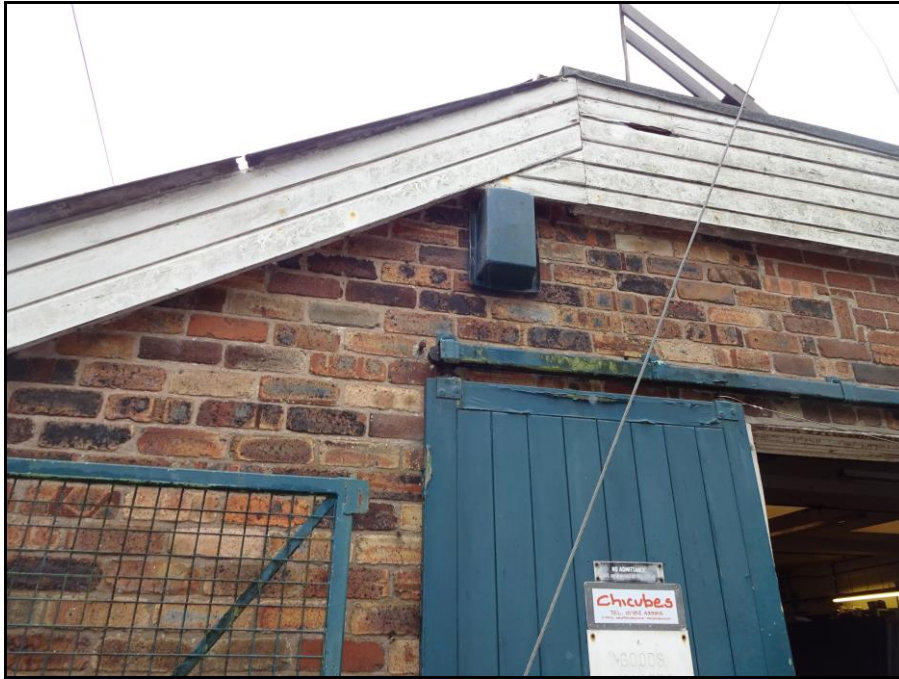
- 3.2 Wooden cladding exists on the upper part of the walls. The panels are in good condition, with only minimal areas of damage (see Photograph 2). No suitable bat roosting cavities were found behind any of the panels and they do not provide access into the internal space. The gap between the wooden panels and the brickwork has been sealed with wooden blocks.

Photograph 2 showing wooden cladding and minor damage

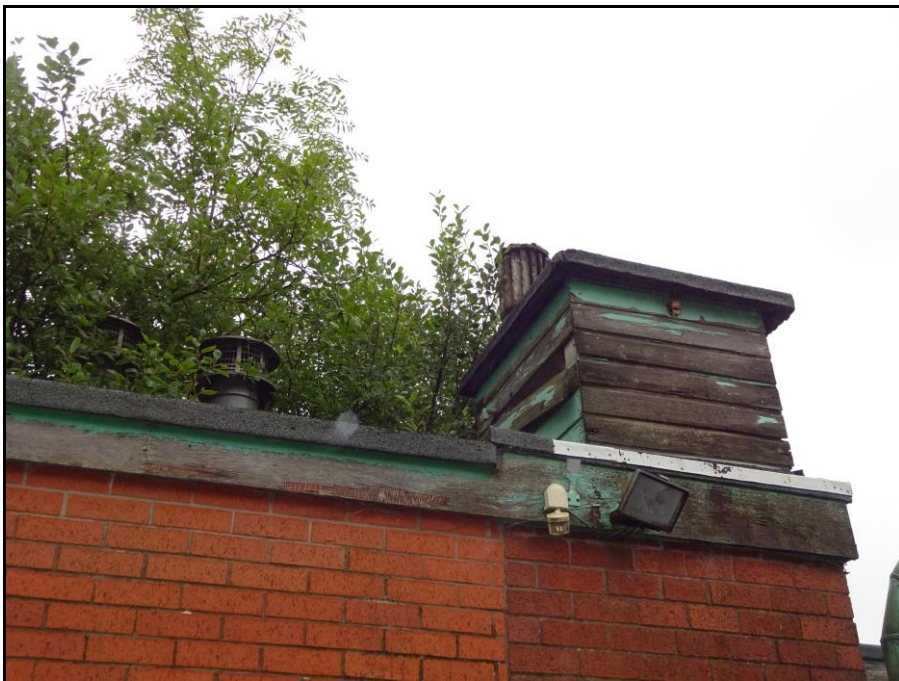
- 3.3 A bargeboard exists on the rear of the property and this is in poor condition (see Photograph 3). The bargeboard is flush with the brickwork. There is a chimney with wooden cladding on the exterior and this was weather damaged. No suitable bat roosting cavities were found behind the damaged panels or bargeboard and no access to the internal space was found. There are two metal shutters on the rear of the property. These are in good condition and flush with the brickwork.

Photograph 3 showing the bargeboard and chimney

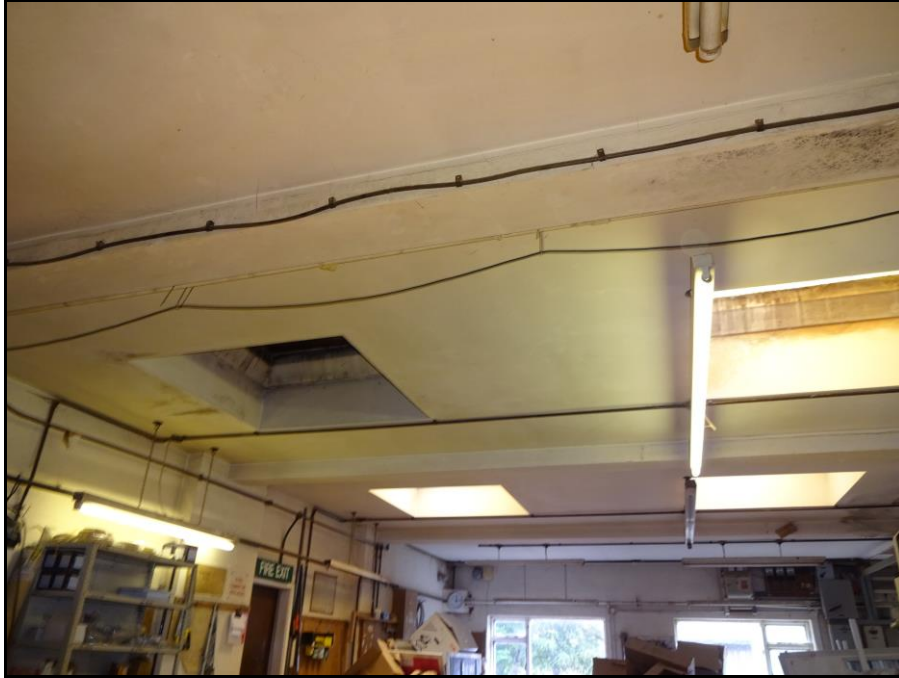
- 3.4 The internal space of the workshop is well-lit with a series of large well-sealed skylights. The metal support beams are in good condition and do not create any bat roosting opportunities. The room is open to the ceiling and there is no loft void (see Photograph 4). The ceiling is flush to the flat roof. The internal walls have been plastered and painted and are in good condition with no suitable bat roosting cavities.

Photograph 4 showing the main work space

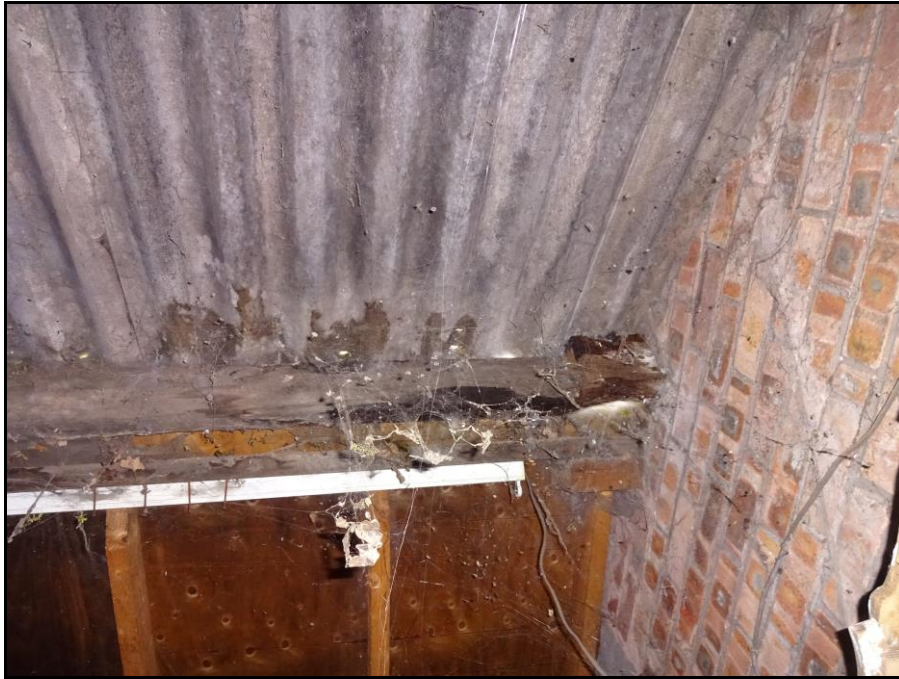
- 3.5 A small section of the interior roof is visible in a storage room at the rear of the property. The roof is very cobwebbed and dusty (see Photograph 5). There is also an office space, a kitchen and toilet space. No evidence of bat activity could be found within any rooms in the main work shop.

Photograph 5 showing the internal roof and cobwebs

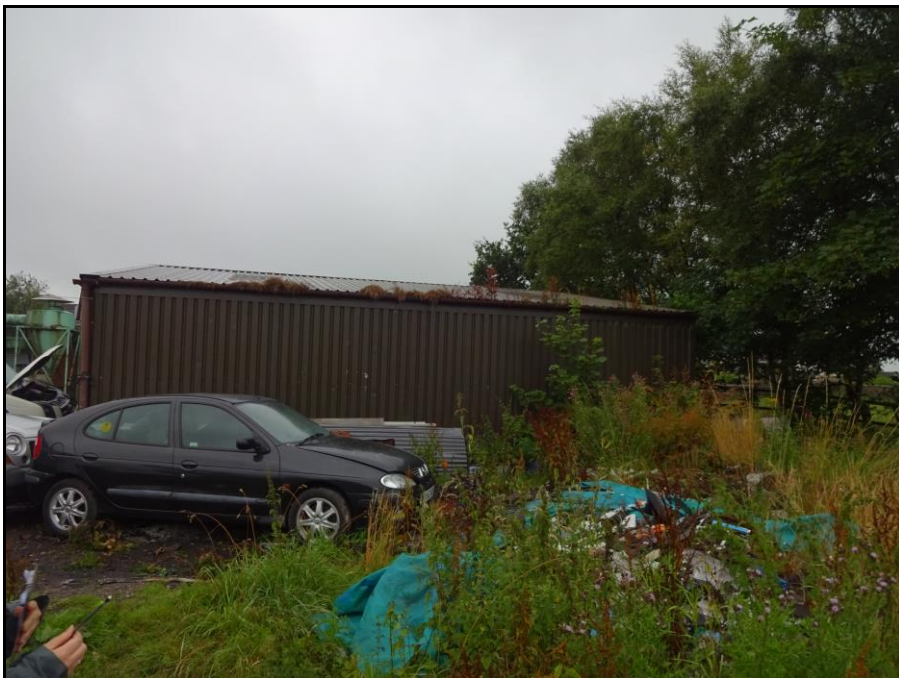
- 3.6 The car repair workshop is constructed entirely from corrugated metal panels, with a pitched roof (see Photograph 6). The panels are all in good condition with no areas of damage. There are gaps along the ridge and edges of the roof as the corrugated sheets do not lie flush. However, it is unlikely these spaces would be used by bats as they have poor thermal qualities. The building is otherwise well-sealed.

Photograph 6 showing the car repair workshop

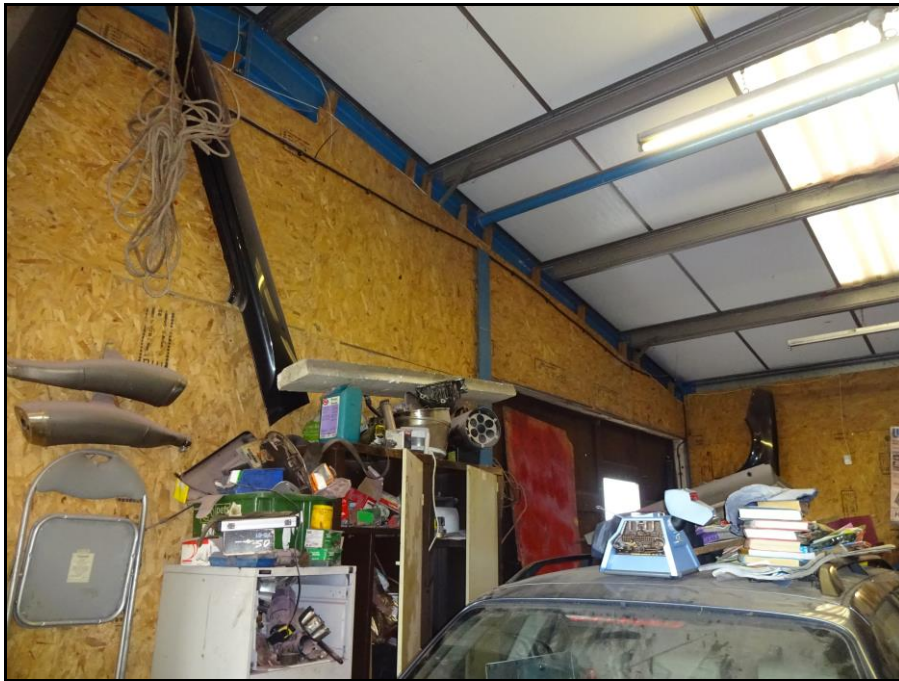
- 3.7 The internal space is well-lit with a series of large well-sealed skylights. The roof has been lined with thin sheets of plastic, these are flush with the roofing material and do not offer any bat roosting opportunities. The internal walls similarly have been lined with wooden boards and these are in good condition and do not provide any suitable bat roosting cavities. The metal support beams are in good condition and do not create any roosting opportunities. The room is open to the ceiling and there is no loft void (see Photograph 7). No suitable bat roosting habitat, or evidence of bat activity was found within the car repair workshop.

Photograph 7 showing the internal space of the car garage

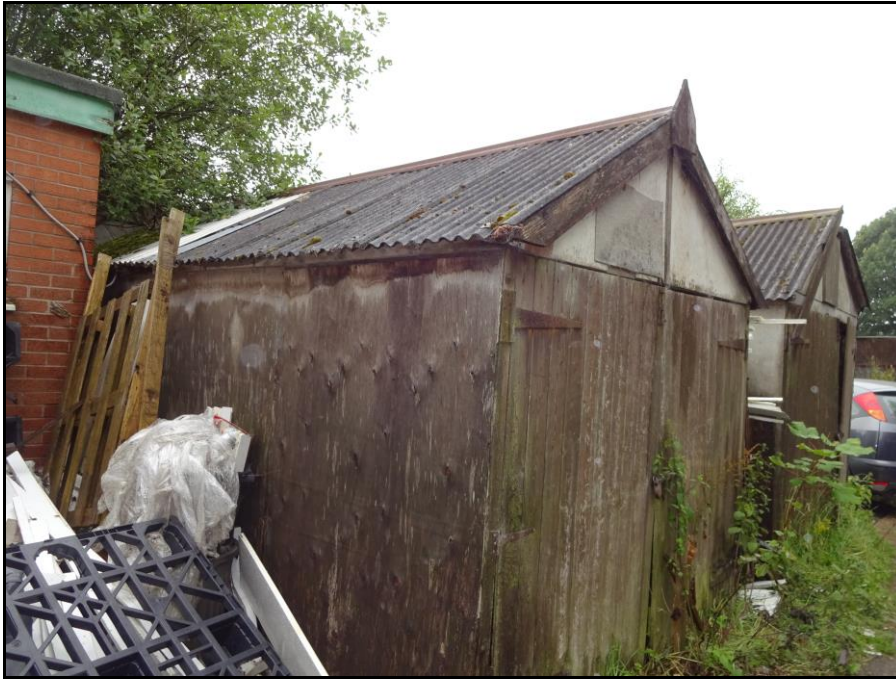
- 3.8 There are six sheds on the site (see Photograph 8). These are all constructed from wood with asbestos cement and wooden roofs. The sheds are all reasonably well-sealed although there are access points for bats into some of the sheds. A sparse covering of Ivy *Hedera helix* has started to grow over one of the sheds. The Ivy does not provide suitable bat roosting habitat. Where wooden window frames exist, these are well-sealed.

Photograph 8 showing two of the sheds on site

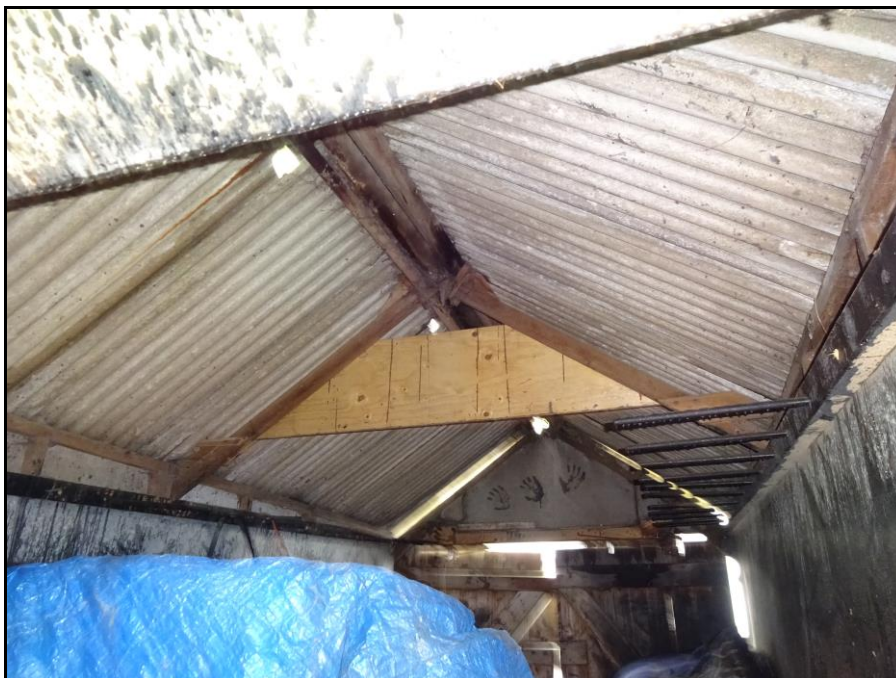
- 3.9 The internal spaces of all the sheds were accessible and are used for storage, or are disused (see Photograph 9). They are all draughty and dusty internally, and there is ivy growing internally in one shed. No suitable crevices for roosting bats were found within the sheds. No evidence of bat activity was found within the sheds.

Photograph 9 showing the internal space of one shed

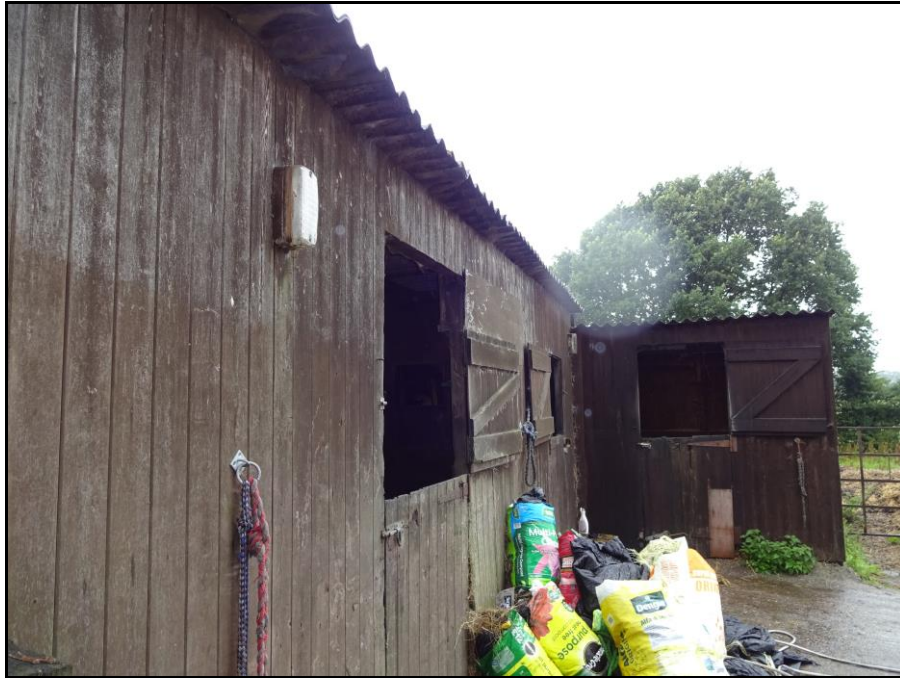
- 3.10 The stable block is constructed of wood with a corrugated sheet metal roof. It is currently in use. The external wooden panels are in good condition and flush with each other. The wooden stable doors are open and provide a potential access point for bats (see Photograph 10). The corrugated sheet metal roof is also in good condition with all of the panels complete and flush with each other.

Photograph 10 showing the stable

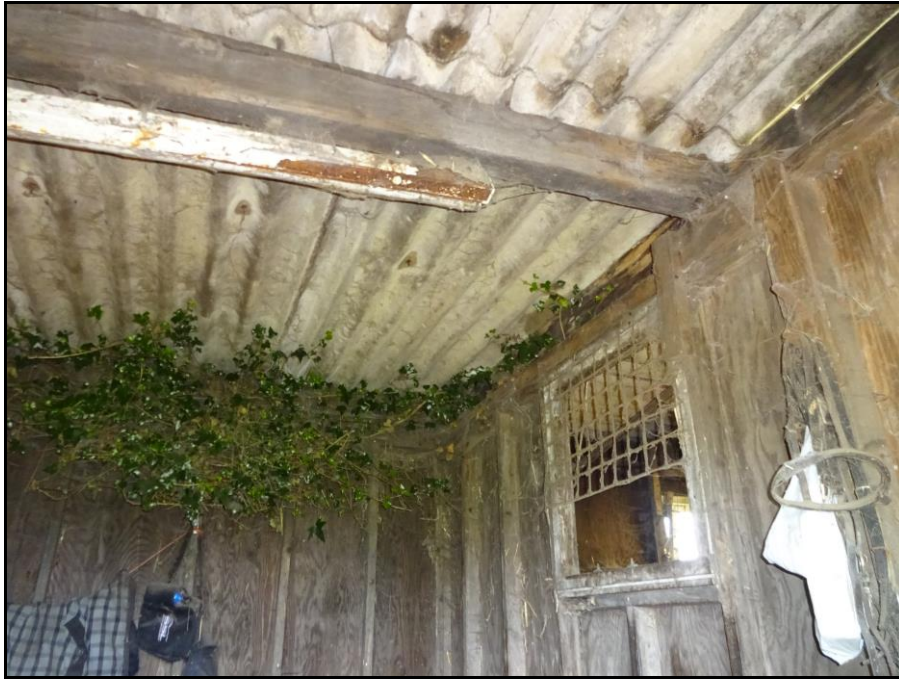
- 3.11 The interior of the stables is dusty and heavily cobwebbed, with Ivy establishing in one stall (see Photograph 11). The internal wooden panels are in good condition and flush with each other. The wooden support beams are in good condition, and provide no suitable bat roosting features. No evidence of bat activity was found within the stables.

Photograph 11 showing the internal space of the stable

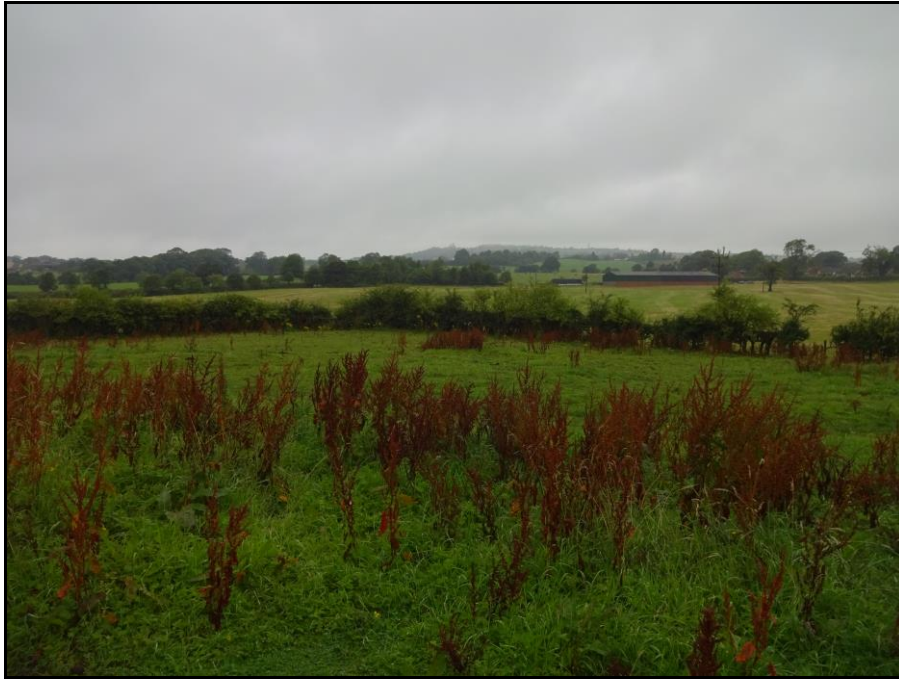
- 3.12 The buildings on site are surrounded by hardstanding.
- 3.13 Two paddocks of grazed species-poor grassland exist on the wider site (see Photograph 12). The grassland is dominated by Perennial Rye-Grass *Lolium perenne*, Yorkshire Fog *Holcus lanatus* and Meadow grasses *Poa* sp. There are also a small number of common herbs within the grassland including Broad-leaved Dock *Rumex obtusifolius*, Stinging Nettle *Urtica dioica* and Common Ragwort *Senecio jacobaea*. Ruderal vegetation has developed beneath the hedgerows and in parts of the grassland which are not grazed. This is dominated by Stinging Nettle, Broad-leaved Dock and Bramble *Rubus fruticosus* agg.

Photograph 12 showing the grassland on site

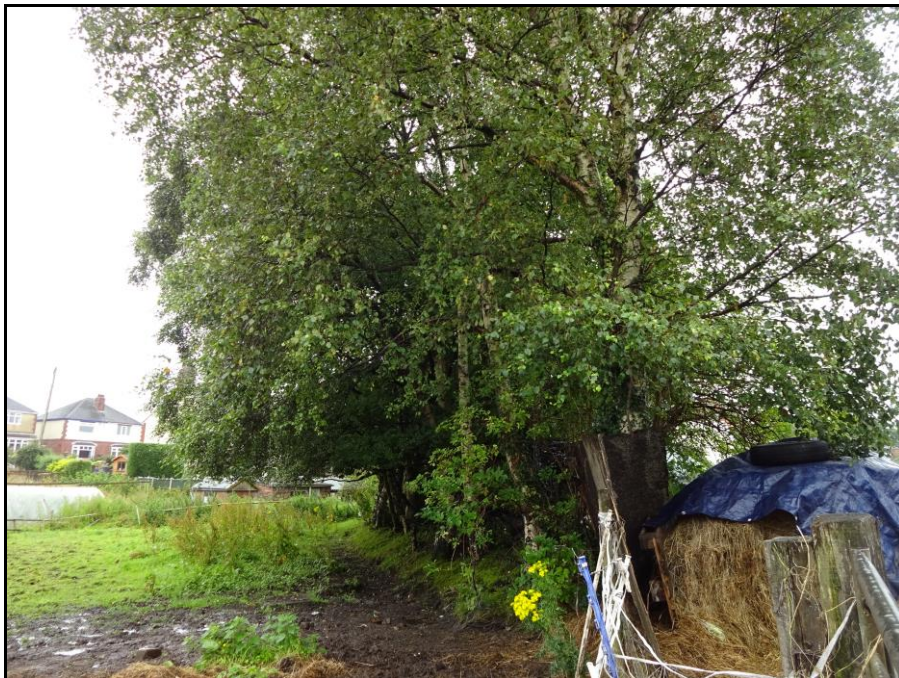
- 3.14 Species-poor hedgerows exist on the site boundary. They are mature and dominated by Hawthorn *Crataegus monogyna* with small amounts of Elder *Sambucus nigra* and Ivy *Hedera helix*. Scattered trees exist on site (see Photograph 13). They are all semi-mature Silver Birch *Betula pendula* trees.

Photograph 13 showing some of the trees on site

- 3.17 The trees were inspected from the ground and were found to not support suitable bat roosting features, such as cavities or limb damage. The trees have the potential to support nesting birds.
