# Preliminary Bat Roost Appraisal Report

## Underwood Hall Farm, Biddulph

March 2017

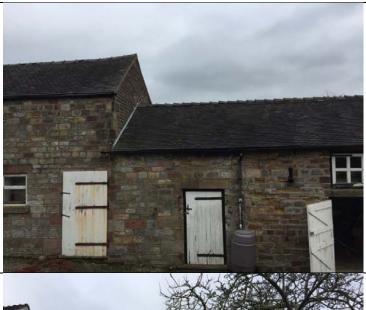
Description/ Potential Roost Features	Level of BRP
Single storey stone walled building with pitched slate roof. The roof has been re-roofed within the last fifteen years and is in good condition there are no obvious gaps, slipped/missing/broken tiles. The ridge tiles are also in good condition with no obvious access points. The stone work is in good condition with no cracks or crevices. There are several slits, however these have chicken mesh over then preventing access internally.	Negligible to Low
	Photograph 1: building to be renovated, looking south-east.

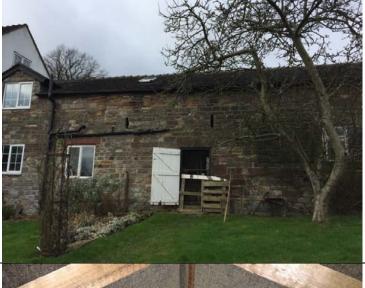
Photograph 2: building to be renovated, looking east.

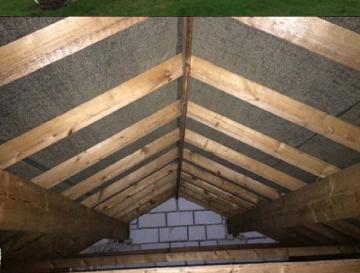
Photograph 3: building to be renovated, looking west.
