# ***Bat and Bird Appraisal Report***

## ***Sneyd Arms Farm, Basford Green***

***October 2017***

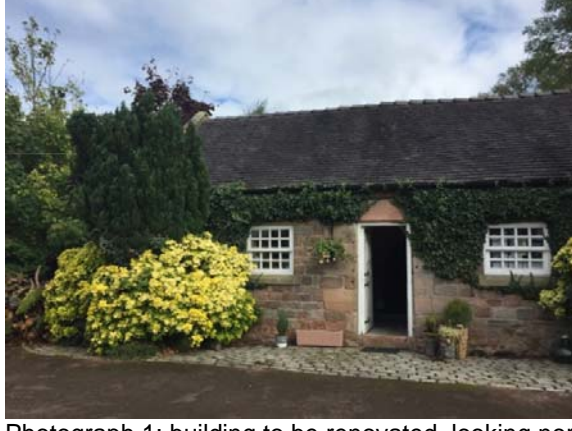
Description/ Potential Roost Features	Level of BRP
<p>Single storey stone walled building with a pitched slate roof. The roof has been re-roofed within the last thirty years and is in fairly good condition. There are a few raised tiles but the ridge tiles are sound and there are no obvious gaps. The stone work is in good condition with no obvious cracks or crevices, although the western side is obscured in part by ivy (<i>Hedera helix</i>) cover.</p> <p>There is no loft space present, the roof is open to the apex and is lined with bitumen felt. The apex was dusty and covered in cobwebs.</p> <p>No bats or evidence of bats was found internally or externally.</p>	<p>Low (due to location of good foraging and commuting habitat, and some external features which may be suitable for individual or small numbers of bats).</p>

Photograph 1: building to be renovated, looking north-east.

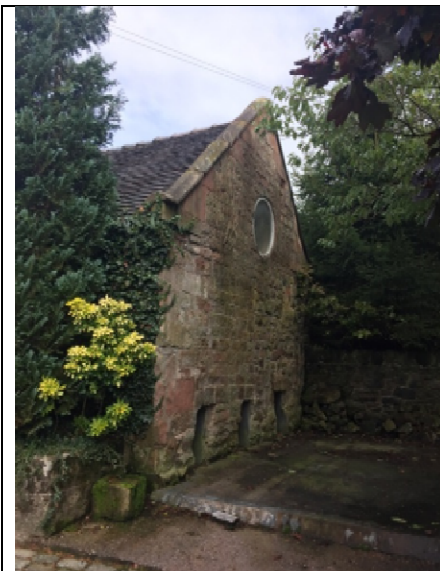
Photograph 2: building to be renovated, looking north.

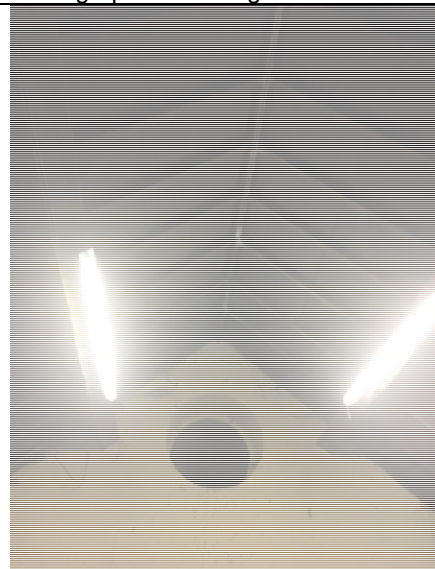
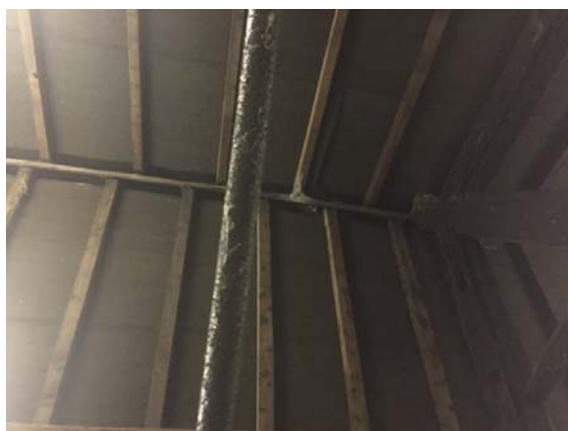
Photographs 3 and 4: internal roof structure of the building.

During the internal inspection of the building no bats or evidence of bats was found. The building was searched internally for signs of bats (i.e. droppings, feeding remains) and none were found. The wooden beams in the apex of the roof were dusty and cobwebs were present, indicating that bats have not been using the apex of roof. In addition the building is used for storage purposes and is regularly entered and lighting switched on. It is therefore concluded that bats are not roosting within the internal structure of the building.
