**Project:** 19\_5837\_10\_12  
**Site:** SK11 0SR, Rudyard Road, and Gun Hill Road  
**Client:** Mr M Edge and Mrs P Edge.

| Document Title: | Arboricultural Implications Assessment |

Date: 7th November 2019

# Arboricultural implications assessment to BS 5837 2012 of trees at: SK11 OSR, Rudyard Road, and Gun Hill Road

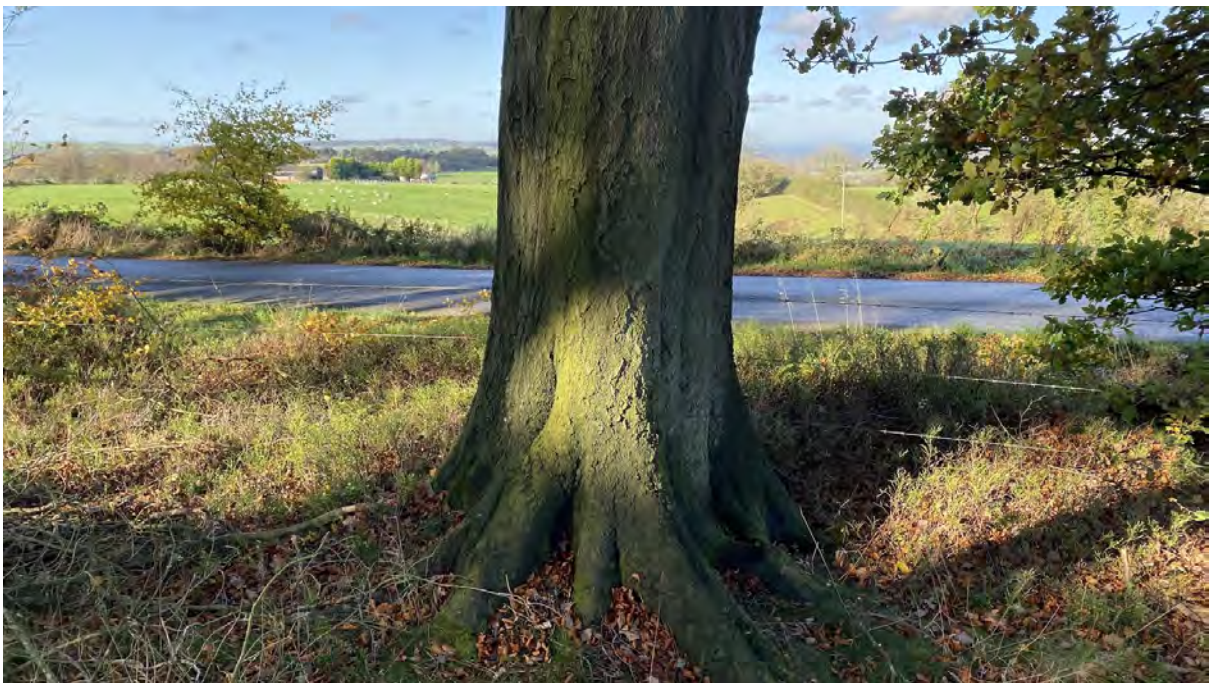
Photographic plate showing one of the many mature Beech trees adjacent to the highway.

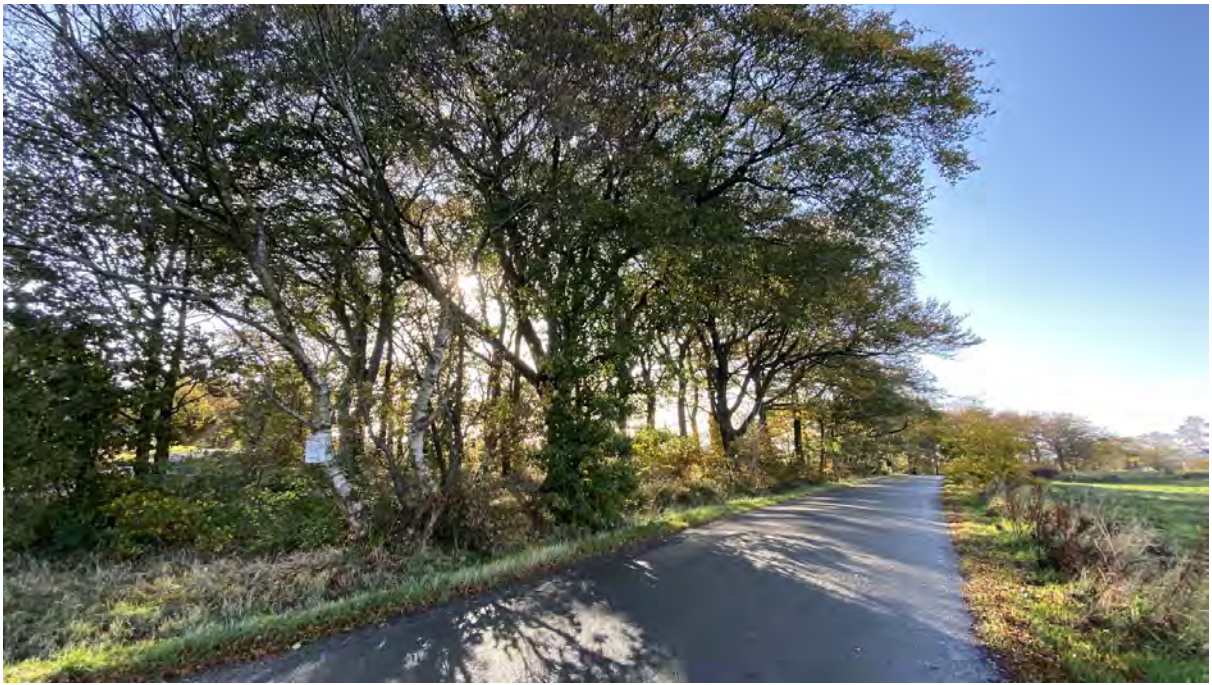
General view showing the density of the woodland block.

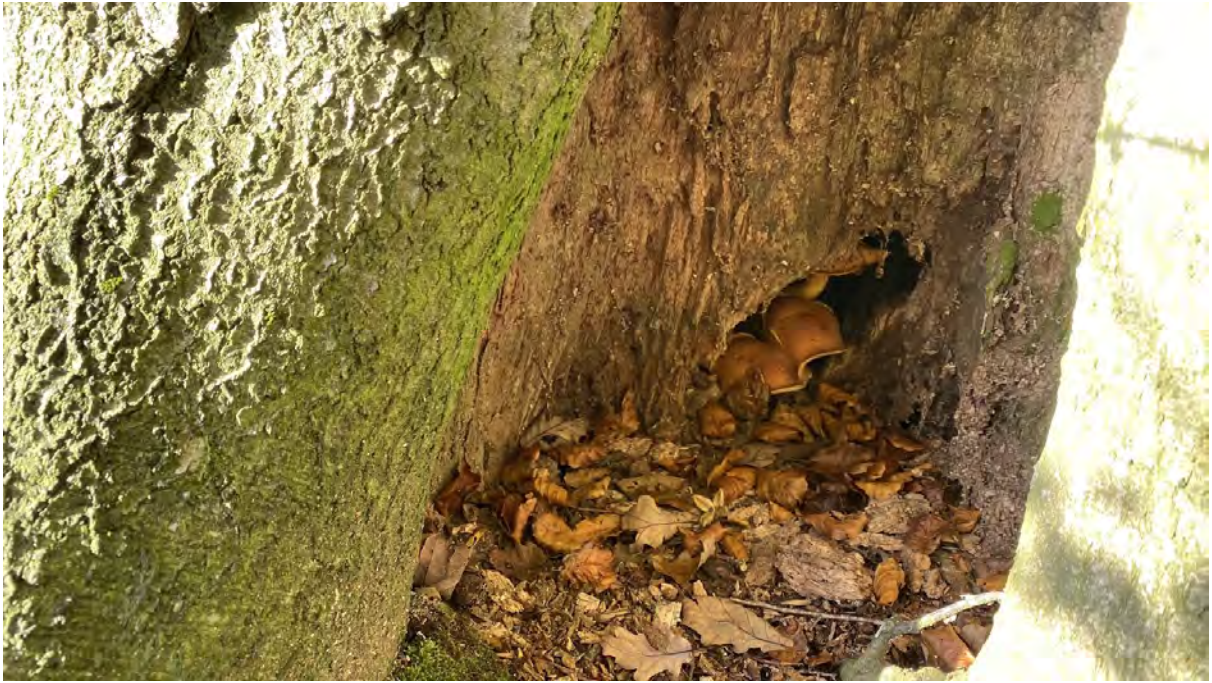
Photographic plate showing a cavity and decay present in one of the beech trees.

| Tree Number | Species | Age Class | DBH | Height (crown height) | N | E | S | W | Condition | Life Expectancy | Physical Description | Managment Recommendations | RPA offset from stem. |
|---|---|---|---|---|---|---|---|---|---|---|---|---|---|
| T9 | Fagus sylvatica (Beech) | OM | 970 | 16(7) | 6 | 7 | 8 | 6 | Poor | <10 | Poor shape & form. Low vitality. Declining. Leaning North. Decay present on stem. Fungal brackets visible on stem. Cavity on stem. Dieback in crown. Low bud/leaf density.Large cavity in base with fungus | Fell for safety | 11.64 |

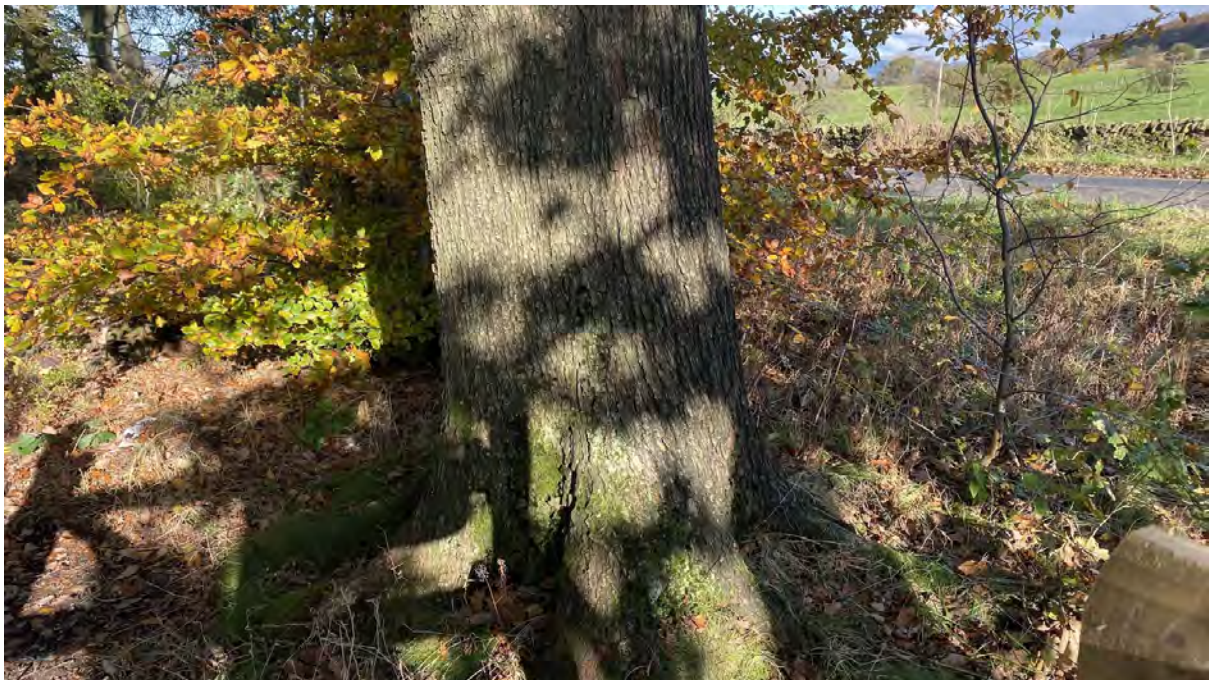
*Photographic plate showing one of the few oak trees.*

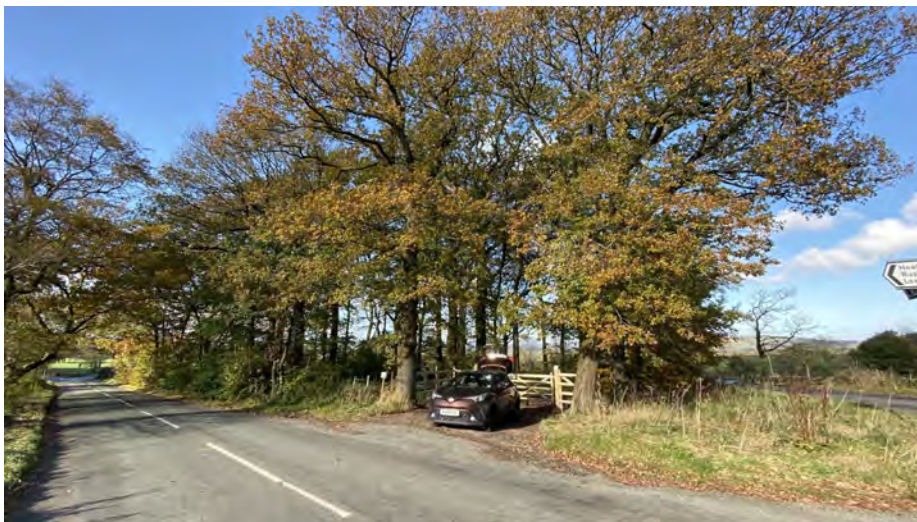
*Photographic plate showing they typical block structure and dense self set regeneration.*

- 7.7 In terms of woodland management, some tree safety works are required to safeguard the road and the dense self set regeneration can be thinned to best stems. It is important to retain some regeneration for succession planning.

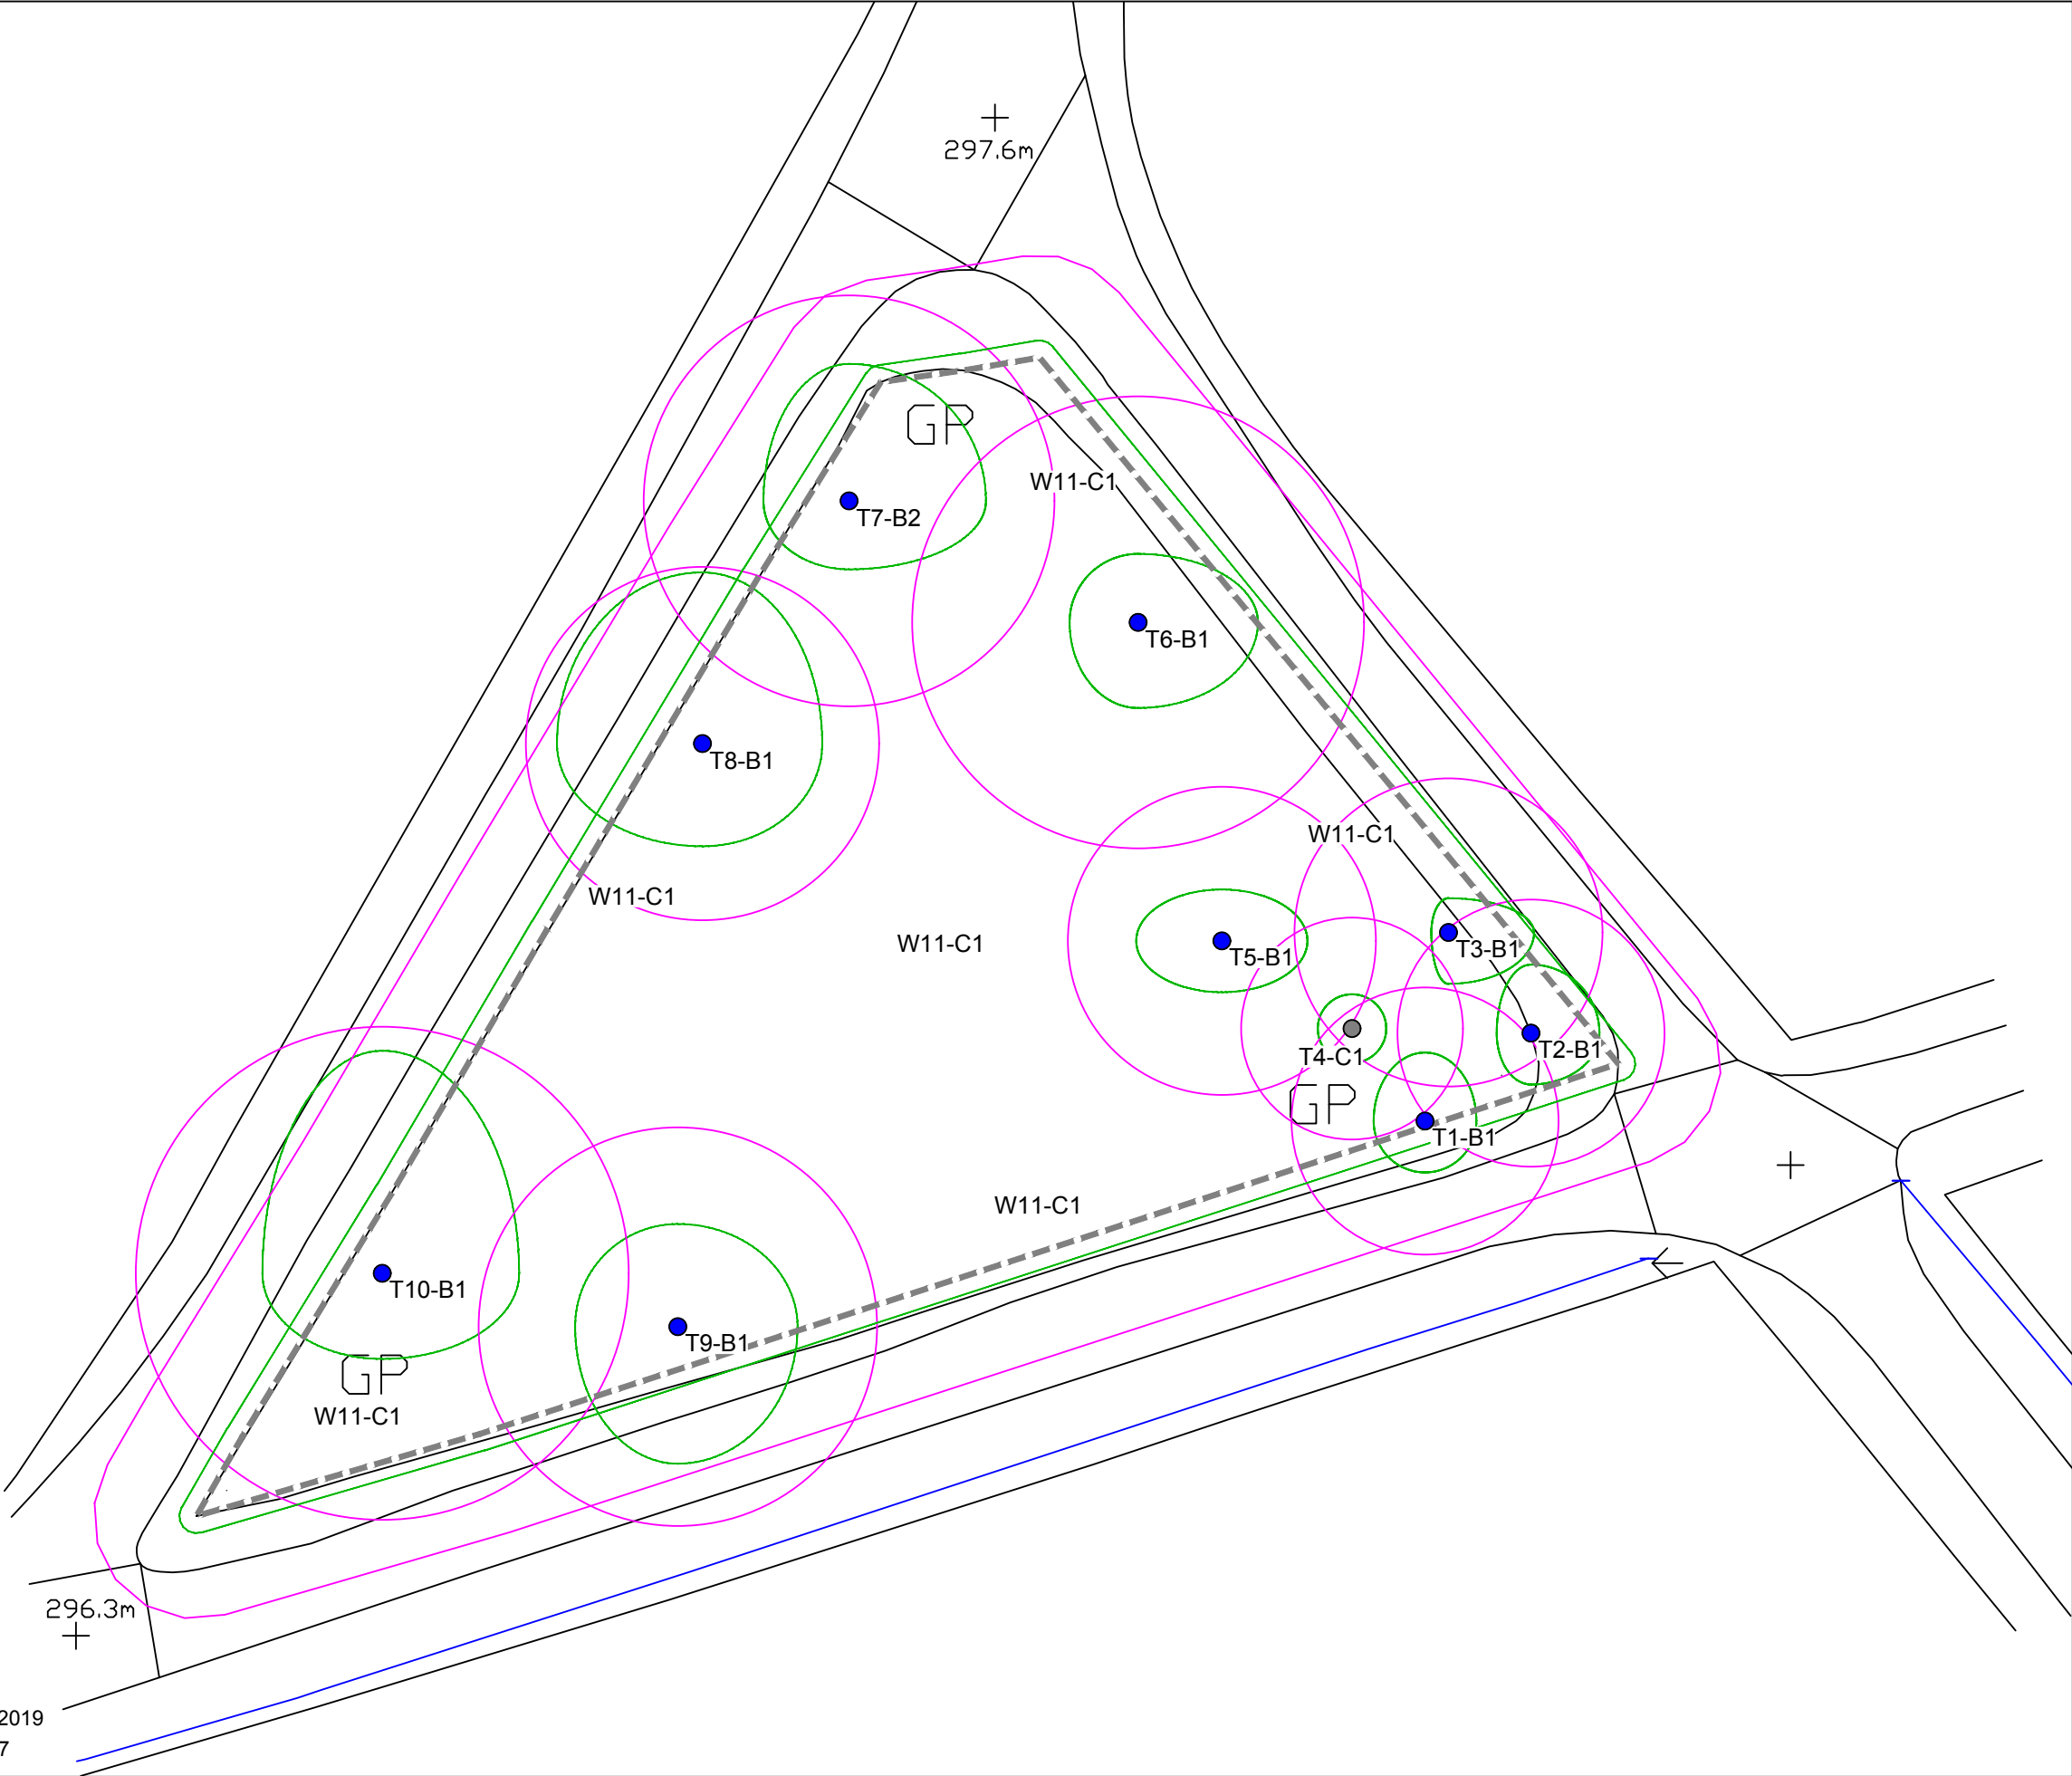
**Tree Constraints Plan**  
showing existing layout with  
tree categories and root  
protection zones.
