# **Bat Survey Report 2021**

## **Building Inspection Report**

Location: **BRADLEY ELMS FARM, ALTON ROAD, THREAPWOOD, Cheadle, Stoke-on-Trent, ST10 4RB**

Date of inspection: **20<sup>th</sup> May 2021**

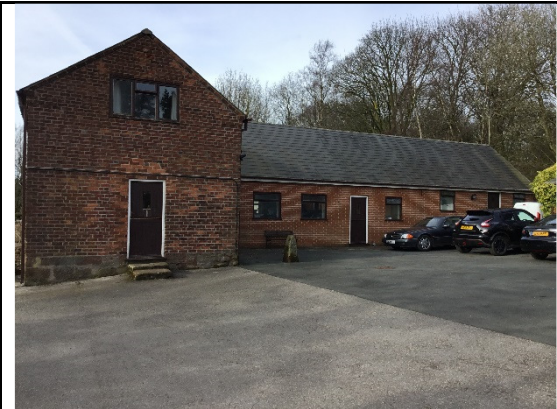
| 1. Building A | 2. Building B |

- 5.2. Externally, as is evident from the photographs no's 1-4, Buildings A, B and C appear to be in good condition; the mortar appears sound and in place and the roof tiles are tight. There were no visible entry points apart from two possible small gaps beneath the ridge tiles on the southern elevation of Building A. Building D is a portal frame building with a long axis from north to south, open at the southern end, and with a wide entry opening at the northern end. No evidence of bats was found on the outside of any of the buildings.

- 5.4. There are two roof spaces in Building A; one in the two-storey part of the building and one at the western end of the single-storey part. Both were inspected using a torch. Both have glass fibre laid between the floor joists and a breathable roof membrane beneath the tiles. The latter is unsuitable for bats because their feet can get easily tangled in the membrane. No light could be seen penetrating the darkness. No sign of bats – dropping or stains - was found in either roof space.

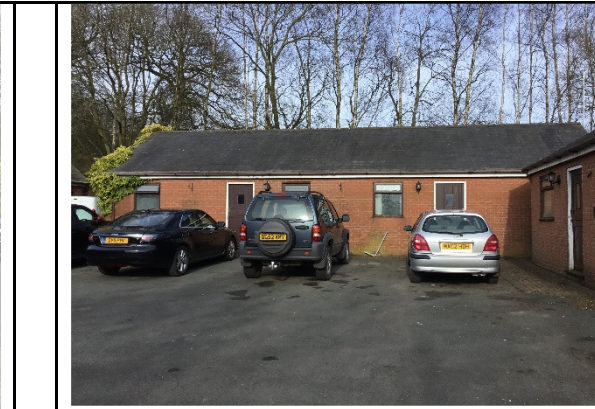
- 5.5. No sign of bats was found in the loft in Building B which has clean glass fibre between the floor joists and breathable roof membrane (BRM) beneath the tiles. The ridge height is about 2.5 to 3 metres and no light percolation was detected. The floor of the roof space is lined with glass fibre and no droppings could be found. The roof is felted with plastic-coated BRM (breathable roof-membrane) which is unsuitable for bats. The roof space stretches from across the full width and the full length of the building. With the torch switched off no light penetrated the space indicating that there were no visible entry points into the space. No shredding of the BRM could be seen which is something that often happens when bats hang from breathable roof membranes.

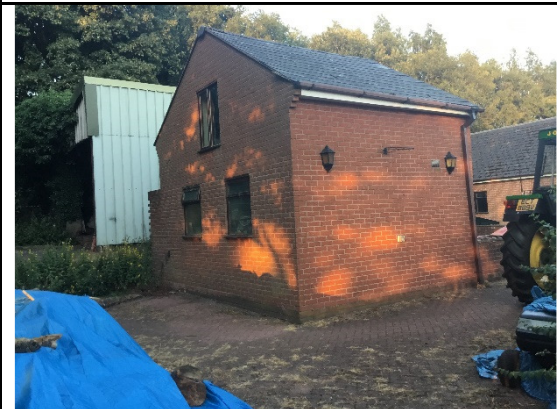
| 3. Building C | 4. Building D |

- 5.6. There is no accessible roof space in Building C. The external inspection of the building revealed no potential access points into the roof space.

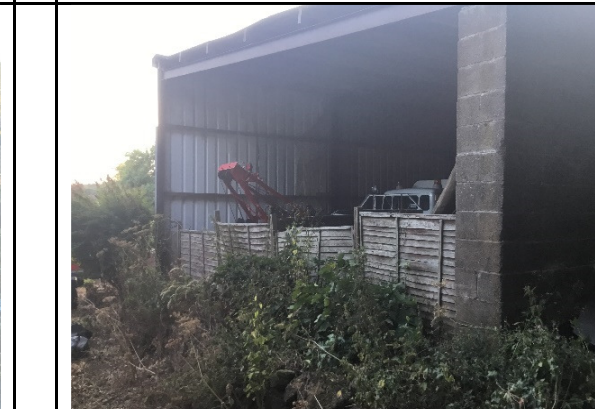
- 5.7. Building D is open to the roof and but bats can access through the doorways on the north and south of the barn. No bat droppings or other sign of bats was found in the building.
