# SLADEN ASSOCIATES

**Re: Updated Assessment of Coal Mining Risks  
Proposed New Residential Conversion  
Old Engine House Farm, Dilhorne, Staffordshire**

<p><b>SLADEN ASSOCIATES</b></p>	<p>Report No 21-2319-2</p>	<p>Project Old Engine Farm Birchenfields Lane Dilhorne</p>	<p>Figure <b>1</b></p>
---------------------------------	--------------------------------	--	----------------------------

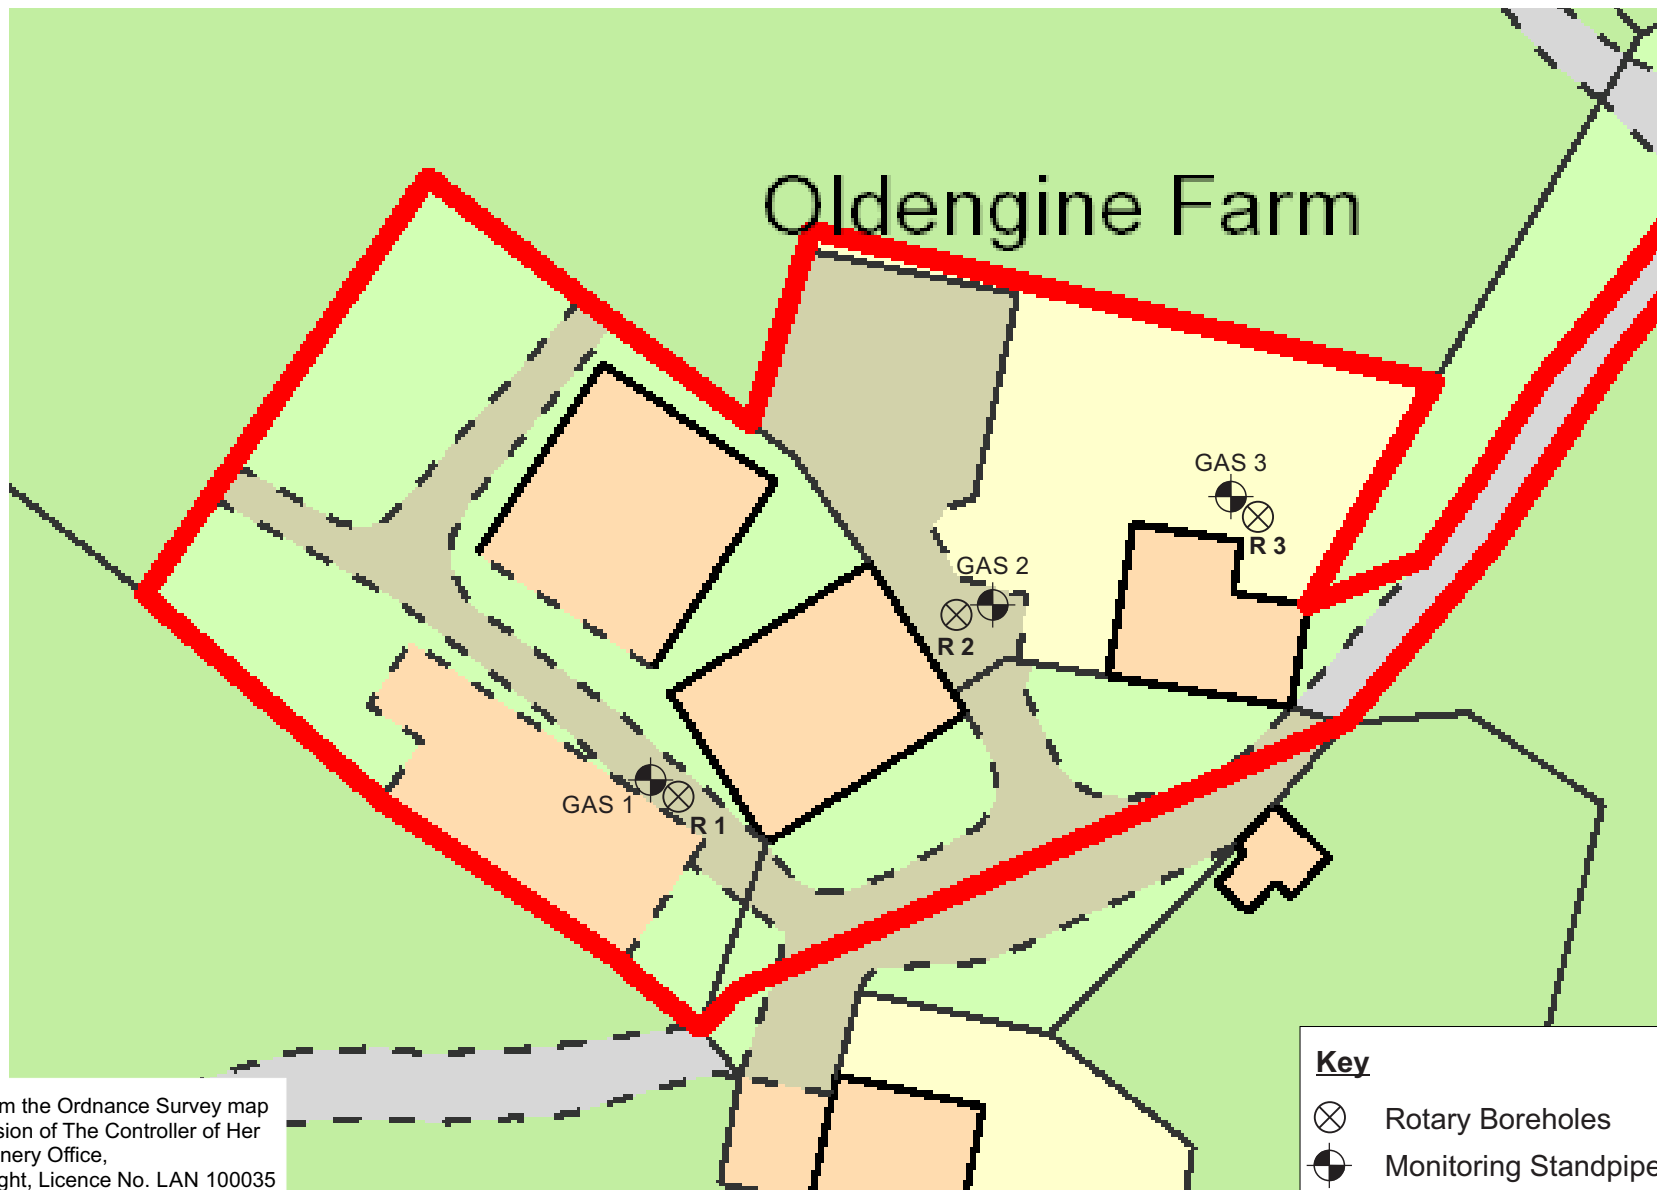
Figure  
**2**

The recommended probe drilling was undertaken by Dragon Drilling Limited working under the supervision of Sladen Associates and comprised three rotary water-flushed boreholes (R1 to R3), each to a depth of 30m. Figure 2 shows the borehole locations. Logs of the boreholes are attached.

Three shallow gas monitoring wells (GAS 1 to GAS3) were installed by open hole rotary drilling to approximately 1.5 m depth. Each was provided with a gas monitoring standpipe with gravel surround up to 0.5 m depth and bentonite seal from 0.5 m depth to ground level. The monitoring locations are shown on Figure 2. A programme of ground gas monitoring was implemented as follows:
