Anzio Camp, Leek

Ecological Assessment, Final Update Report

SLR Ref: 421-04017-00001

August 2014

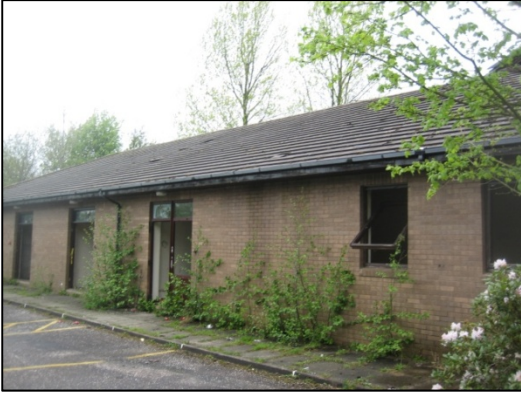
| <p><b>Moderate Potential</b></p> | <p>Description:<br/>A single storey brick building with a double pitch clay tile roof. The windows and doors are open. The brickwork is in good condition with no cracks, crevices or eroded mortar joints. The roof is of modern construction with a bitumastic membrane beneath the tiles.</p> <p>Potential Roosting Features:<br/>- Slipped and broken roofing tiles</p> <p>Evidence of Bat Activity in 2012:<br/>- None</p> <p>Evidence of Bat Activity in 2014:<br/>- None</p> | |

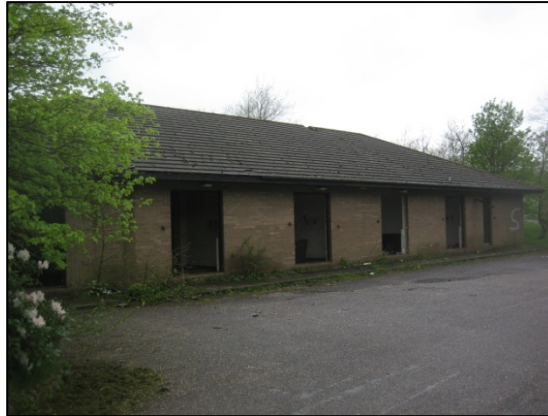
**Building B2**

**Moderate  
Potential**

A single storey brick building with a double pitch clay tile roof. The windows and doors are open. The brickwork is in good condition with no cracks, crevices or eroded mortar joints. The roof is of modern construction with a bitumastic membrane beneath the tiles.

- Slipped and broken roofing tiles

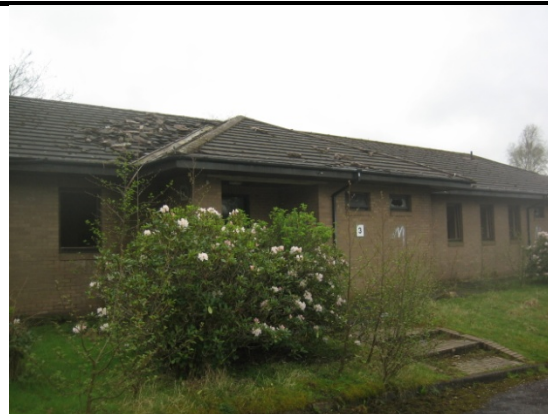
**Building B3**

**Moderate  
Potential**

A single storey brick building with a double pitch clay tile roof. The windows and doors are open. The brickwork is in good condition with no cracks, crevices or eroded mortar joints. The roof is of modern construction with a bitumastic membrane beneath the tiles. An internal inspection was not possible due to health and safety considerations

- Slipped and broken roofing tiles
- Holes into soffit box

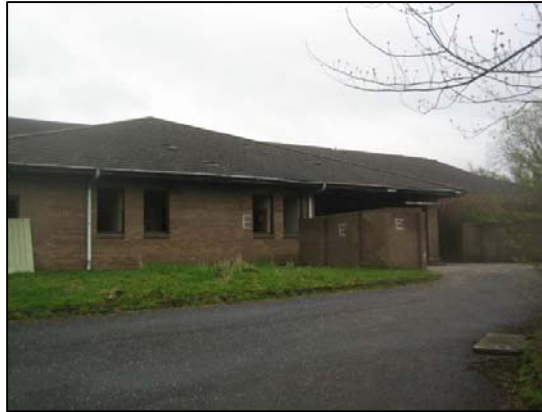
**Building B4**

**Moderate/High  
Potential**

A single storey brick building with a double pitch clay tile roof. The windows and doors are open. The brickwork is in good condition with no cracks, crevices or eroded mortar joints. The roof is of modern construction with a bitumastic membrane beneath the tiles. An internal inspection was not possible due to health and safety considerations

- Slipped and broken roofing tiles
- Gaps into soffit box
- Holes into cavity wall

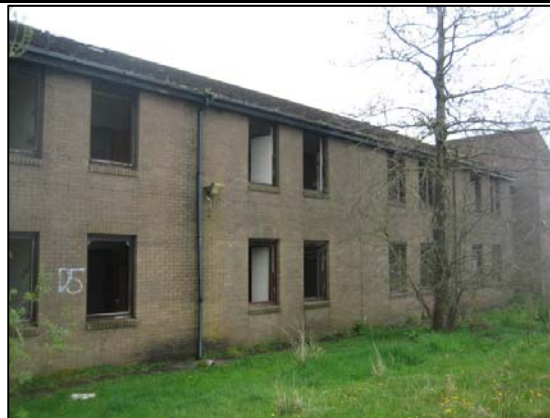
**Building B5**

**Confirmed  
Roost in 2012**

A two storey brick building with a multiple pitched clay tile roof. The brickwork is in good condition; though the roof has been broken open in many locations. The roof is of modern construction with a bitumastic membrane beneath the tiles. An internal inspection was not possible due to health and safety considerations

- Slipped and broken roofing tiles
- Gaps into soffit box
- Some lead flashing remains on the eastern aspect

- Common pipistrelle observed emerging during dusk survey in 2012

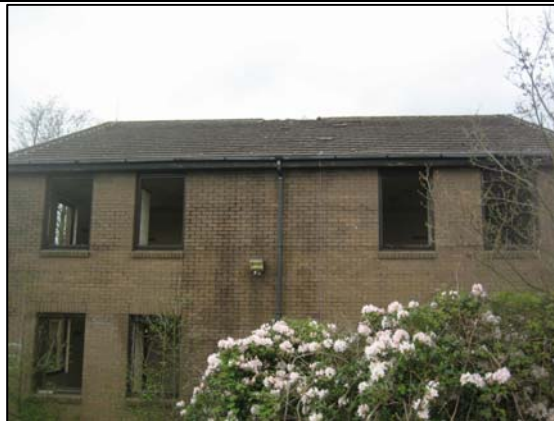
**Building B6**

**Moderate  
Potential**

A two storey brick building with a multiple pitched clay tile roof. The brickwork is in good condition; though the roof has been broken open in many locations. The roof is of modern construction with a bitumastic membrane beneath the tiles. An internal inspection was not possible due to health and safety considerations

- Slipped and broken roofing tiles
- Gaps into soffit box

- 2 Common pipistrelle bats observed emerging during dusk survey and re-entering during dawn survey
-

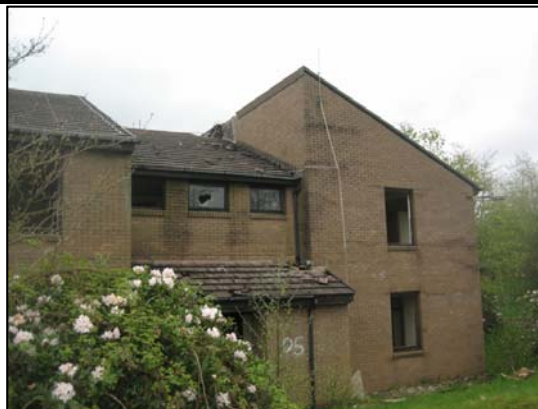
**Building B7**

**Moderate  
Potential**

A two storey brick building with a multiple pitched clay tile roof. The brickwork is in good condition; though the roof has been broken open in many locations. The roof is of modern construction with a bitumastic membrane beneath the tiles. An internal inspection was not possible due to health and safety considerations

- Slipped and broken roofing tiles

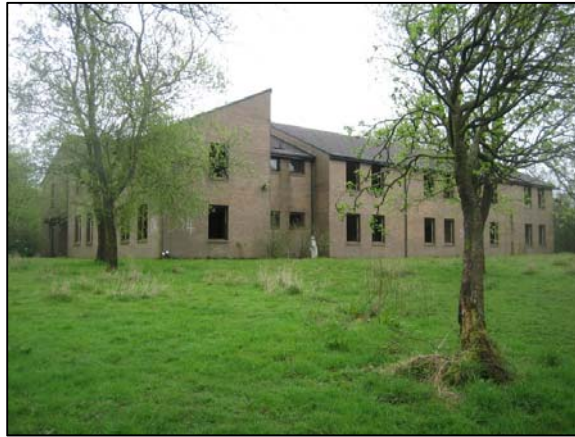
**Building B8**

**Confirmed  
Roost in 2012**

A two storey brick building with a multiple pitched clay tile roof. The brickwork is in good condition; though the roof has been broken open in many locations. The roof is of modern construction with a bitumastic membrane beneath the tiles. An internal inspection was not possible due to health and safety considerations

- Slipped and broken roofing tiles

- Common pipistrelle observed entering roost during dawn survey

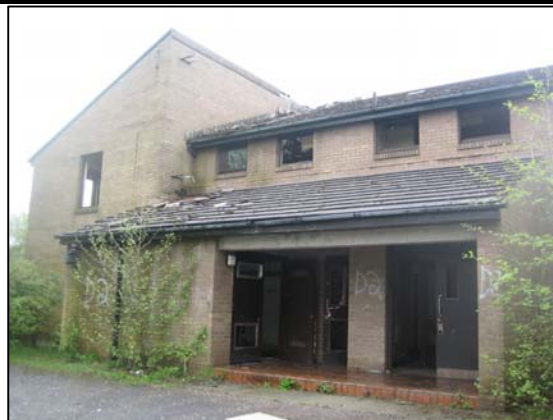
**Building B9**

**Confirmed  
Roost in 2012**

A two storey brick building with a multiple pitched clay tile roof. The brickwork is in good condition; though the roof has been broken open in many locations. The roof is of modern construction with a bitumastic membrane beneath the tiles. An Internal inspection was not possible due to health and safety considerations

- Slipped and broken roofing tiles

- Common pipistrelle observed entering roost during dawn survey

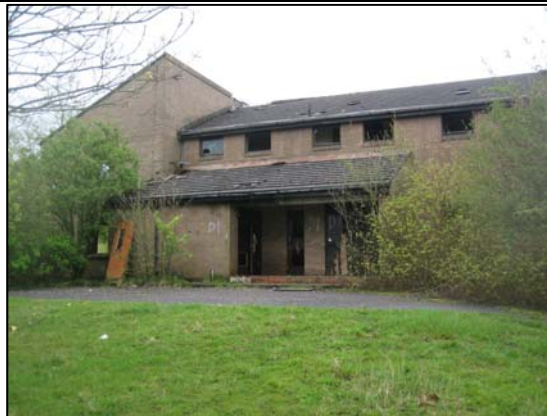
**Building B10**

**Moderate  
Potential**

A two storey brick building with a multiple pitched clay tile roof. The brickwork is in good condition; though the roof has been broken open in many locations. The roof is of modern construction with a bitumastic membrane beneath the tiles. An internal inspection was not possible due to health and safety considerations

- Slipped and broken roofing tiles

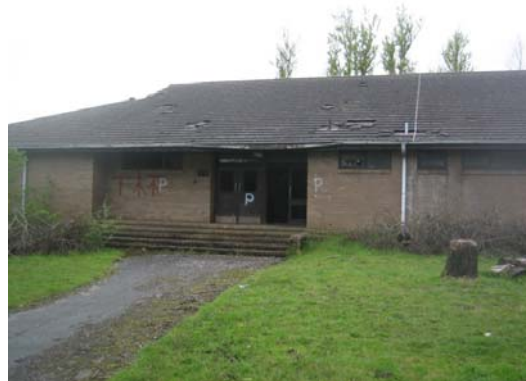
**Building B11**

**Moderate  
Potential**

A one and two storey brick building with a single pitched clay tile roof. The brickwork is in good condition; though the roof has been broken open in many locations. The roof is of modern construction with a bitumastic membrane beneath the tiles. An internal inspection was not possible due to health and safety considerations.

- Slipped and broken roofing tiles

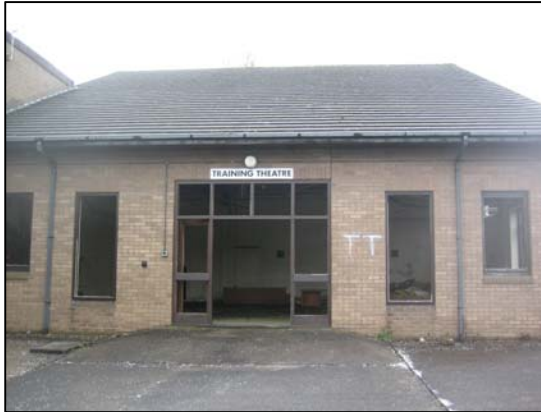
**Building B12**

**Confirmed  
maternity  
roost in 2006**

**Confirmed  
roost in 2012**

A single storey brick building with a multiple pitched clay tile roof. The brickwork is in good condition; though the roof has been broken open in many locations. The roof is of modern construction with a bitumastic membrane beneath the tiles. The roof is of modern construction with metal beams and wooden joists, light levels were high, and the roof void was cool and drafty due to the number of holes in the roof.

- Slipped and broken roofing tiles
- Wooden soffit box on northern aspect

- Two droppings consistent with common pipistrelle were found in the roof void. The droppings appeared quite old

Nesting swallow *Hirundo rustica* were recorded breeding in Building B12.

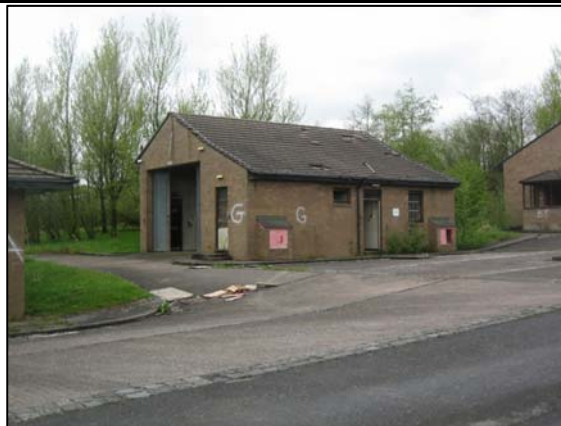
**Building B13**

**Moderate  
Potential**

A single storey brick building with a single pitched clay tile roof. The brickwork is in good condition; though the roof has been broken open in many locations. The roof is of modern construction with a bitumastic membrane beneath the tiles. The roof void was cluttered with numerous wooden joists and metal beams, light levels were high and the roof void was cool and drafty.

- Slipped and broken roofing tiles

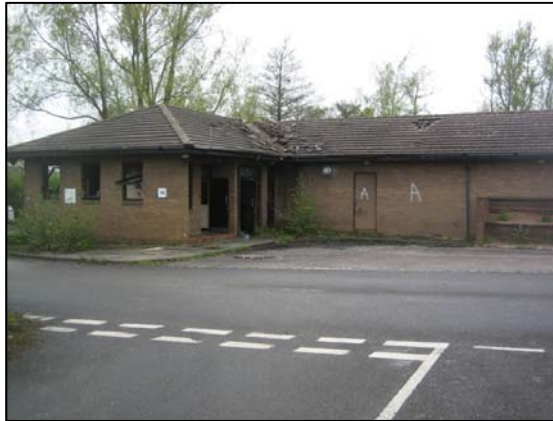
**Building B14**

**Moderate  
potential**

A single storey brick building with a multiple pitched clay tile roof. The brickwork is in good condition; though the roof has been broken open in many locations. The roof is of modern construction with a bitumastic membrane beneath the tiles. An Internal inspection was not possible due to health and safety considerations

- Slipped and broken roofing tiles

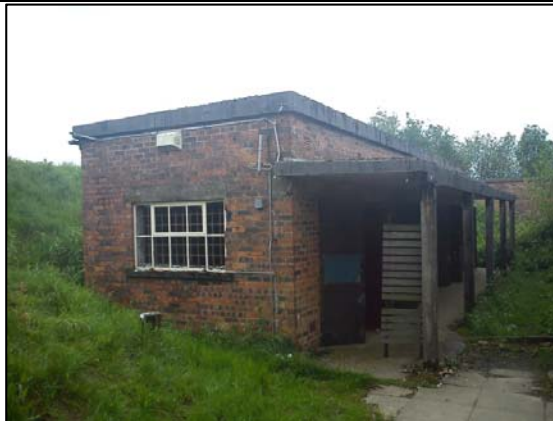
**Building B15**

**Negligible  
Potential**

A single storey brick building with a flat concrete roof. The brickwork is in good condition. Light levels within the building were low to moderate.

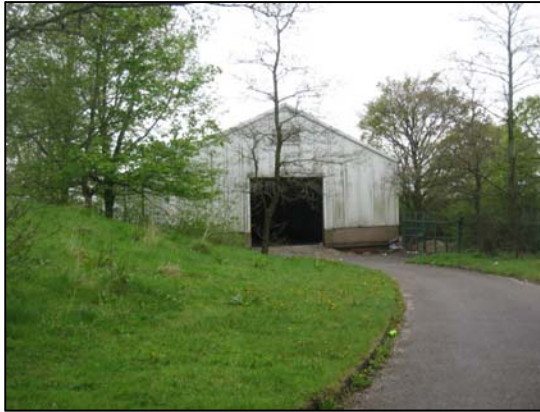
**Building B16**  
**Negligible**  
**Potential**

A single storey metal skin building, with a single pitched metal roof.

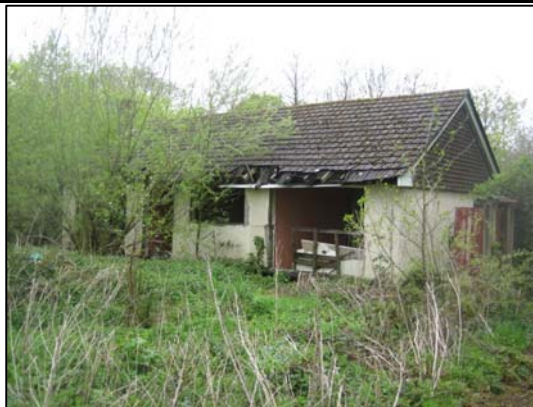
**Building B17**

**Moderate /**  
**High Potential**

A single storey prefabricated concrete building with a pitched clay tile roof and hanging tiles on the east and west aspects. The building is in poor condition and the roof appears to be unstable, preventing any internal inspections.

- Slipped and broken roofing tiles
- Hanging tiles on east and west aspects
