Greenfields Farm  
**Design and Heritage Statement**  
Repairs and Upgrades to Existing House plus Extension

June 2022

**James Boon Architects**

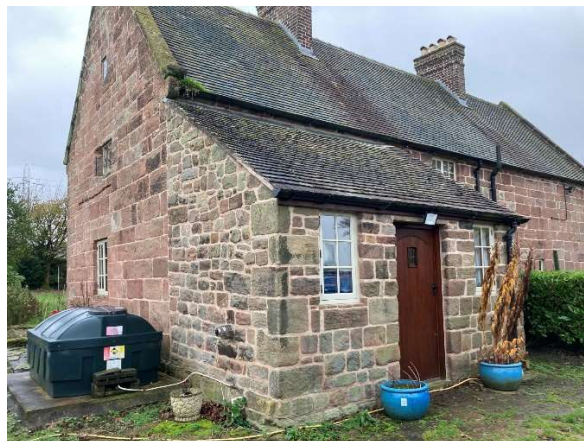
The existing utility room extension is of poor-quality construction and needs to be reordered to give decent boot room, downstairs toilet, laundry and plant facilities commensurate with a farmhouse such as this. In order to provide accommodation for the above, and to improve the structural and aesthetics of the building, we propose to demolish the existing extension and reconstruct it in matching materials with an increased width of 0.75m.

Image: Northeast corner of lean-to extension showing poor quality construction.
