**ROCK CLIFFE, PRINCE GEORGE STREET, CHEADLE, ST10 1JB –**

**CONVERSION OF STABLES / OUTBUILDING TO SELF CONTAINED ANNEX ACCOMMODATION  
ANCILLARY TO ROCK CLIFFE HOUSE**

**SCHEDULE OF EXTERNAL REPAIR, RENOVATION AND ALTERATION WORKS  
(TO DISCHARGE CONDITIONS 3, 5 AND 7 OF PLANNING PERMISSION SMD/2021/0057)**

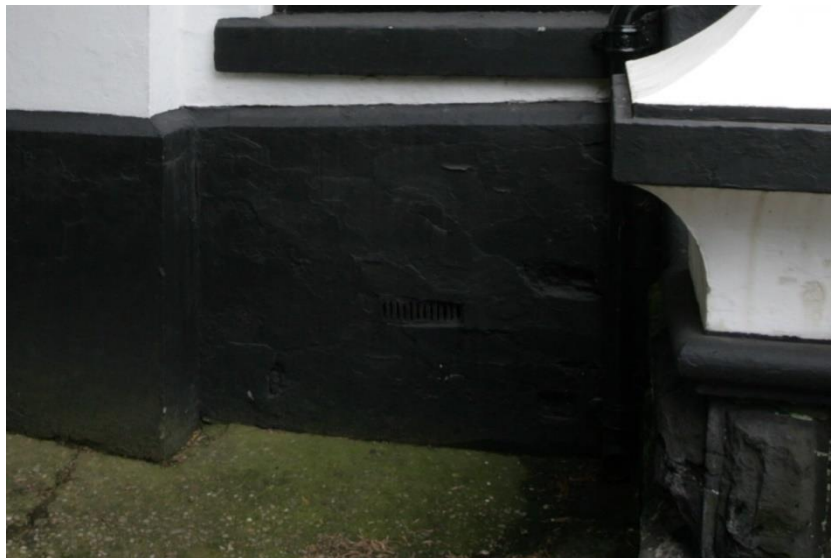
photograph 7 - view of one of the existing cast iron, hit and miss pattern, sub floor, air bricks  
this is on the south elevation

- 11.1 The existing building has cast metal, sub-floor air bricks to the south elevation, as shown on drawing 00793-011C and one of them is shown on photograph 7. As is required by building control for the annex conversion, additional air brick vents will be required for sub-floor ventilation and extract ventilation. The proposed air bricks are cast iron of a pattern to match the existing air bricks, and are on the west elevation that faces the private driveway to Rock Cliffe. The sub-floor air bricks and the toilet, bathroom, kitchen air bricks as shown on drawing 00793-011C are all to be J&JW Longbottom cast iron hit and miss pattern airbricks. All airbricks to be painted with white or black Hammerite (rust preventing) paint, colour to match the colour of the adjacent render (white or black). Note this pattern of cast iron airbrick and use of colour to match the adjacent wall / plinth, is all to match the existing sub floor airbricks on the south elevation. Air bricks to be set 10mm back from the render face to match the existing airbrick set-back.

- 12.3 New and existing cast iron air bricks to be painted with white or black Hammerite (rust preventing) paint, colour to match the adjacent render colour. This will be black to the sub-floor air bricks and white to the kitchen, bathroom and toilet air bricks.
