**Arboricultural Impact Report**

**PLANNING APPLICATION FOR EXTENSIONS, OUTBUILDINGS AND LANDSCAPING  
AT HILLCROFT, FRODHALL ROAD, FROGHALL, ST10 2HQ**

November 2023

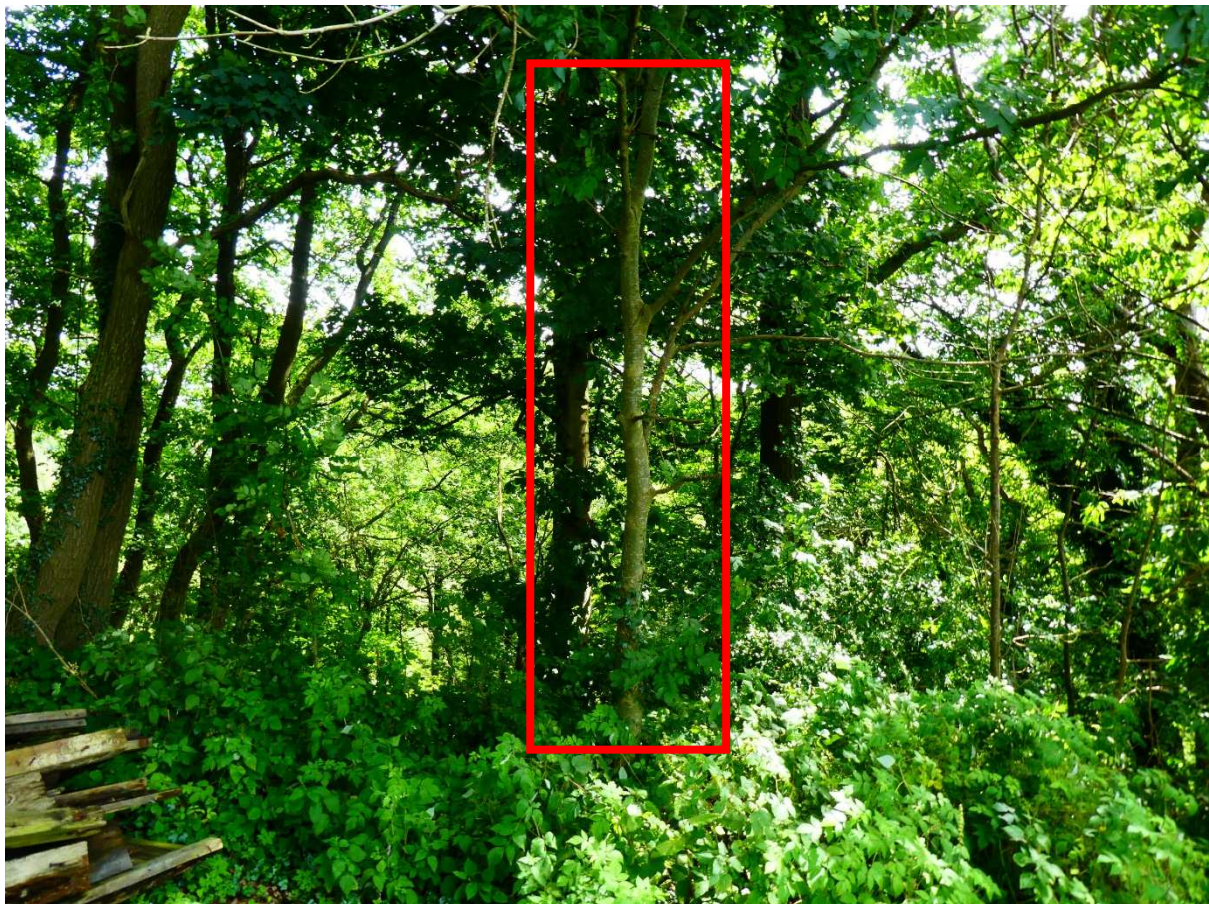
The majority of trees shrubs are a Cat A mature Oak trees and shall be retained and protected as part of the development. T16 is a Cat C Ash tree, and T15 is a Cat U Ash tree. The removal of no trees is required to facilitate any part of the development. T15 is self-set, under the canopy of the mature Oak trees. Given its poor form and lack of space required for it to mature, it could be removed as it is interfering with the canopy growth of the adjacent Oak trees.

T1, T2, T3 and T4 are within the area of influence of the driveway and proposed outbuilding. These are four category A mature oak specimens which have blended canopies to form the edge of the wider woodland setting. The average trunk diameter is 0.7m and heights range from 12-14m. It should be noted the existing driveway and parking area is assumed not to have any ground protection measures in place, yet the condition of the trees seems to not be adversely affected by this. Also, the proximity of the existing outbuildings to the trunks is far closer than any new building should be constructed from a tree that is suitable to be retained and protected. The removal of the existing outbuilding should be undertaken carefully to preserve the surrounding trees, and it turn, it should have a beneficial impact on the trees if the cleared ground is left to naturalise as an extension to the forest floor.
