# Infiltration testing: Newfields Farm, Rownall Road, Wetley Rocks

**Report reference:** 4272R1

**Date of reporting:** 21<sup>st</sup> July 2022

**Prepared by  
Ground First Ltd**

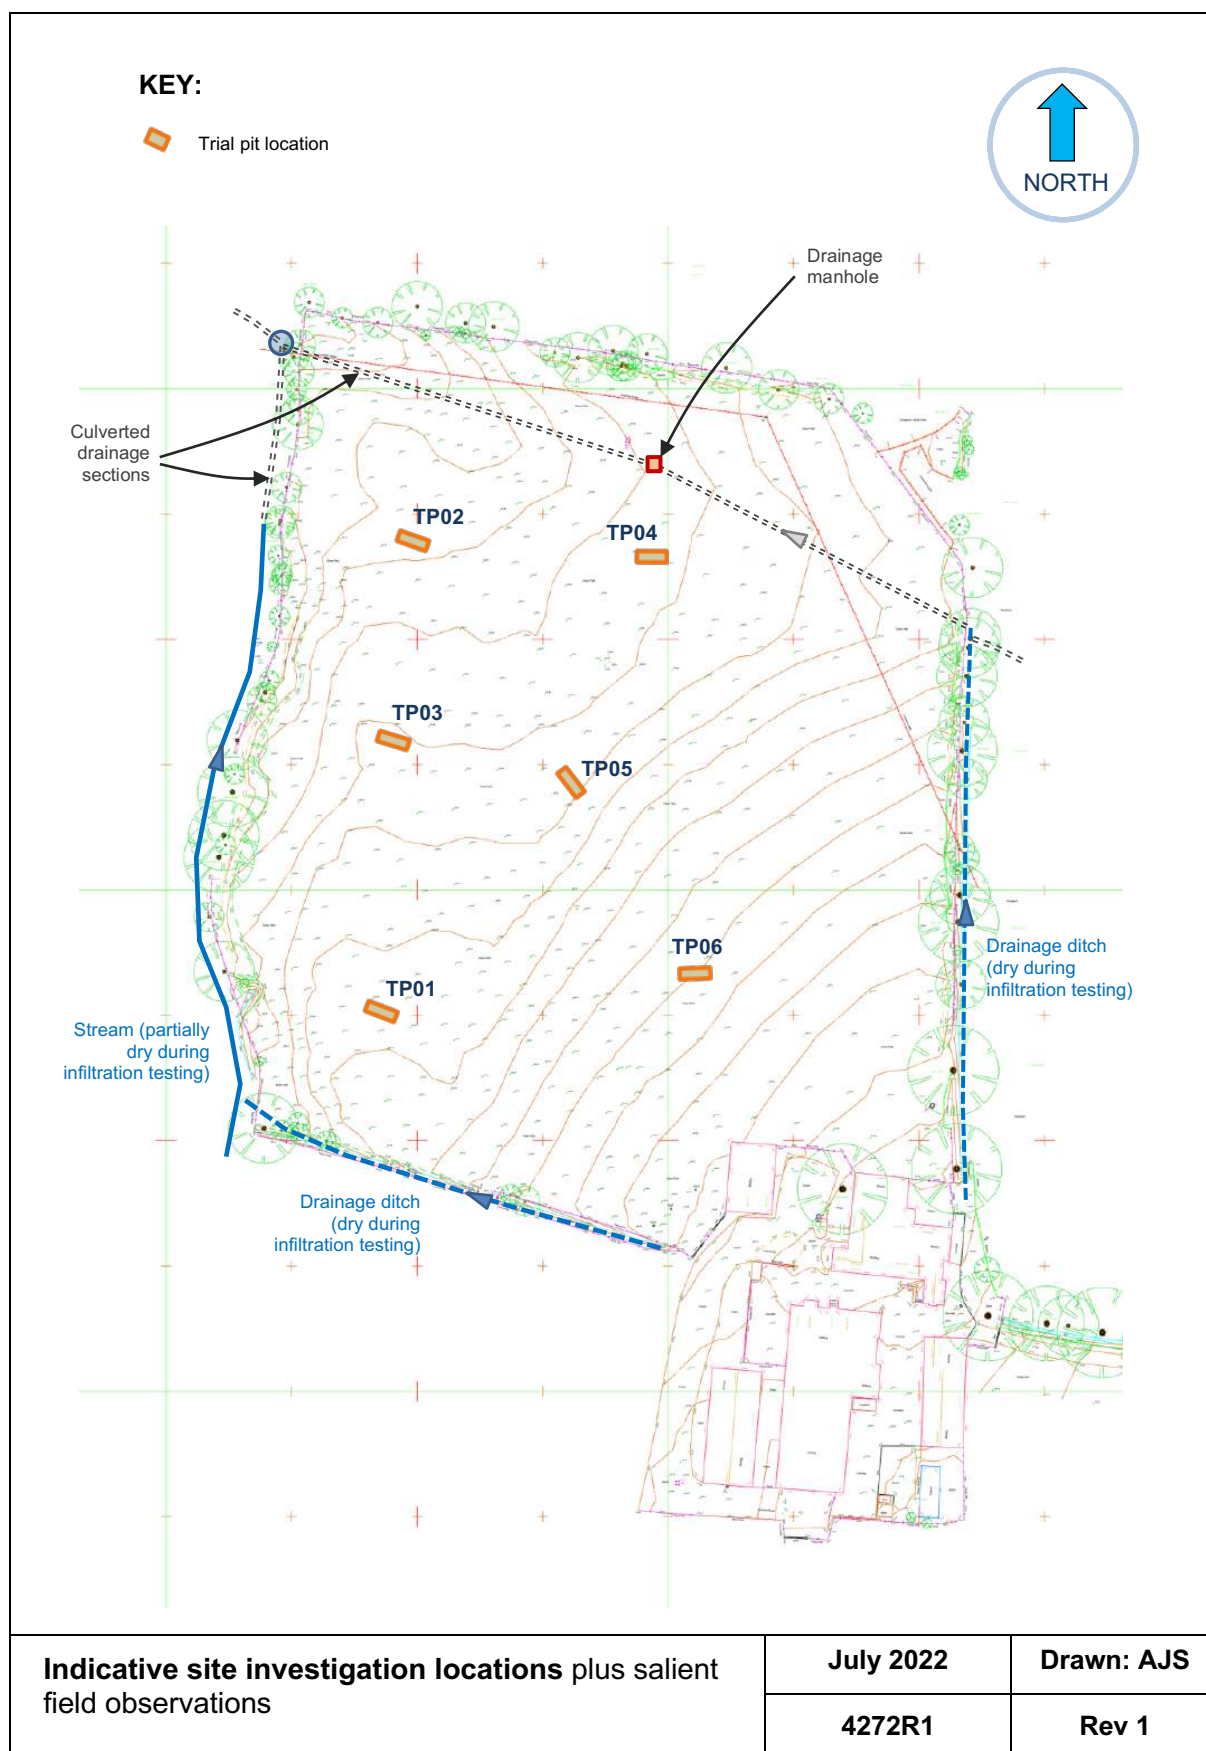
**Figure 3.1 Site investigation location plan**

OS mapping shows the presence of a surface water channel positioned alongside the western Site boundary (see Figure 3.1); this feature ultimately discharges into Stanley Pool, located c. 2.4 km to the north. A potential surface water channel is also mapped in the north-west corner of the Site; this appears to be a perennial water feature which drains into the surface water channel located along the western Site boundary. A recent topographic survey identified further drainage ditches along the southern and eastern Site boundaries (see Figure 3.1).

- The stream section adjacent to the north-western part of the Site was culverted (see Figure 3.1).
- The culverted stream section ended in a small depression located close to the north-western corner of the Site (see Figure 3.1 and also Photograph 7 in Appendix A). A second culvert, which passes beneath the northern part of the Site, also discharges into this depression. The outflow from the depression is via a large diameter (c. 0.8 m wide) concrete pipe.

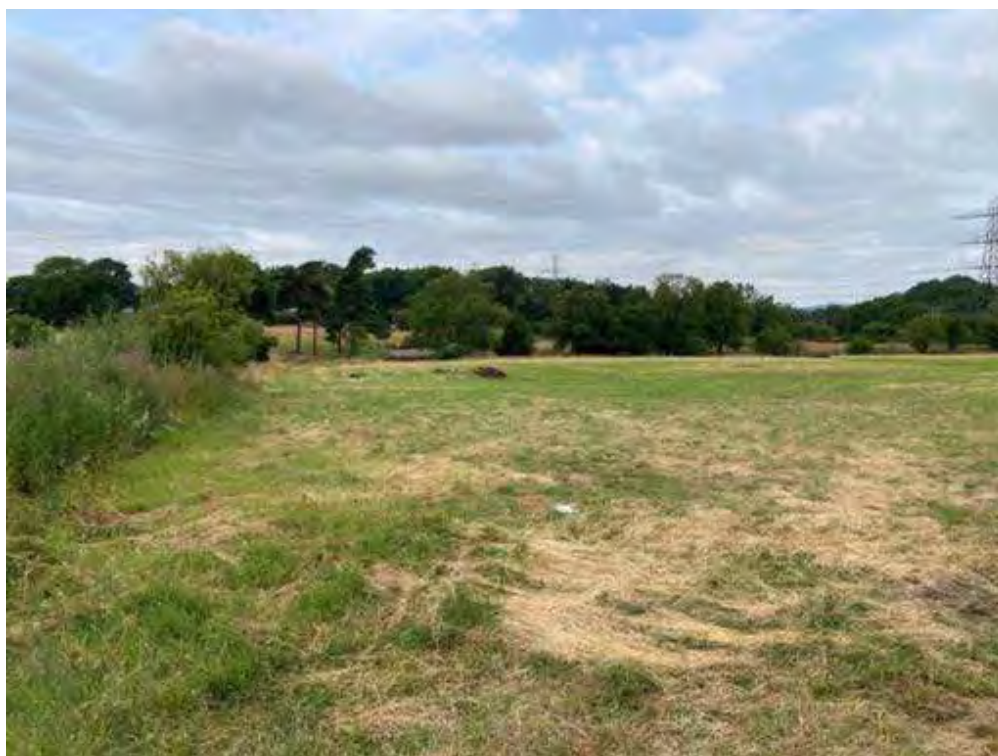
**Photograph 1**

- The Site was covered by short grass (see Photographs 1 and 2 in Appendix A).
- No standing water was observed across the Site at the time of the infiltration testing.

**Description:** View across the Site from Newfield Farm; looking to the west  
**Date:** 20/07/2022

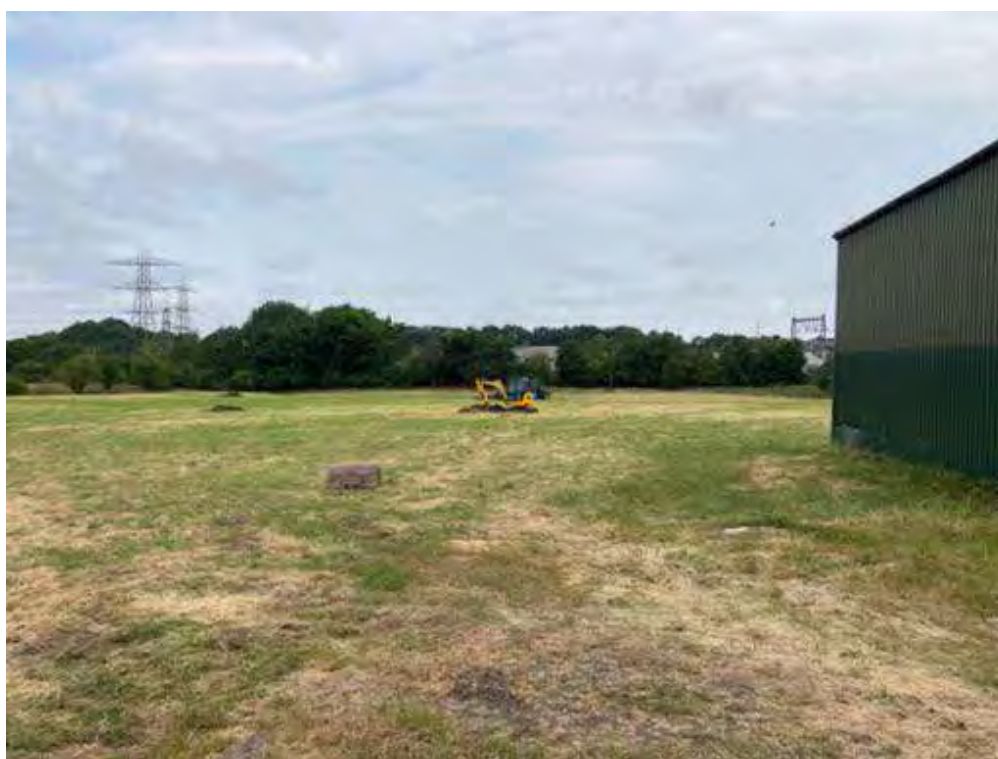
**Photograph 2**

**Description:** View across the Site from Newfield Farm; looking to the north  
**Date:** 20/07/2022

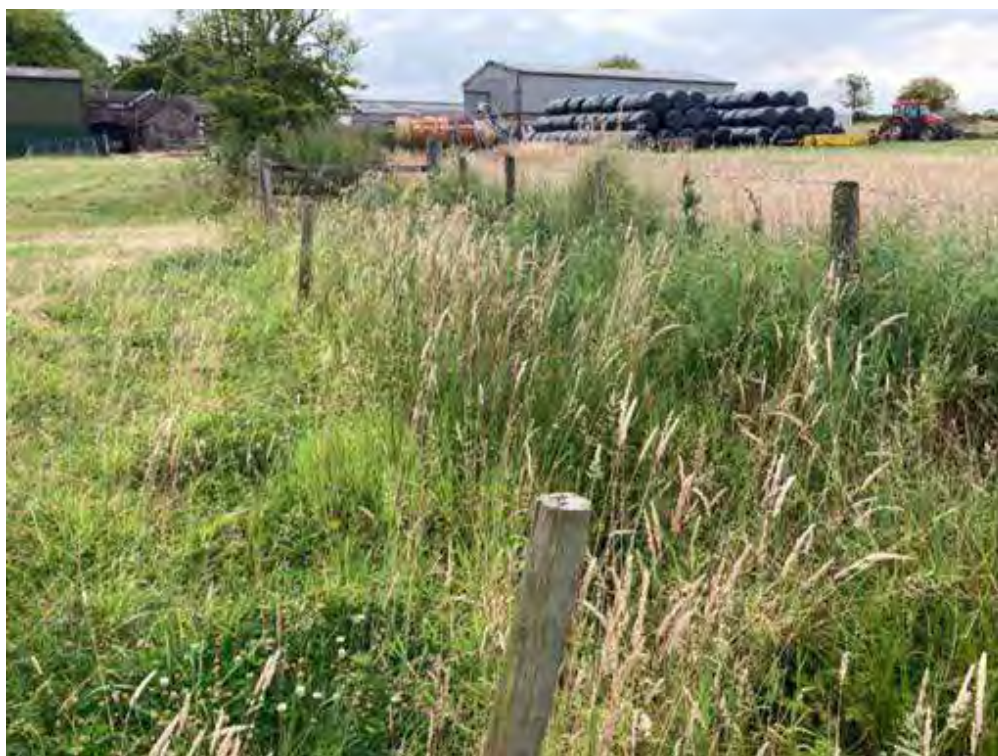
**Photograph 3**

- The modest drainage ditch present along the south-western Site boundary (see Figure 3.1) contained appreciable vegetation and was observed to be dry (see Photograph 3 in Appendix A).

**Description:** View of shallow drainage ditch along the south-western Site boundary; looking to the south-east

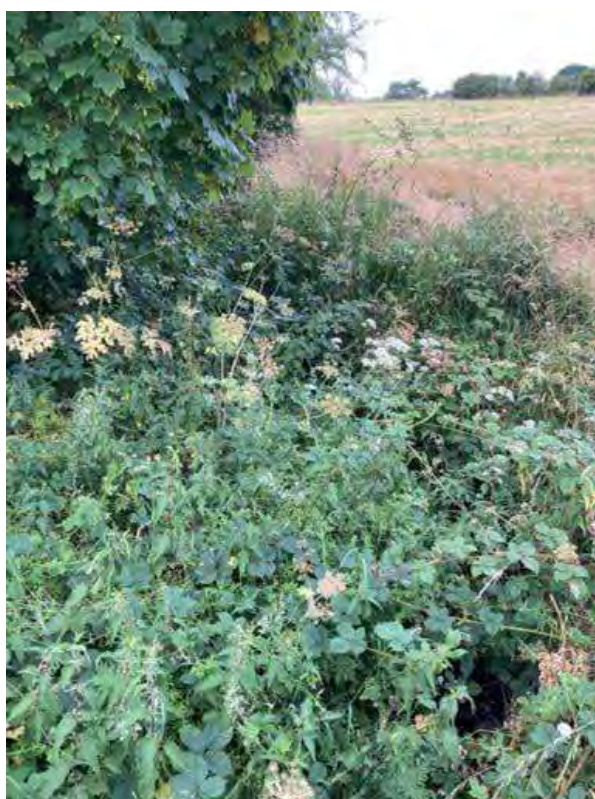
**Photograph 4**

- The stream channel located adjacent to the western Site boundary (see Figure 3.1) contained variable amounts of vegetation; ponded water was present within the channel to the south-west of the Site whereas the stream section adjacent to the central-western Site area was dry (see Photographs 4 to 6 in Appendix A).

**Description:** View of stream directly adjacent to the south-western Site boundary
