# Arboricultural Report

**Construction of a 45-unit retirement home  
complex, parking and landscaping  
Woodhead Hall  
Cheadle  
Staffordshire**

**Report Date:**  
6 November 2024

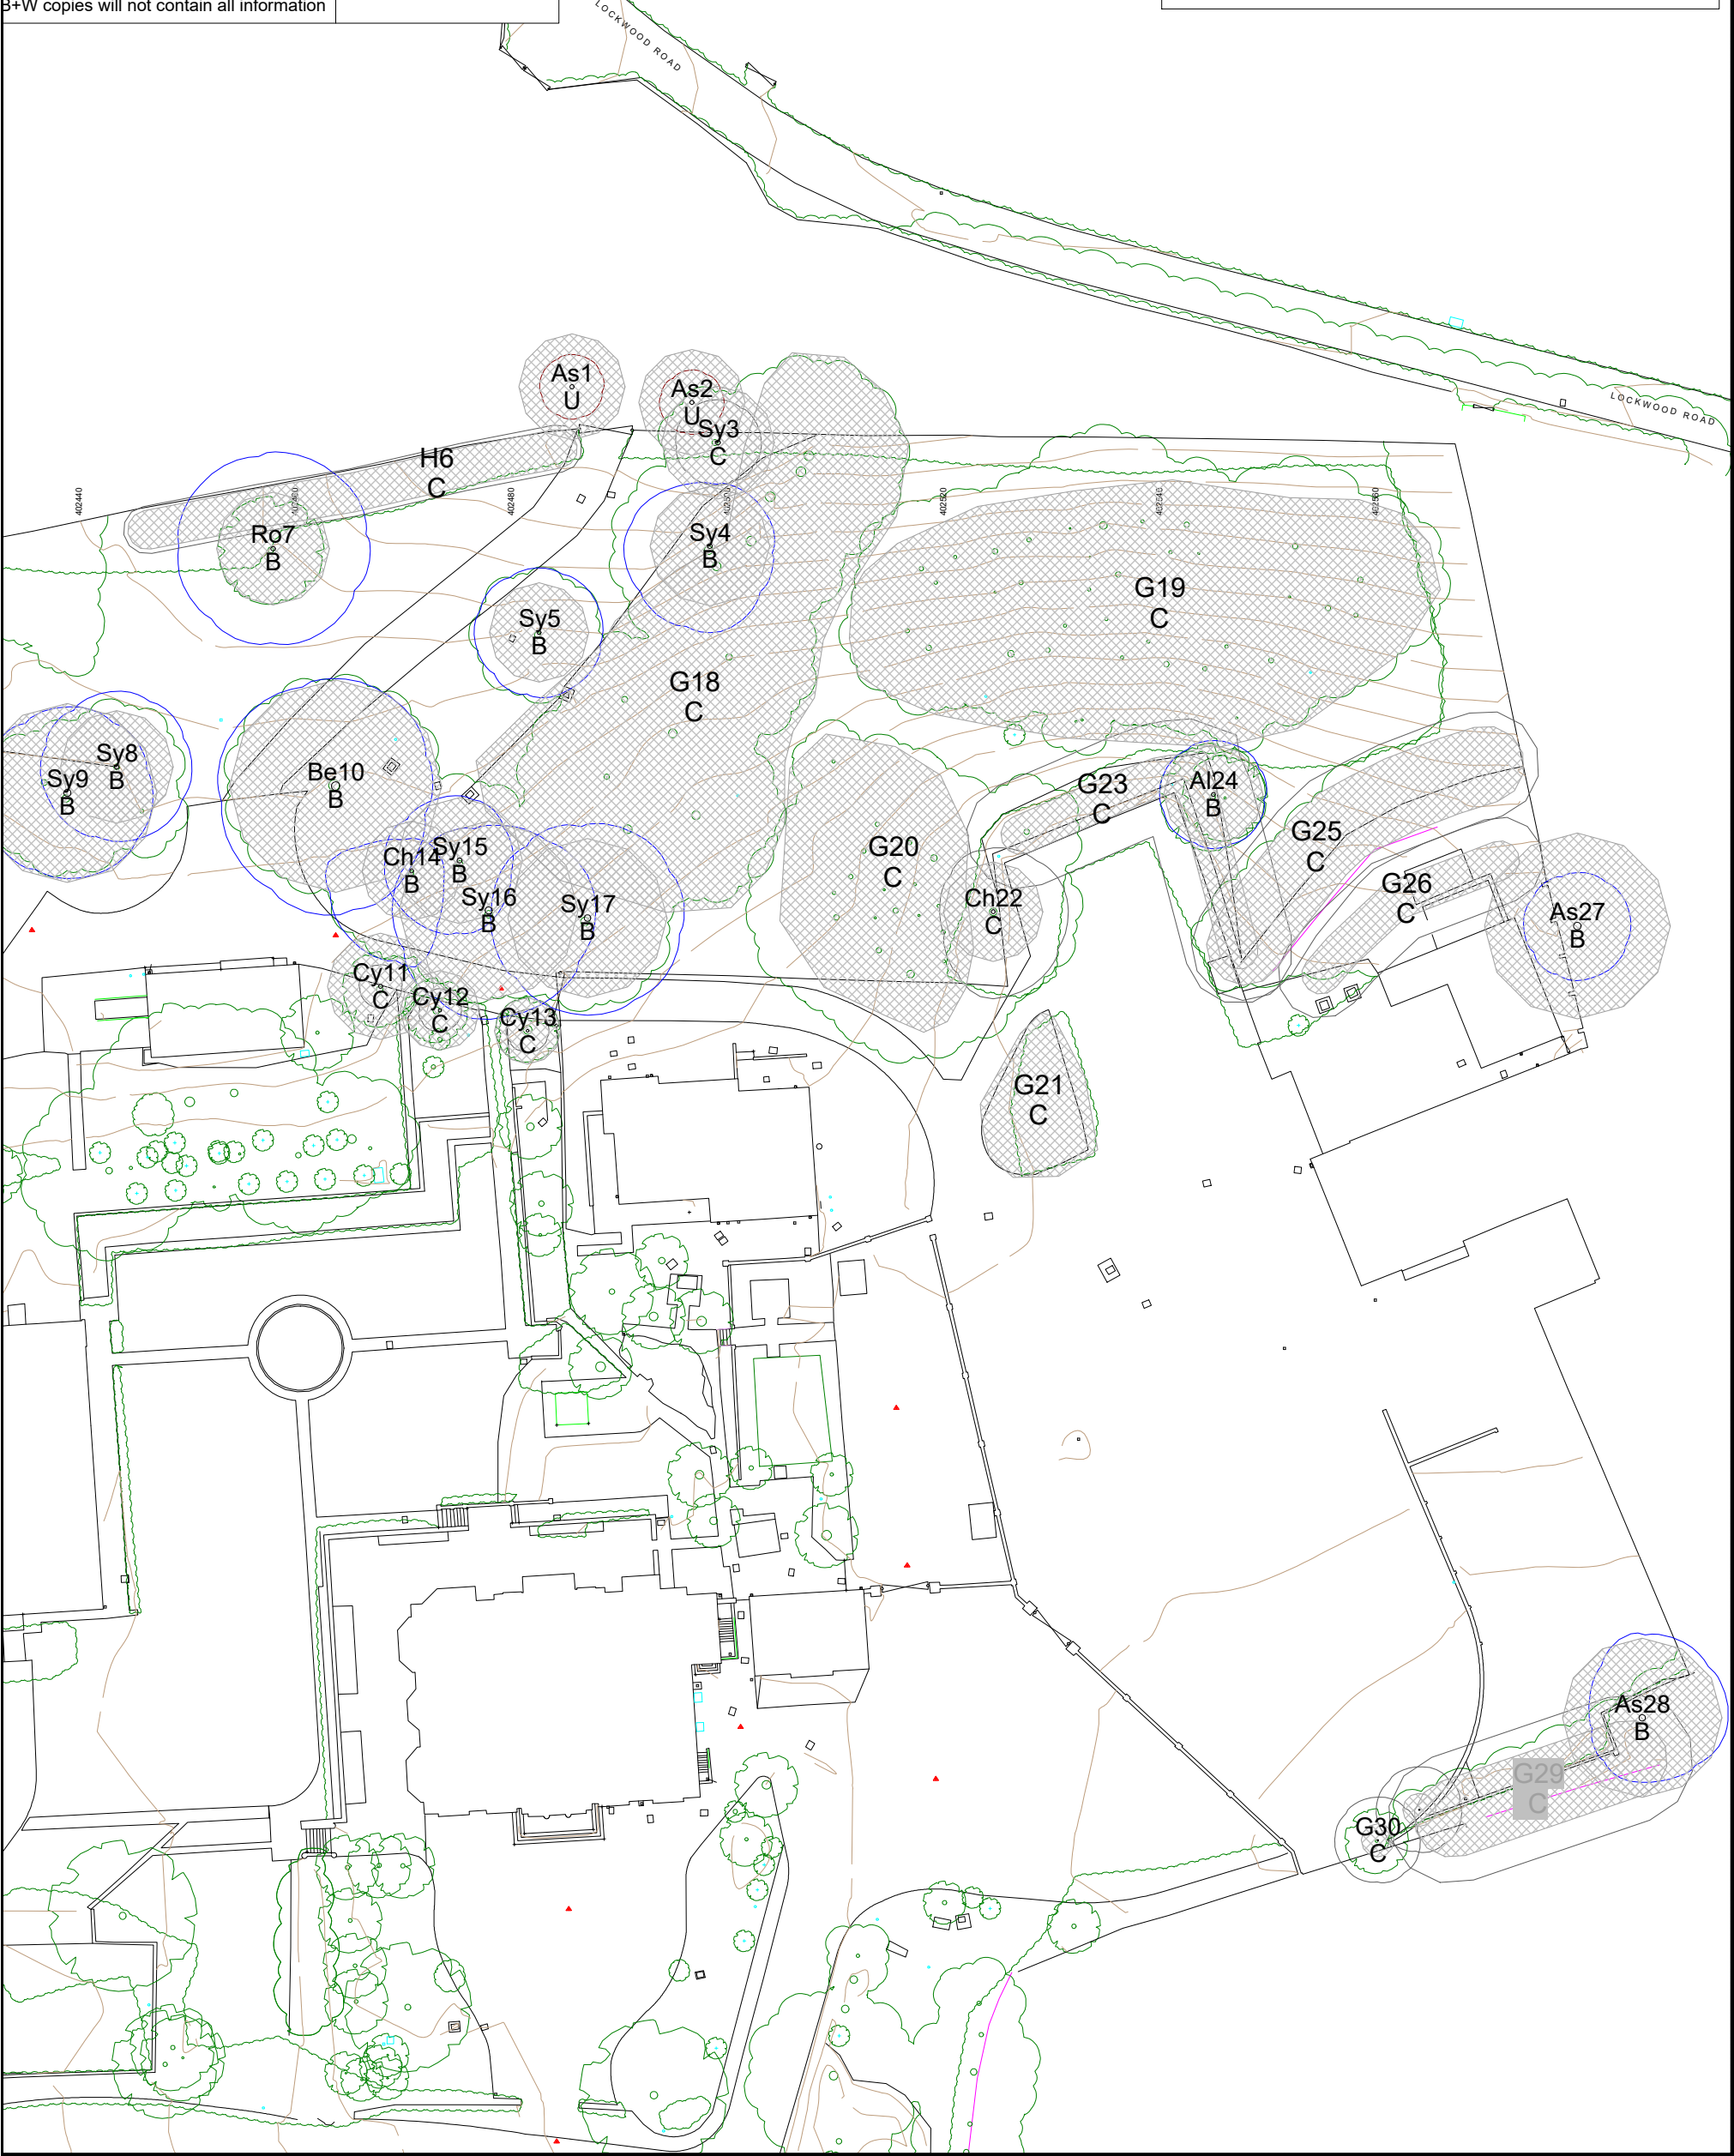
# Appendix A

Tree Constraints Plan  
Showing all trees, crown dimensions, tree categories  
and root protection areas (RPAs)

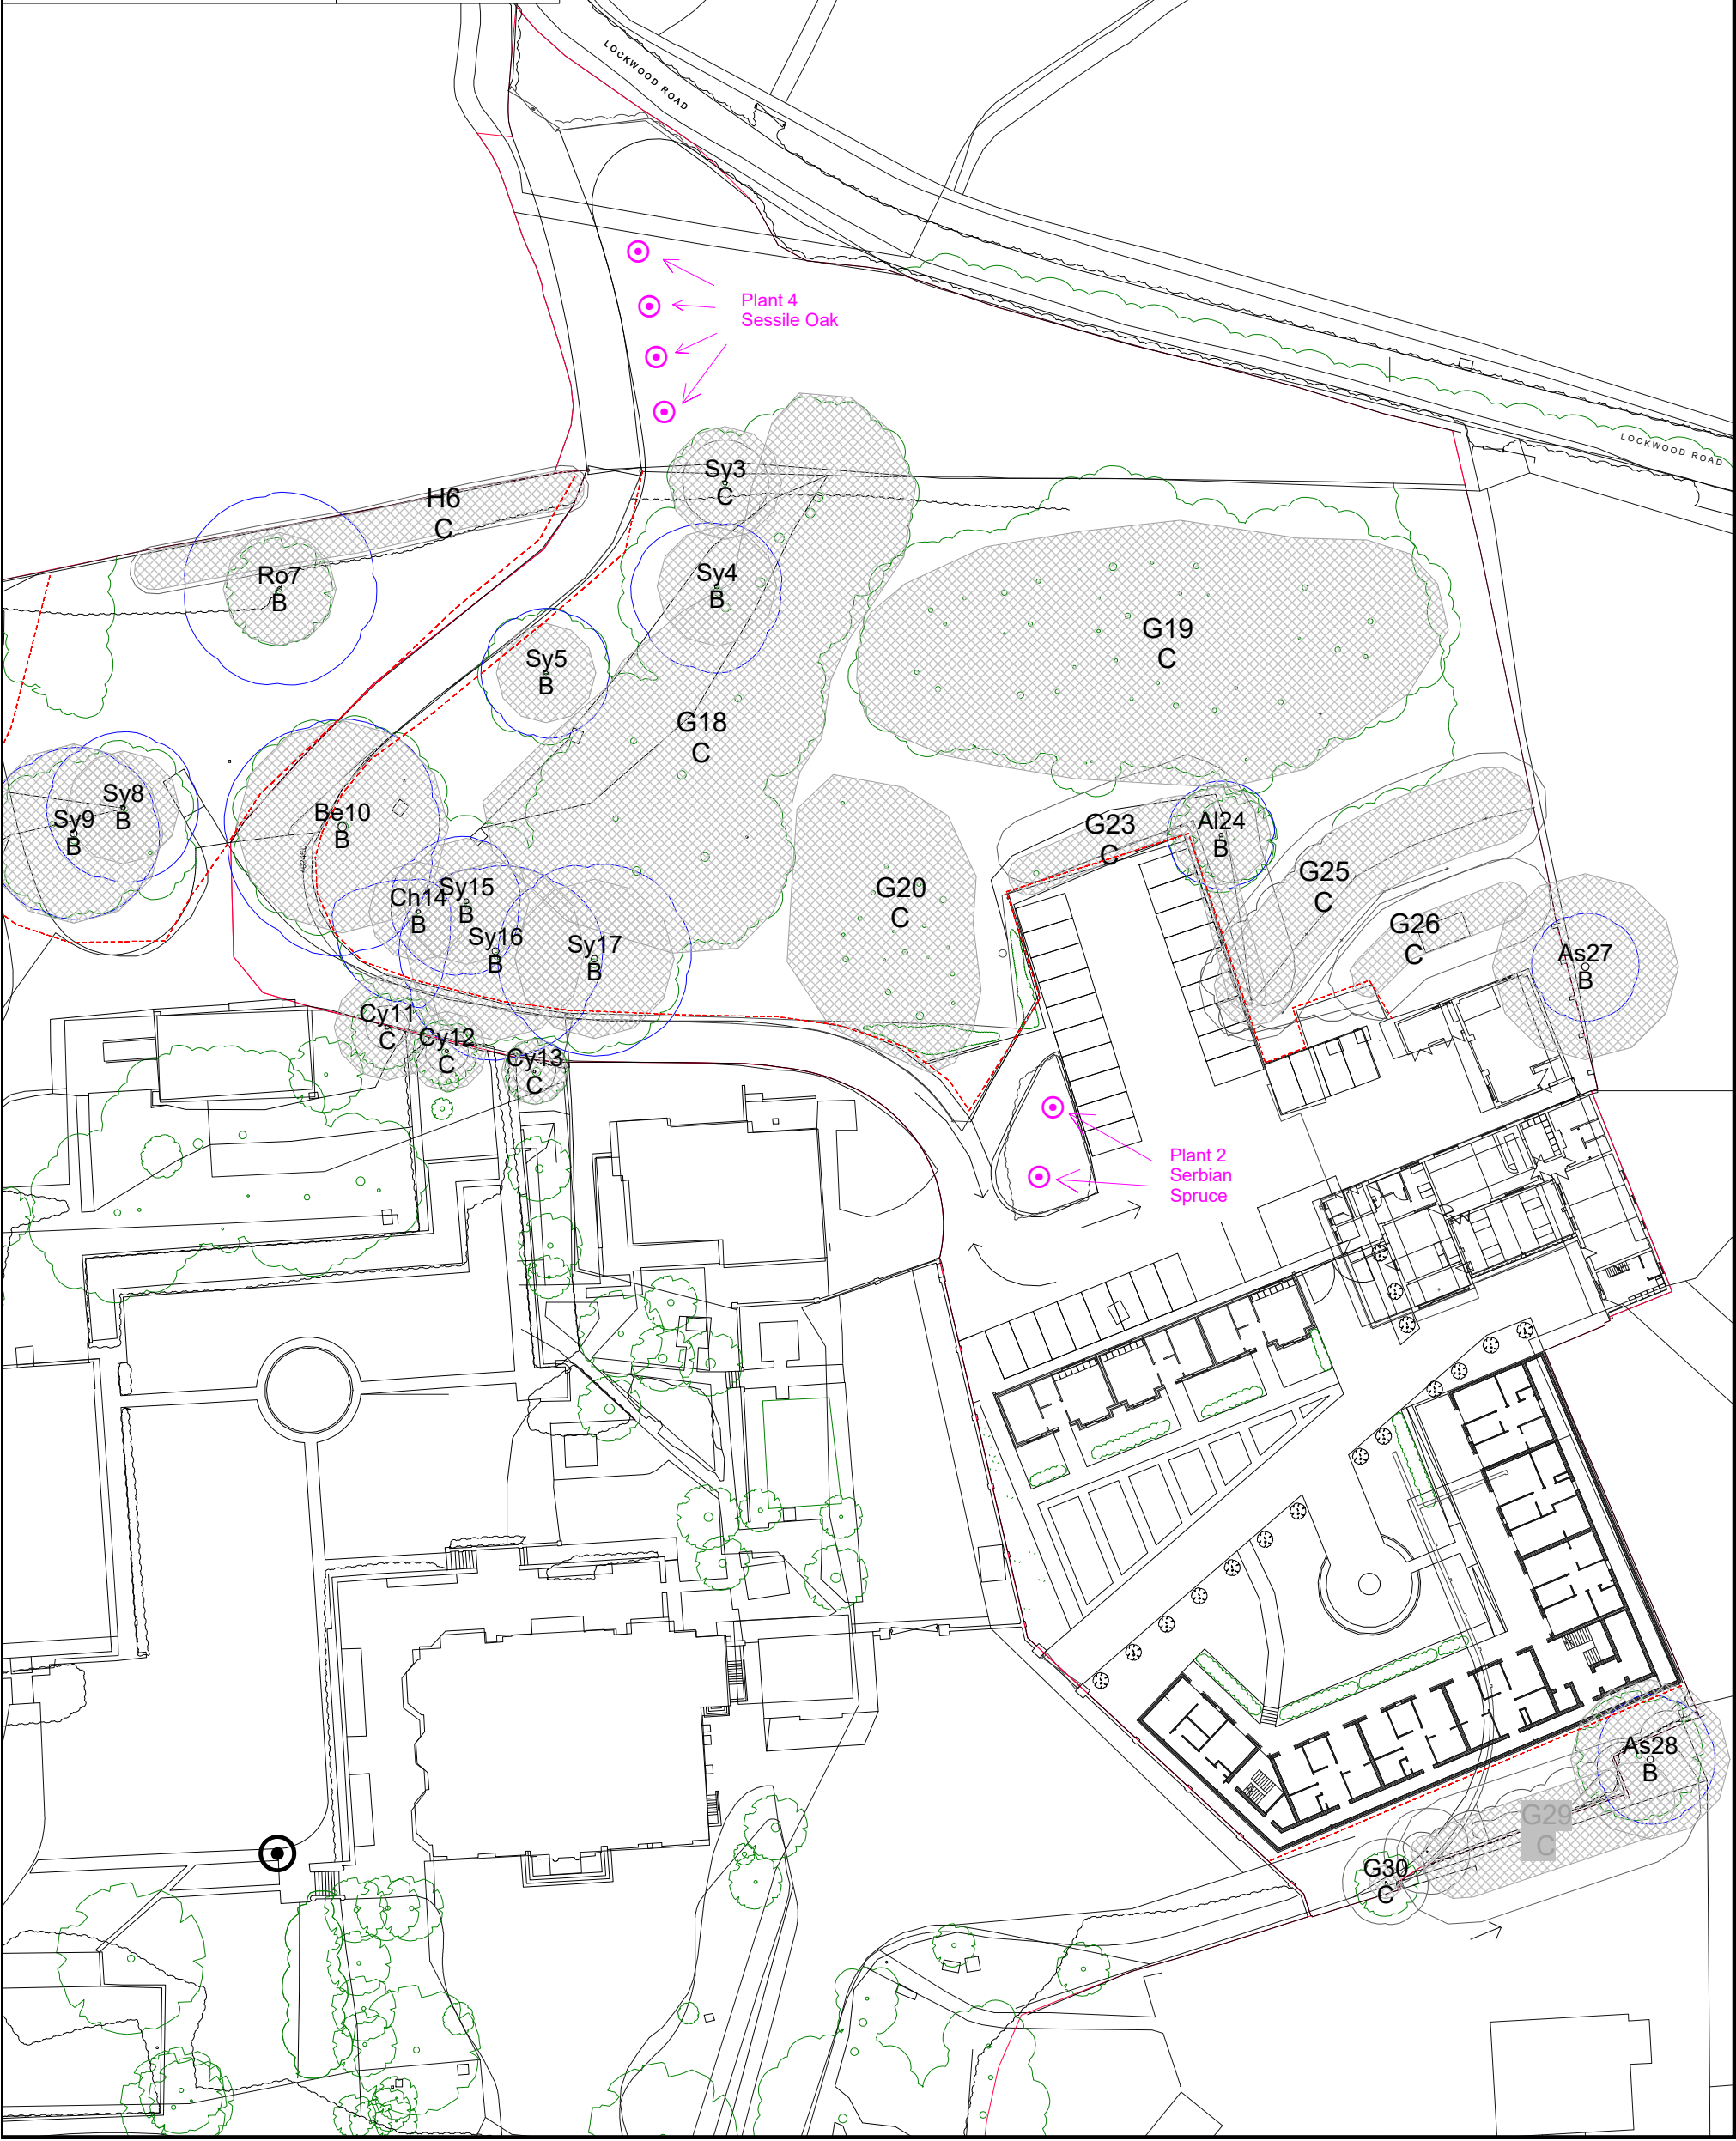
# Appendix B

Tree Protection Plan  
Showing all retained trees, crown dimensions, tree categories,  
root protection areas (RPAs) protective fencing and proposed planting

- 8.5 Protective fencing similar to that presented in BS5837, shown in Appendix D, is to be used to protect RPAs from vehicular and foot access. The fencing is to be securely joined and attached to immovable objects to prevent it from being moved. Fencing should be firmly attached into the ground and will require tools to move it.
