Gate Farm, Foxt, ST10 2HN  
HERITAGE STATEMENT & IMPACT ASSESSMENT

Produced for Mr and Mrs Wilbraham

24<sup>th</sup> October 2025

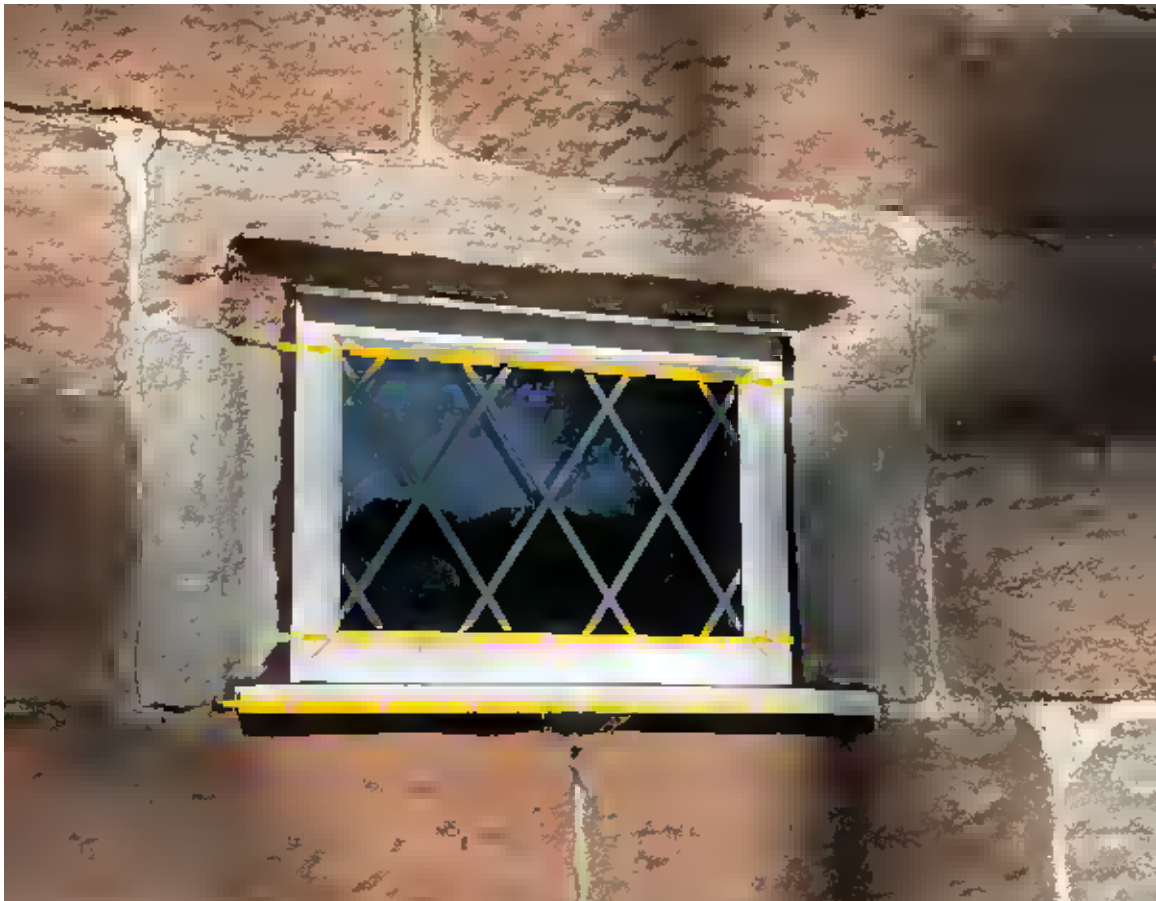
#### GFW9

The original window has been modified by cutting out the chamfer on the lintel and by removing the deep chamfer on the cill. This window is so small that it is unlikely it ever had a mullion. As this window will serve a WC and it is close in size to the original window, a true leaded light window with true lead comes is proposed for this opening and as it will not have a metal sub-frame the distribution of comes in a rectangular pattern will be bespoke for this window, rather than standardised to match others. The cill will be dressed in Code 4 lead.

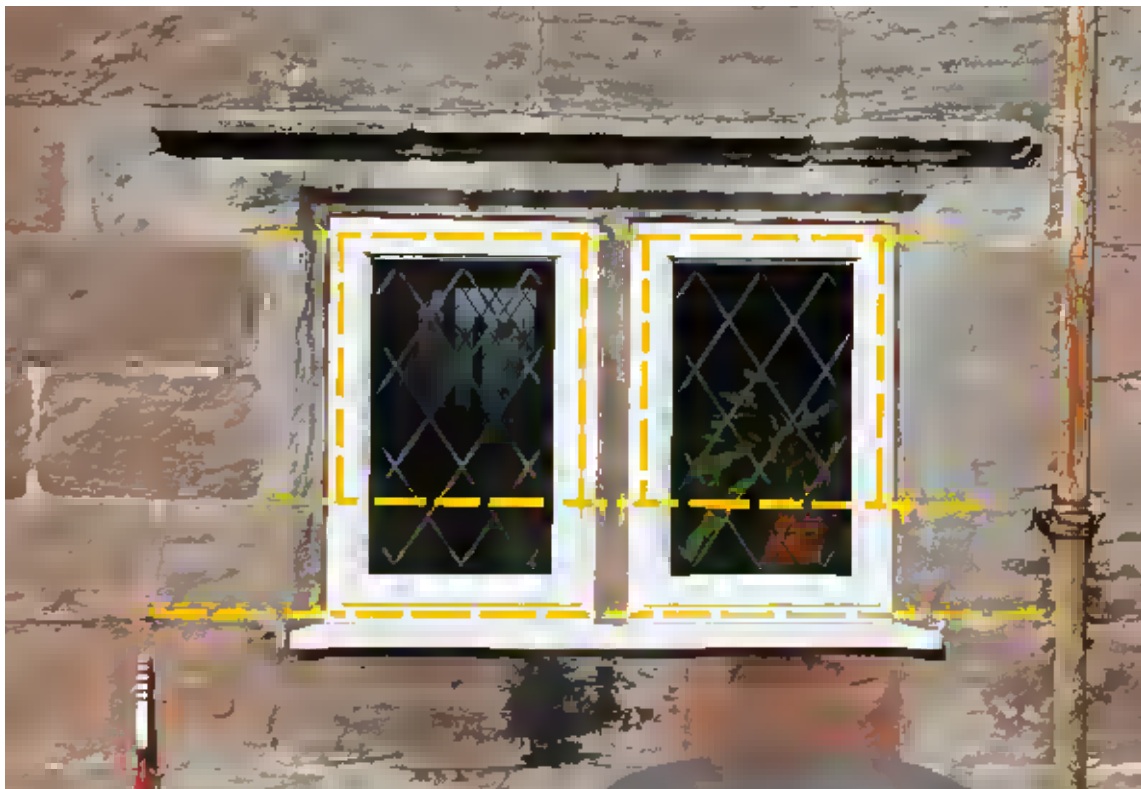
### GFW1

This window to the Houseplace has been altered with the removal of the deep chamfer to the cill and the cutting out of the secondary chamfer to the lintels and jambs, and the introduction of a new mullion. As a result, the white uPVC frames sit further forward than the historic leaded lights. The proposed windows are a pair of metal side-hinged casements with black-painted finish (or similar), retaining the mullion in-situ, but inserting a new Code 4 lead flashing to the cill. Windows will be double-glazed with applied faux lead. This is an enhancement and more sympathetic than white uPVC, whilst reducing the impact of the white uPVC frames, increasing the amount of light with slim metal frames, and adopting a rectangular form of leading as a nod to 18<sup>th</sup> century changes.

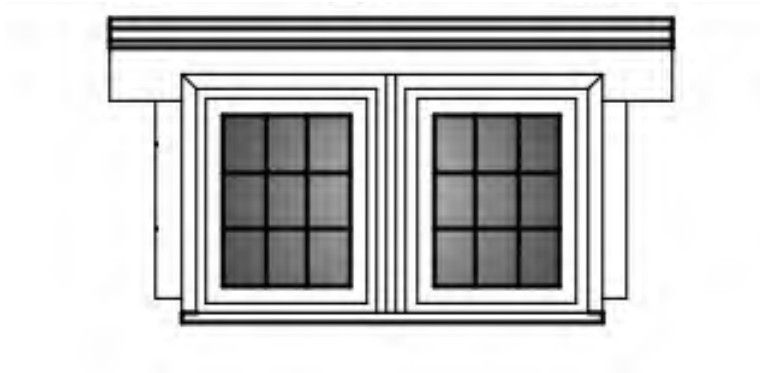
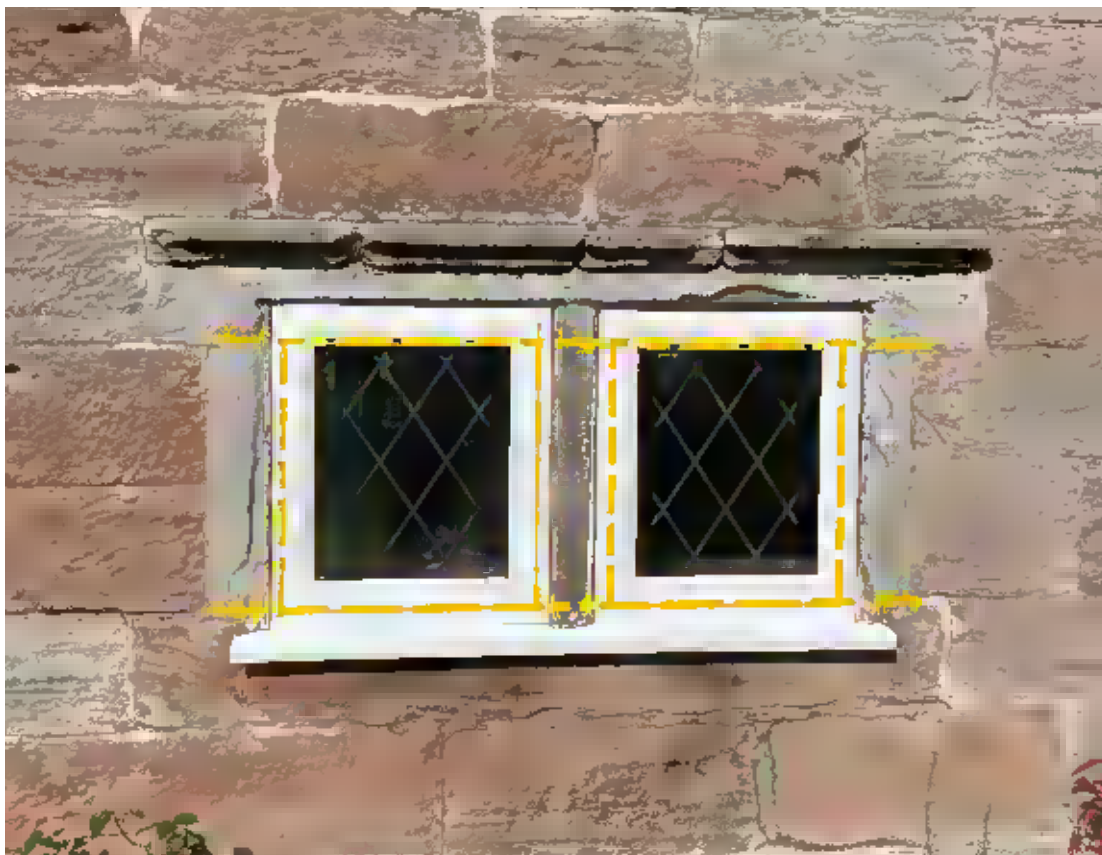
### GFW2

This window to the first phase parlour retains more of its original cill than GFW1, with just the deep chamfer removed, the head cut out and some modifications to the jambs and a replacement mullion. The original joint for the centre mullion is visible, demonstrating it was always a 2-light window. The proposed windows are a pair of metal casement windows with black-painted finish, or similar, retaining the mullion in-situ, but inserting a new Code 4 lead flashing to the cill. Windows will be double-glazed with applied faux lead. This is an enhancement and more sympathetic than white uPVC, whilst reducing the impact of the white uPVC frames, increasing the amount of light with slim metal frames, and adopting a rectangular form of leading as a nod to 18<sup>th</sup> century changes.

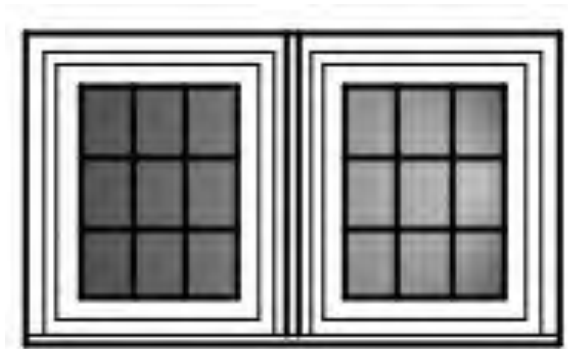
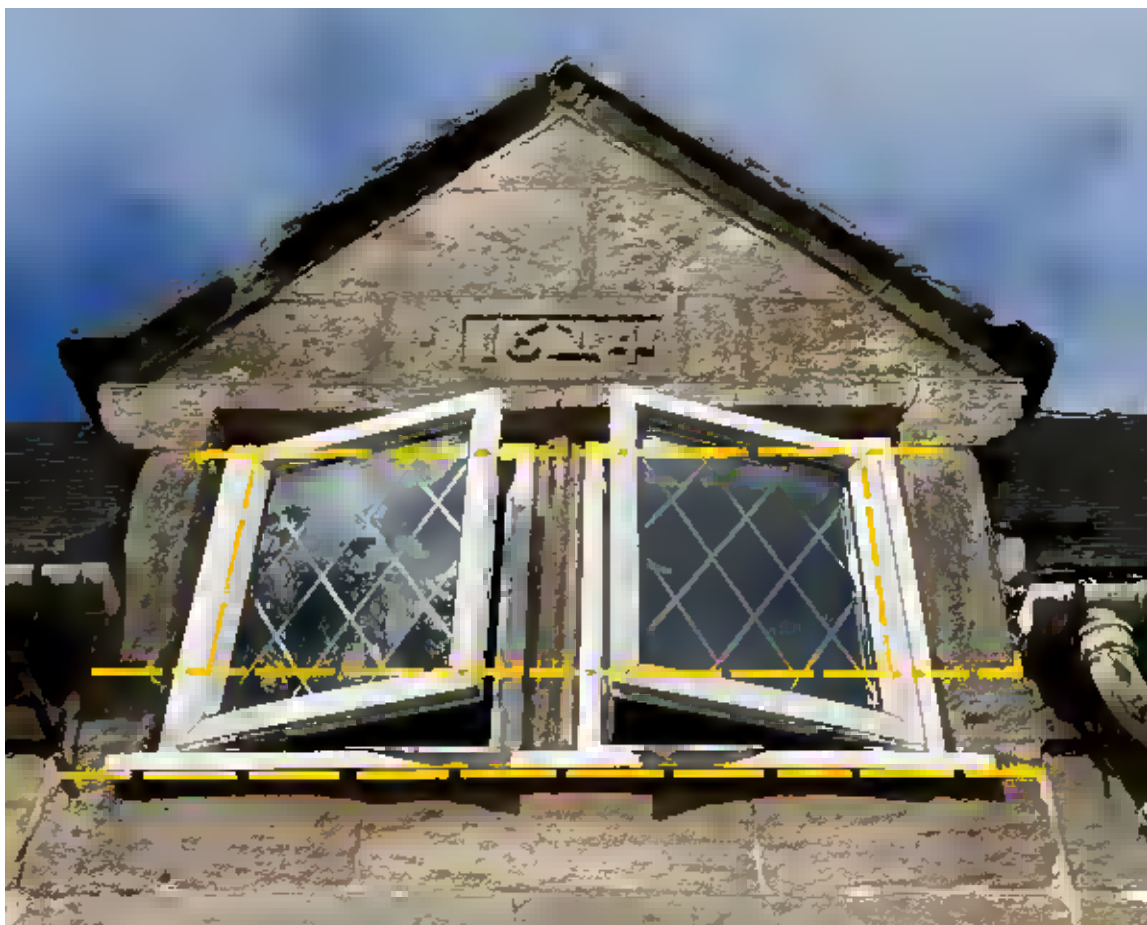
FFW3

The dormer window has been altered with the cutting out of the original cill. The small pieces of stone to either side of the window, below the jambs are remnants of this cill. The mullion is a replacement, but the chamfered form of this mullion may indicate that the window was enlarged in the 17<sup>th</sup> or 18<sup>th</sup> century. The proposed windows are metal casements with opening lights and a black-painted finish, or similar, retaining the mullion in-situ, but inserting a new Code 4 lead flashing to the cill. Windows will be double-glazed with applied faux lead.

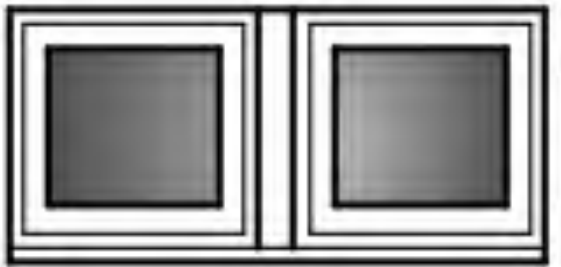
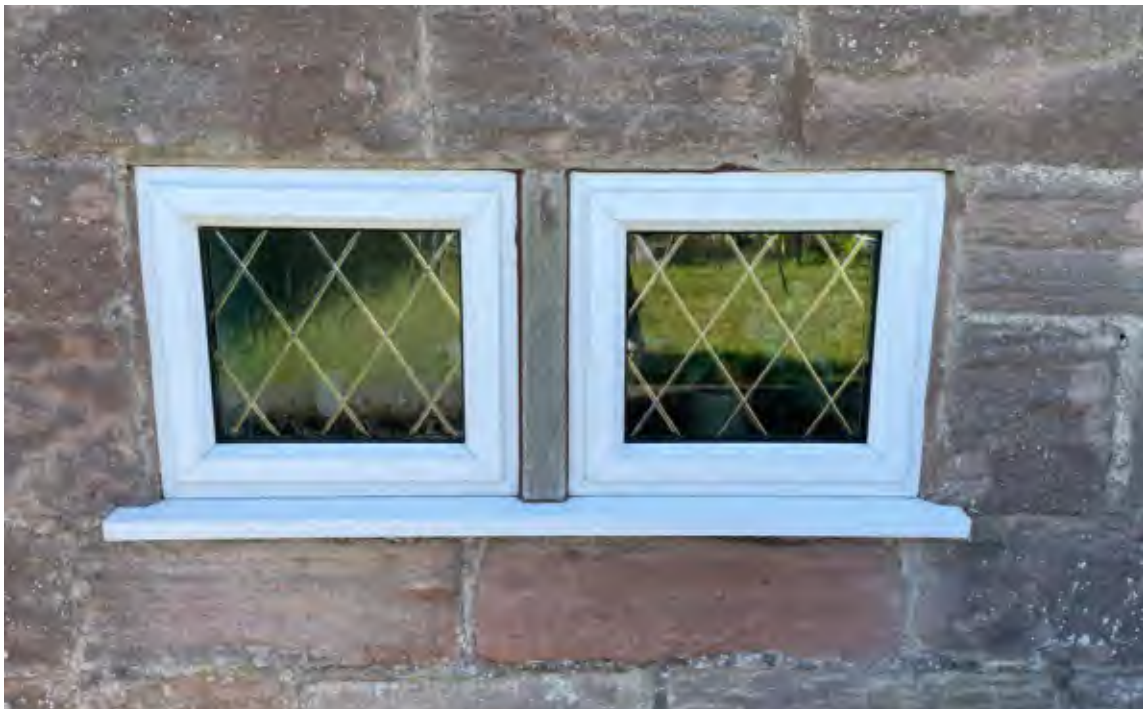
#### GFW3

This window is a modern insertion, probably added in the 20<sup>th</sup> century. There are no details which would date the opening. The central mullion is a recent addition (pers. comm. A Wilbraham). The proposal is to replace the uPVC window with plain metal opening casement windows, painted black, with plain double-glazed sealed units. As this is a modern opening, this approach provides a simple treatment which removes the starkness of the white uPVC and is at the same time sympathetic to the historic window openings.

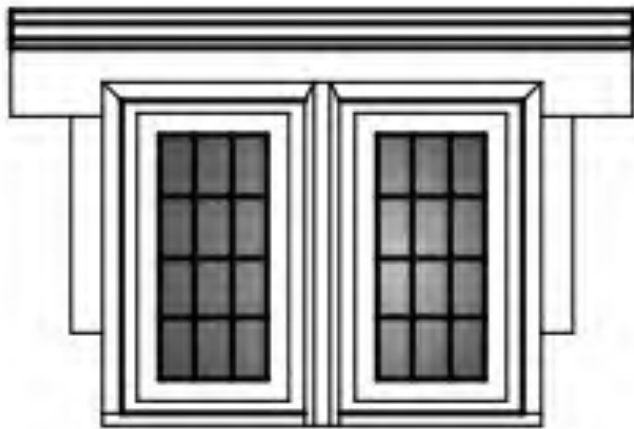
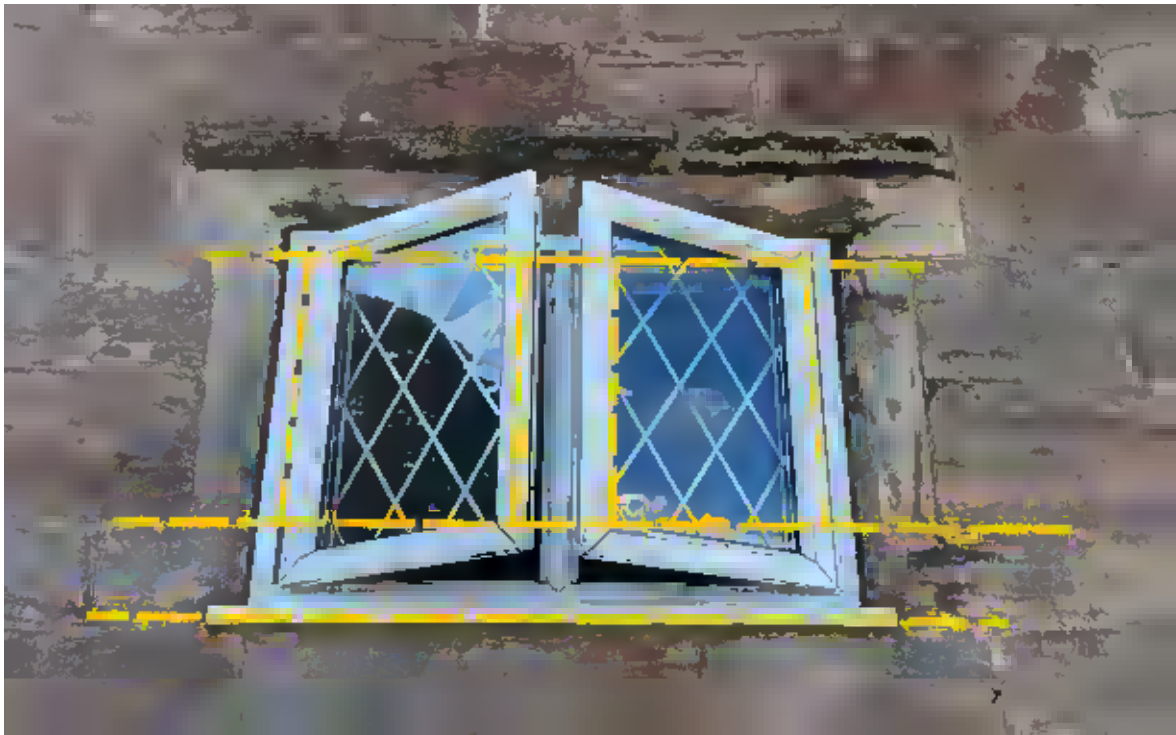
### FFW4

This window to the north gable has been altered with the removal of the deep chamfer to the original stone cill and the cutting out of the secondary stone chamfer to the lintels and jambs. Unlike the 17<sup>th</sup> century windows to the front elevation, this window is missing a central stone mullion, and it is proposed that a mullion be reintroduced to match those on the front elevation. The proposed window is a metal casement with black-painted finish (or similar), inserting a new Code 4 lead flashing to the cill. Paired casement windows will be double-glazed with applied faux lead, as this elevation is seen in conjunction with the front elevation. This is an enhancement and more sympathetic than white uPVC, whilst reducing the impact of the white uPVC frames, increasing the amount of light with slim metal frames, and adopting a rectangular form of leading as a nod to 18<sup>th</sup> century changes.

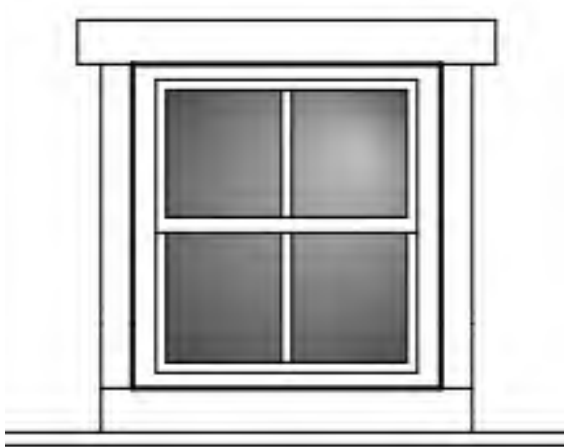
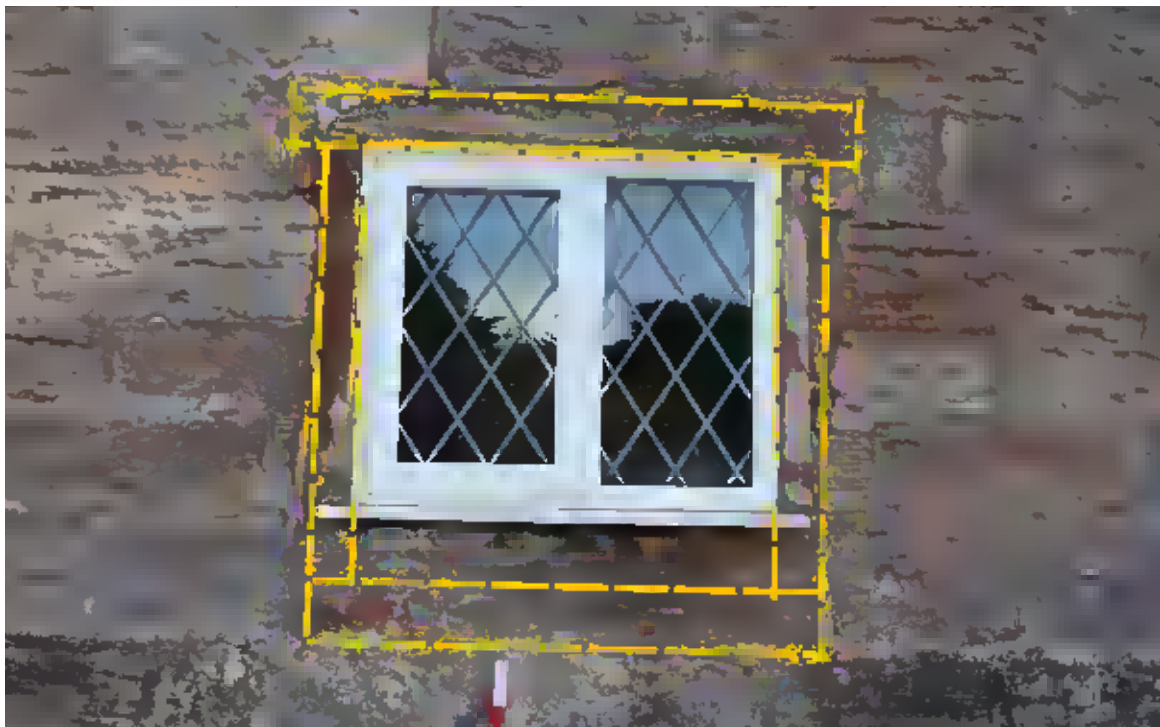
#### GFW8

This window has been remodelled multiple times. The straight joints reveal a much deeper window, and this is coeval with internal straight joints and a possible window seat, with evidence that this had a sash window when it was a parlour. The two stone jambs are much later than the sash window and may be quite recent additions as stone mullions appear to have been added throughout the building during the 20<sup>th</sup> century. The current window is unsightly and there is no surviving evidence for a mullioned window in this opening. The stone surrounds will be repaired with samples of stone and sections to be submitted as a condition of LBC. The repaired / new stone jambs will support the end of the lintel, which cannot be enlarged. The intention is to restore a timber sash window to this opening, with a single true vertical glazing bar, with exposed, traditionally-weighted sash boxes. The window will be double-glazed with slim units (4/4/4), with 7mm sightlines, finished in putty and painted, the precise details to be specified and true ovolo-moulded or ogee glazing bars. This is a very positive enhancement.

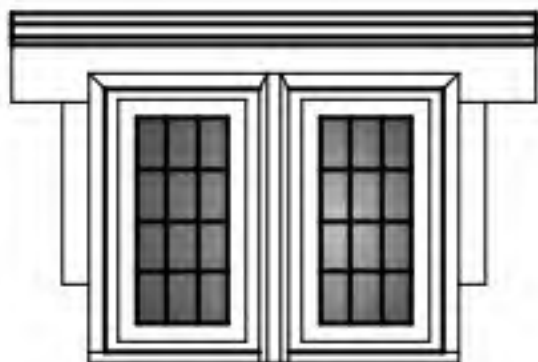
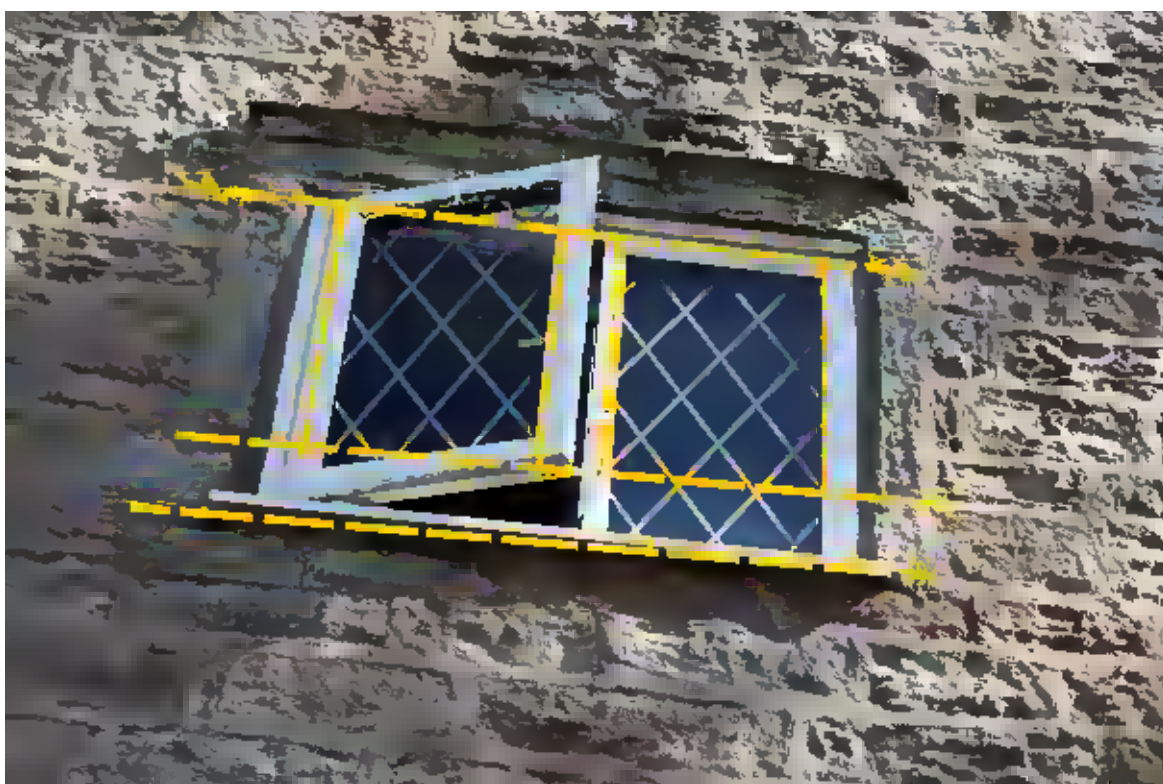
### FFW5

This window to the south gable has been altered with the removal of the deep chamfer to the original stone cill and the cutting out of the secondary stone chamfer to the lintels and jambs. Unlike the 17<sup>th</sup> century windows to the front elevation, this window is missing a central stone mullion, and it is proposed that a mullion be reintroduced to match those on the front elevation. The proposed windows are a pair of metal casements with black-painted finish (or similar), inserting a new Code 4 lead flashing to the cill. Paired side-hinged opening metal casement windows will be double-glazed with applied lead. This is an enhancement and more sympathetic than white uPVC, whilst reducing the impact of the white uPVC frames, increasing the amount of light with slim metal frames.

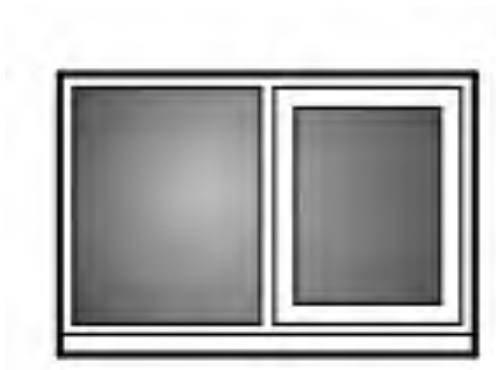
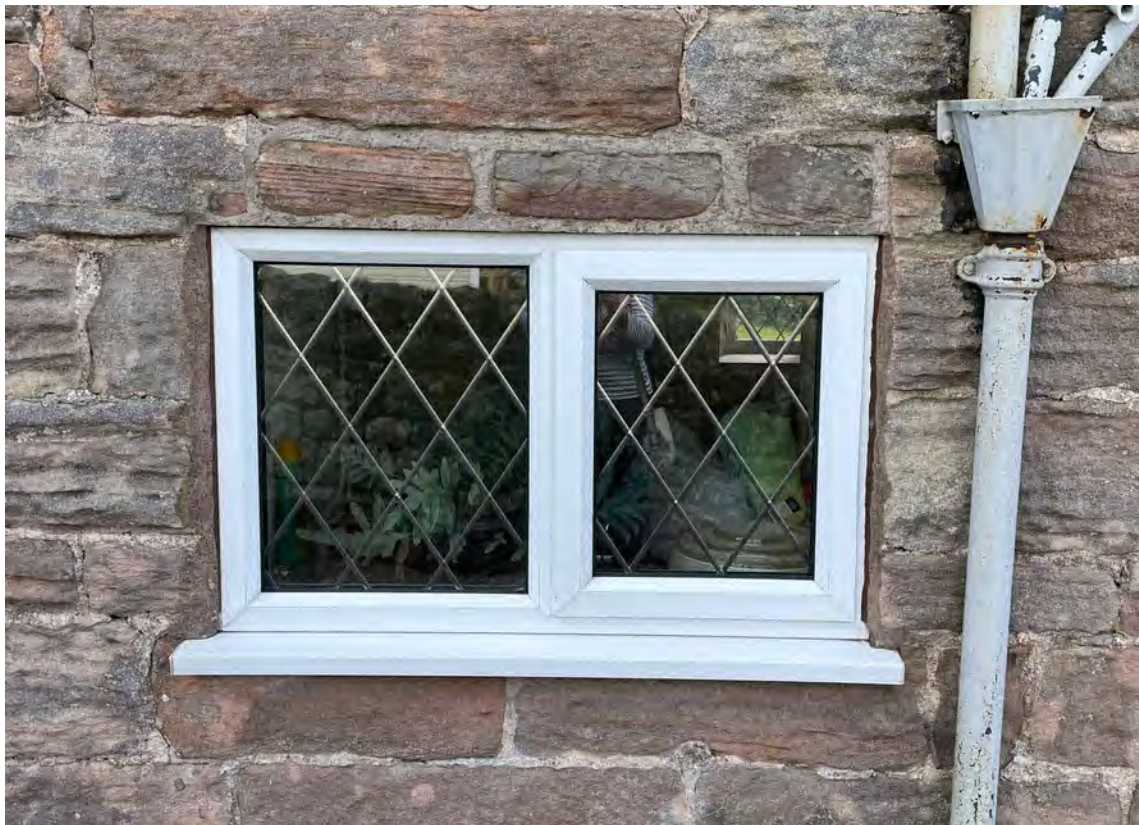
#### GFW4

This window is a modern insertion, probably added in the 20<sup>th</sup> century. There are no details which would date the opening. The proposal is to replace the uPVC window with a plain metal casement framed window and a side-hinged single opening casement, all painted black, with plain double-glazed sealed units. As this is a modern opening, this approach provides a simple treatment which removes the starkness of the white uPVC and is at the same time sympathetic to the historic window openings.

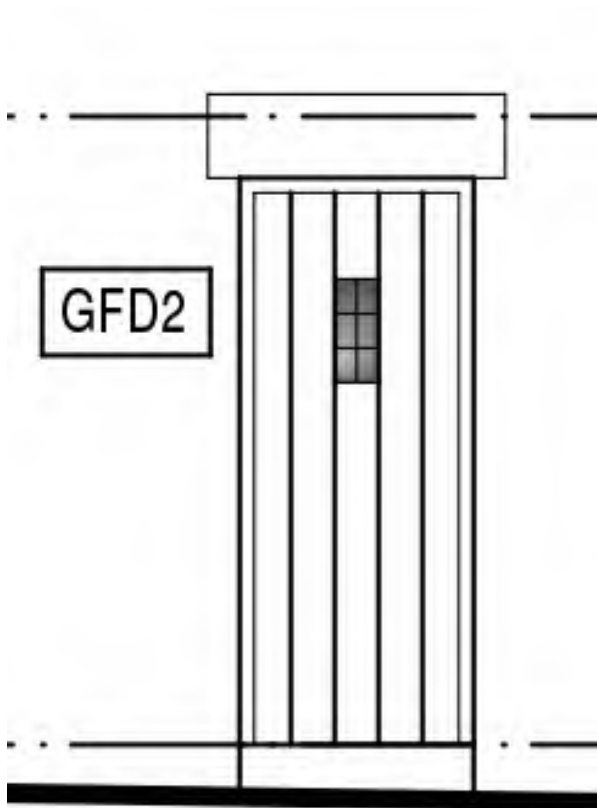
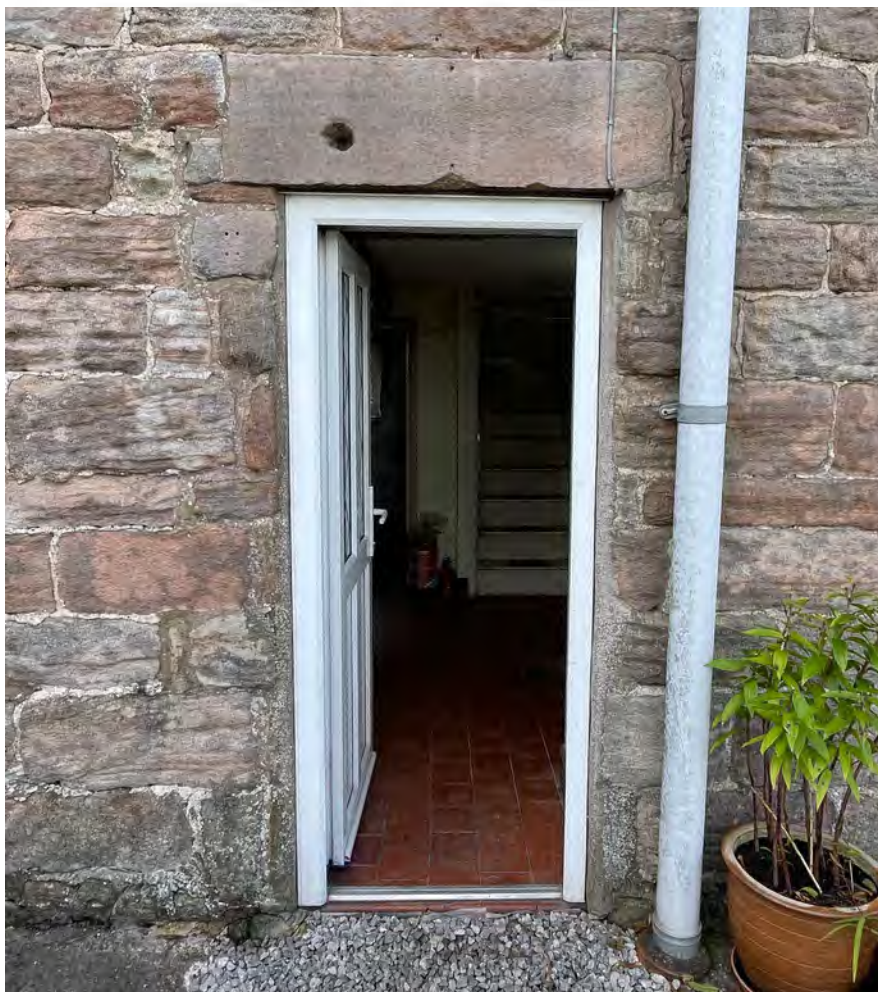
#### GFD2

This door served the kitchen (which was recorded in 1775) and the opening was probably added in the 18<sup>th</sup> century, although there is a modern steel lintel to the back of the stone lintel. It is a narrow doorway with a plain stone lintel and is now a white uPVC door. The proposed door is a timber boarded door with scratch moulding to the panels, which is typical of the late 18<sup>th</sup> century.

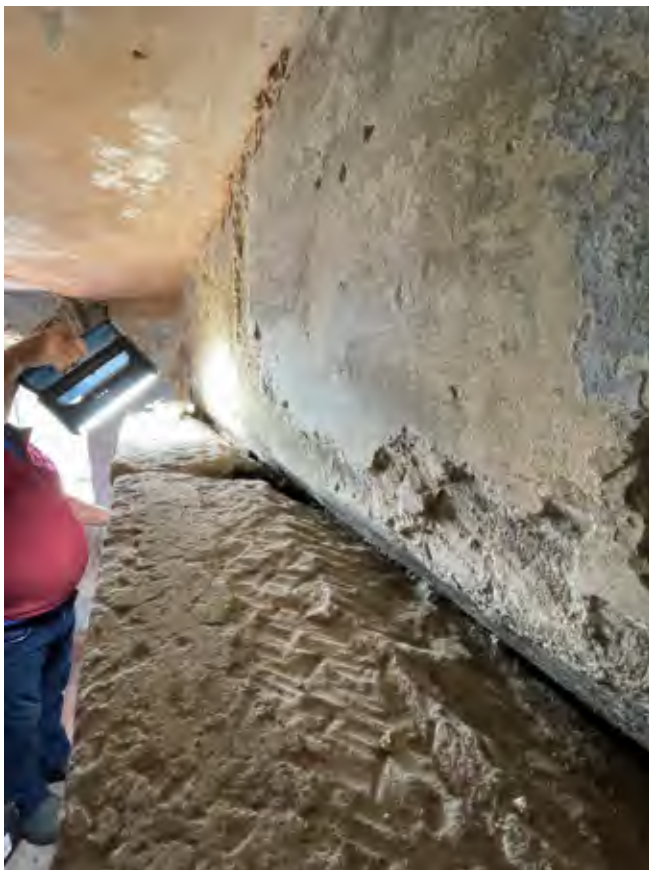
13. Corner fireplace with stone masonry chamfered surround to the full-height of the ceiling of ca. 1680 in-situ. This detail shows the chamfer intact with the back of the later stone surround tooled to avoid defacing the original chamfer. This was filled in a weak mortar and the face of the hearth of 1680 was given a thin coat of lime plaster, which has become largely detached.

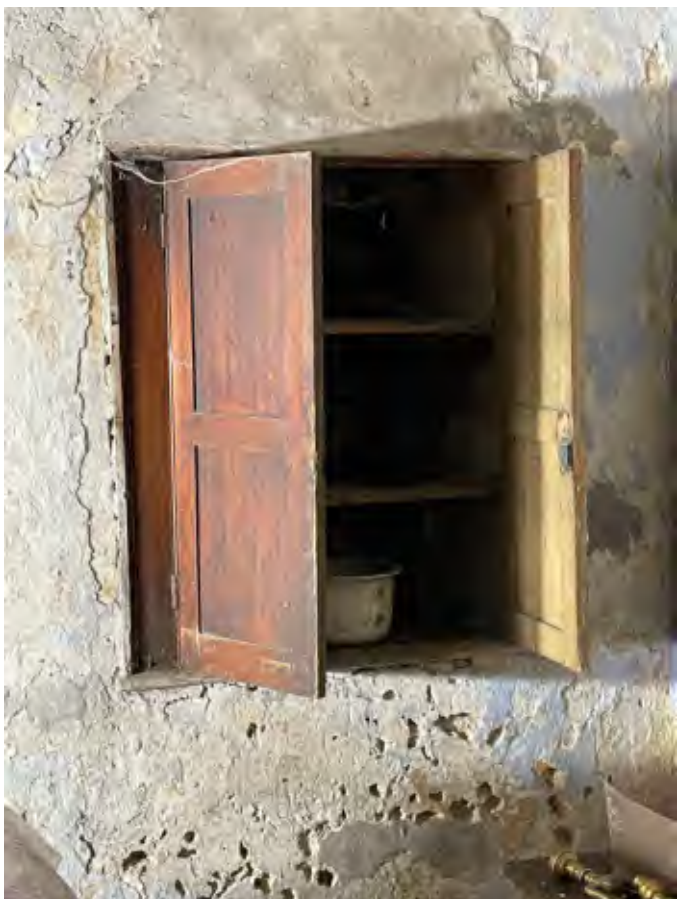
17. 19<sup>th</sup> century plain kitchen cupboard with plain rebated cupboard doors to former oeil-be-boeuf window.

The proposal is to remove these doors and two shelves to permit light from the new leaded-light window. Alternatively, the doors could be pinned open. The reinstatement of the oeil-de-boeuf window would require the shelves to be removed.

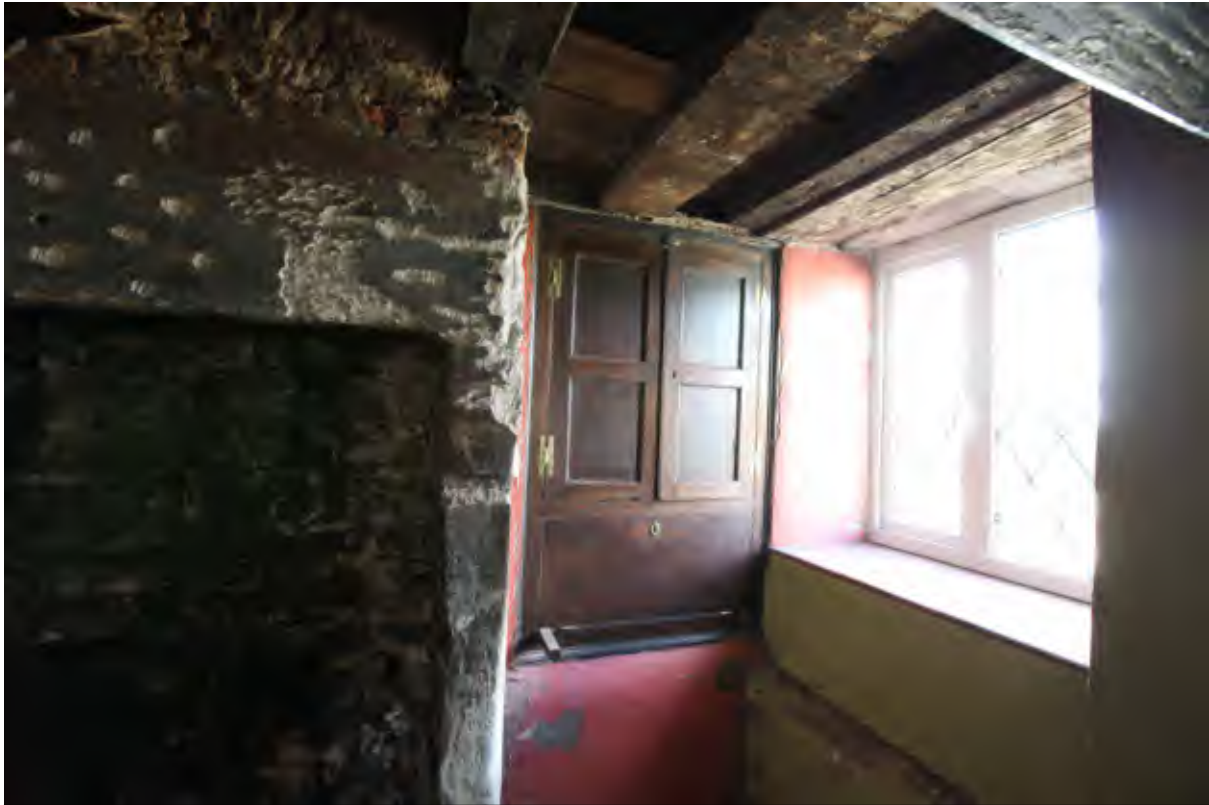
23. 18<sup>th</sup> century china corner cupboard with writing desk and altered fire window. Soffit needs local reinstatement of plasterboard and plaster skim.

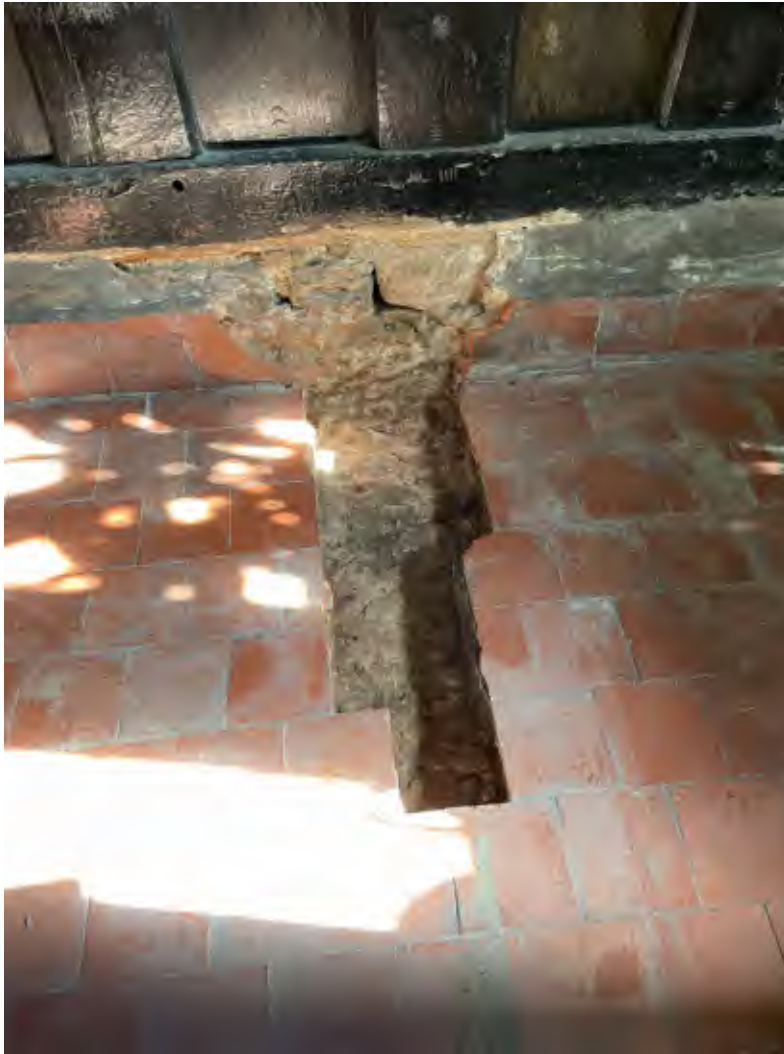
28. Detail of the quarry tiled floor, an area of cement removed from below the sole plate of the plank-and-muntin screen. The bedrock is close to the surface, so there is insufficient room to insert a Limecrete floor. Alternative options will be assessed once the quarry tiles are removed.

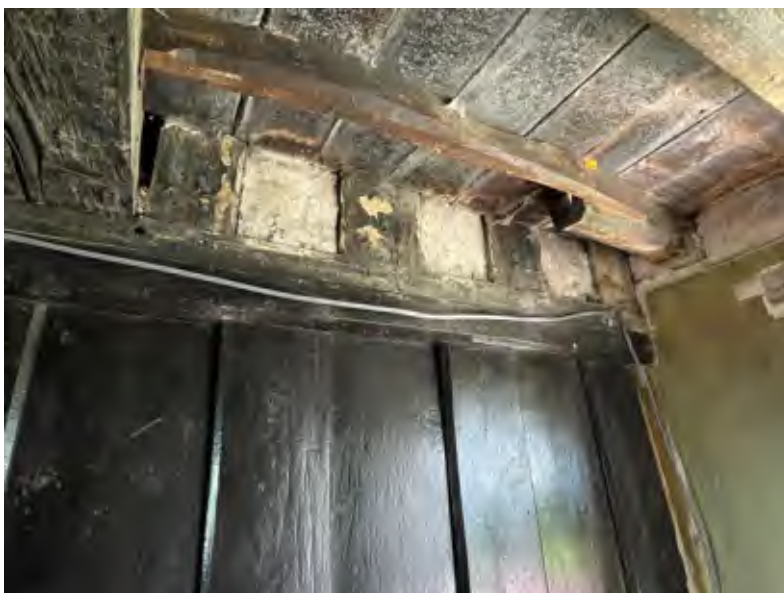
29. Detail of the joist which has been part removed and part replaced with a narrow section of oak in order to accommodate a piece of tall furniture. The integrity of this joist is compromised and will be repaired by scarfing in new oak to match the 1624 profile, with the historic stop-chamfered which is seen here in the wall retained (see SPAB scarf detail above).

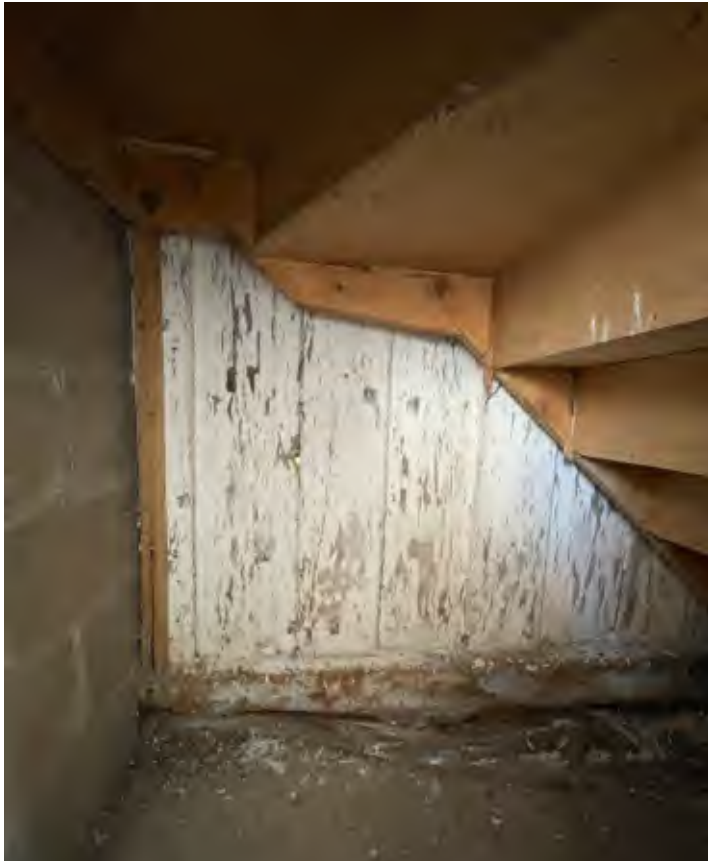
30. The back of the plank-and-muntin screen has been lime-washed at some point, although this is not across the whole of the screen. This area underneath the stair will be hidden from view when the stairs are turned.

The proposal is to remove the limewash by steam cleaning.

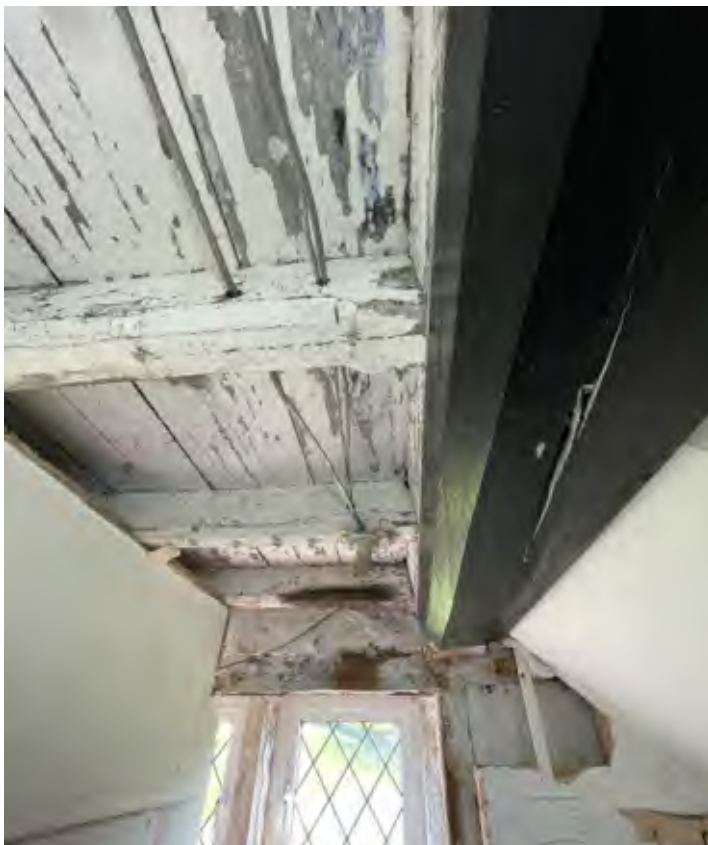
31. The plasterboard ceiling has been part removed to reveal the original stop-chamfered joists and oak boarded floor above the kitchen. At some point these were lime-washed. The spine beam has been painted black at a later date and some services such as electrical cabling has been inserted by drilling holes through the joists.

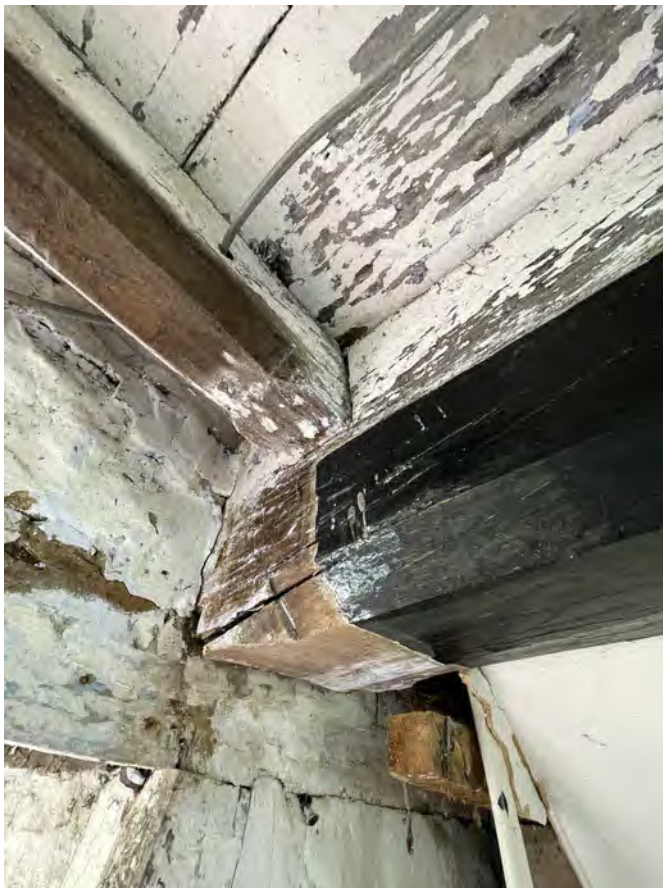
33. Detail of spine beam which has some deterioration and rot bearing onto the internal timber frame and the wall, with test area of steam cleaning to joist.

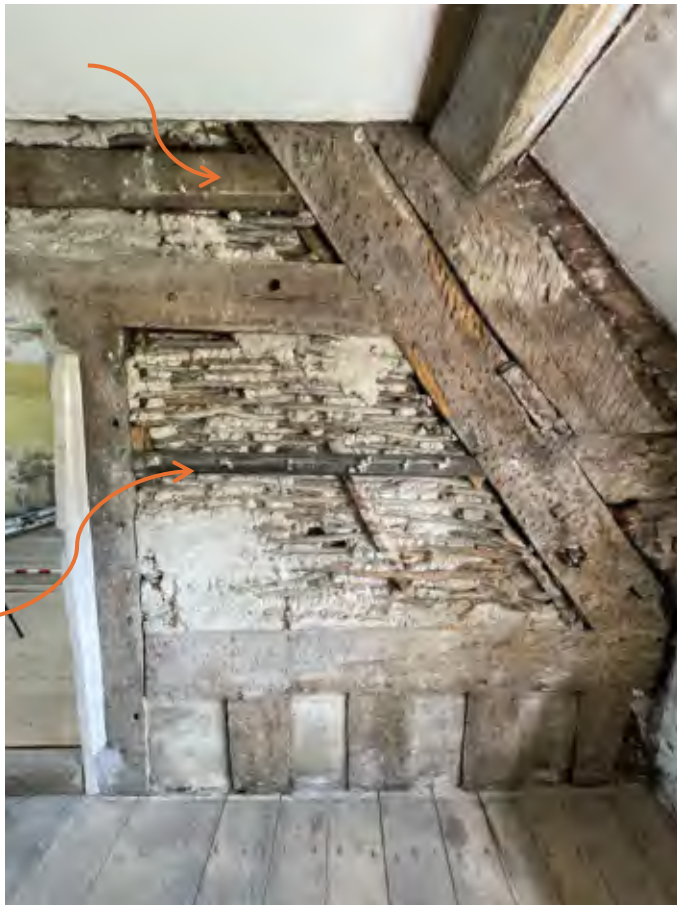
34. Detail of the closed truss and wattle-and-daub. The close studding below the main tie beam is complete with original plaster finish to wattle-and-daub intact. The principal rafter end where it meets the tie beam is rotted but this is no longer structural as the eaves has been raised and a spur added along with secondary principal rafters and supplementary trenched purlins. Later softwood timbers were added to provide a key for a later plastered finish (arrowed). These will need to be removed to undertake the repair of the wattle-and-daub in lime plaster, so that it finishes flush with the oak frame.

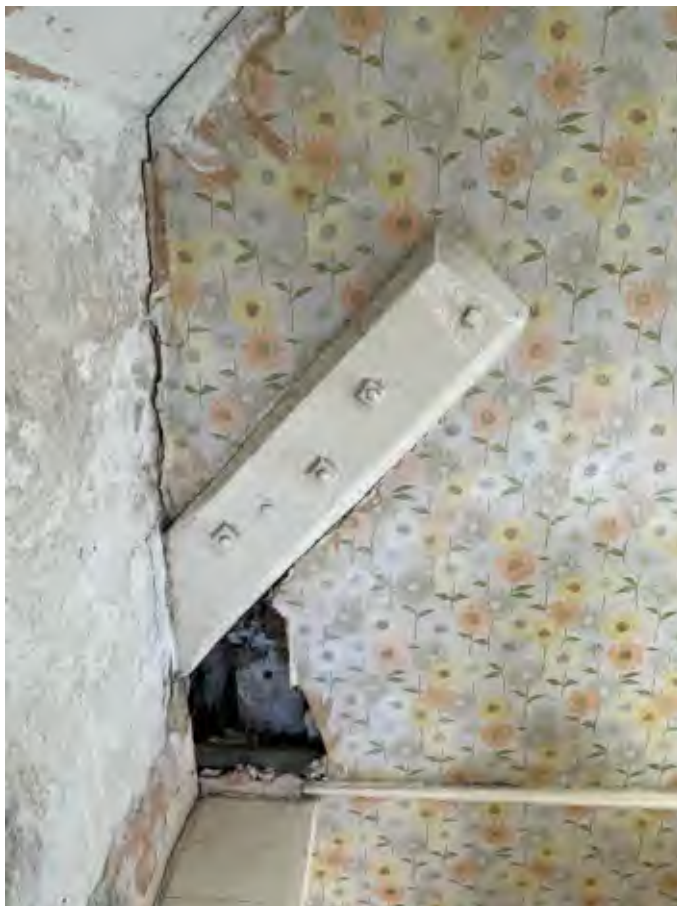
35. The opposing side to the closed truss has additional strengthening oak timbers to both roof slopes which are bolted through to the 1624 principal rafters. Modern plasterboard has been added (wall-papered) to the original lime-plaster and oak frame.

The plasterboard will be removed and the wattle-and-daub repaired in three-coat haired lime plaster.
