BAT SURVEY OF TALBOT HOTEL IN LEEK, STAFFORDSHIRE

October 2012

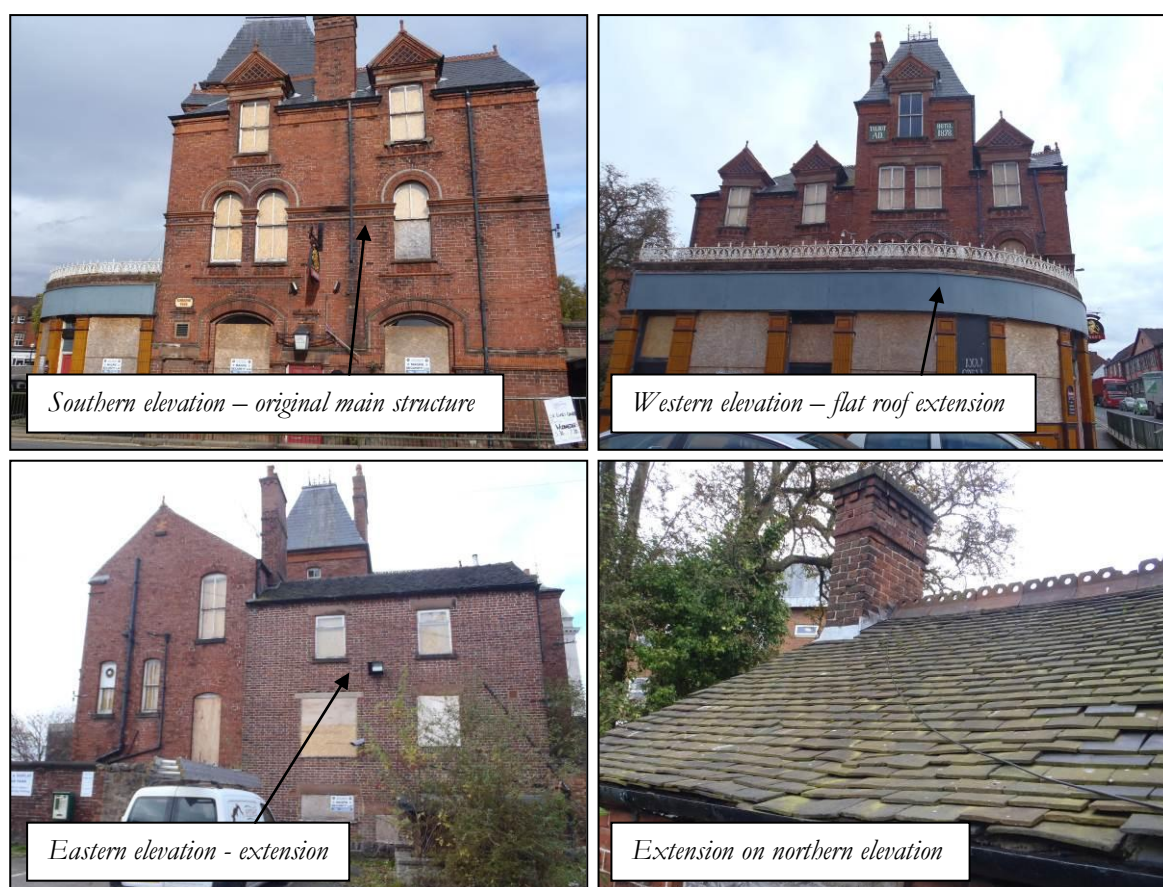
Section 1 is solid red brick with decorative corbel detailing. The roof is in very good condition with no visible lifted or missing slates and no mortar loss beneath the ridge tiles. The lead flashing is flush to the brickwork around the chimney and dormer windows. Section 2 has a bitumastic felt roof which is in good condition with no areas of standing water or lifted felt.

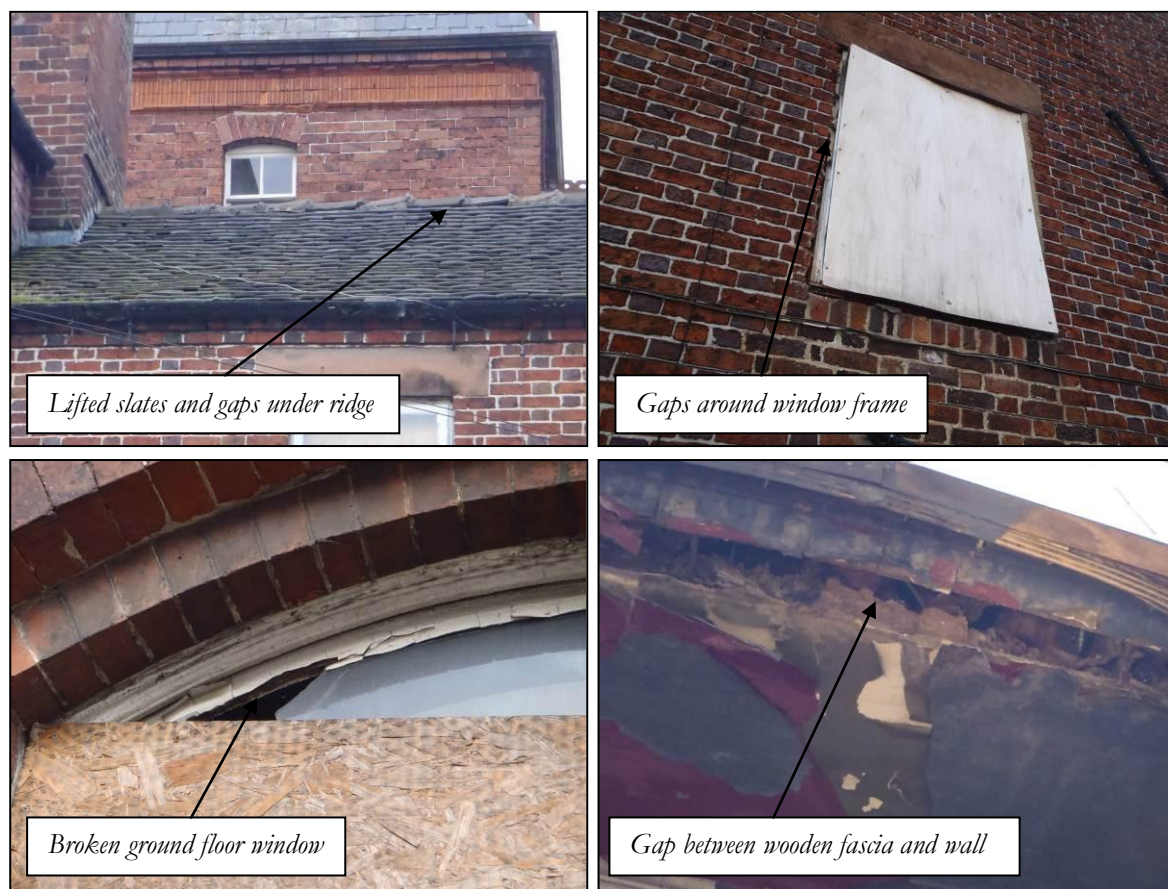
Section 3 is in a poorer state of repair with numerous gaps present under lifted tiles and where mortar is missing beneath ridge tiles. Section 4 is in poor condition with numerous lifted tiles and occasional missing tiles creating gaps and access to the interior.

Numerous gaps are present on the exterior of the building around the window frames where the brickwork and mortar has been weathered and also between the wooden fascias and the wall of the flat roof extension. All windows except for those on the fourth storey are boarded-up. However the top of the ground-floor window in Section 1 is exposed and has been broken providing potential interior access.

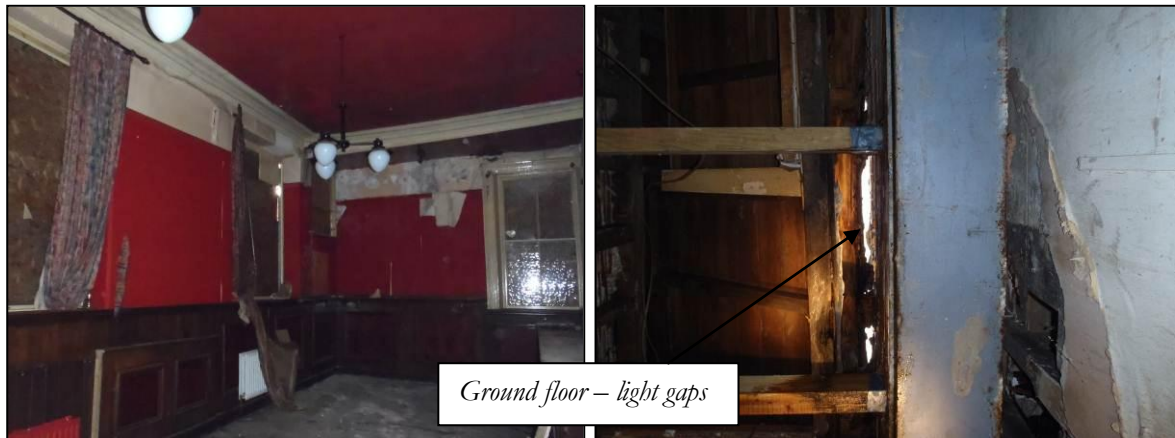
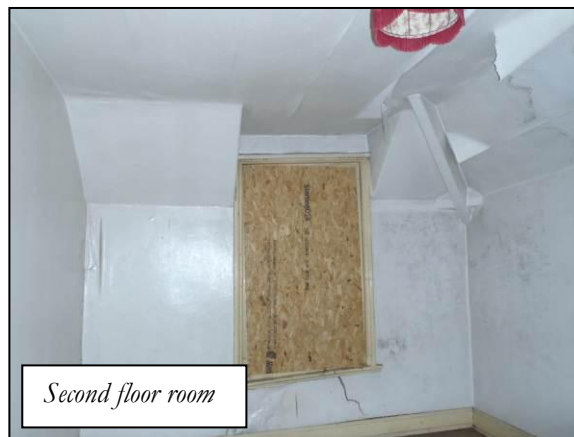
The ground floor is dark and damp with evidence of mould growing on the walls. It contains a bar and seating area. It is extremely dirty with all surfaces covered in dust. Light gaps are visible within the ground floor where the flat roof section joins the original building. The first floor has an additional bar area as well as private quarters including bedrooms, a kitchen and an office. The rooms are all dark with boarded windows and have smooth painted walls or wall-paper. Further bedrooms and a bathroom are present on the second floor which are all dusty and dirty with cobwebs. These rooms have flat ceilings with sections that were vaulted indicating a small apex loft space is present above. The small four storey section contains a single bedroom which is well-lit as the window is not boarded and is intact. Access to the loft space above this section is via a small loft hatch.

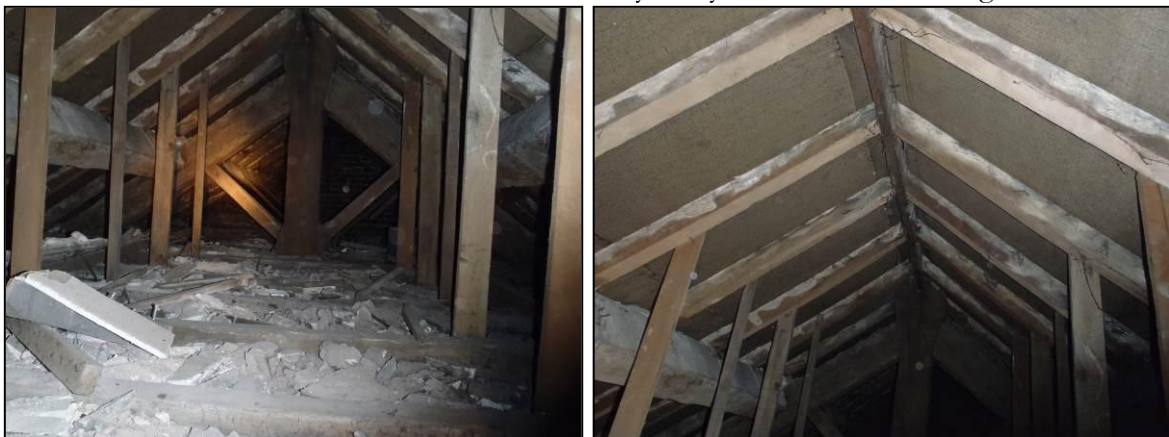
The loft space above Section 3 is accessed via a hatch in a bedroom. This has a king post roof with additional support timber posts. The roof is lined with bitumastic felt which does not appear to have any tears in. no light gaps are visible within the loft. The surfaces are very dusty with old tiles littering the floor.

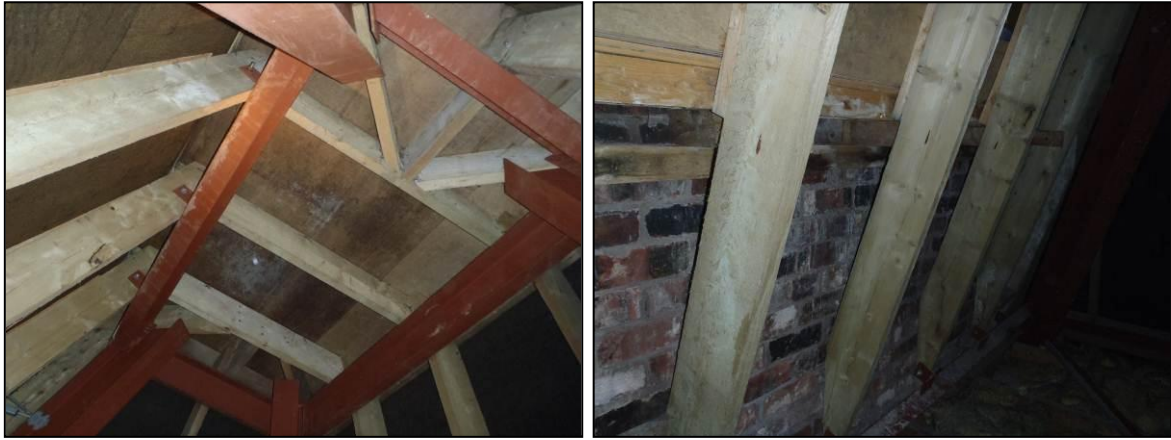
The loft space above the four storey section is a box shape with a steel frame with timber joists attached to brick walls which are approximately 0.5m tall. The remaining side walls have bitumastic felt beneath the slates. No light gaps are present and the surfaces are generally dusty.

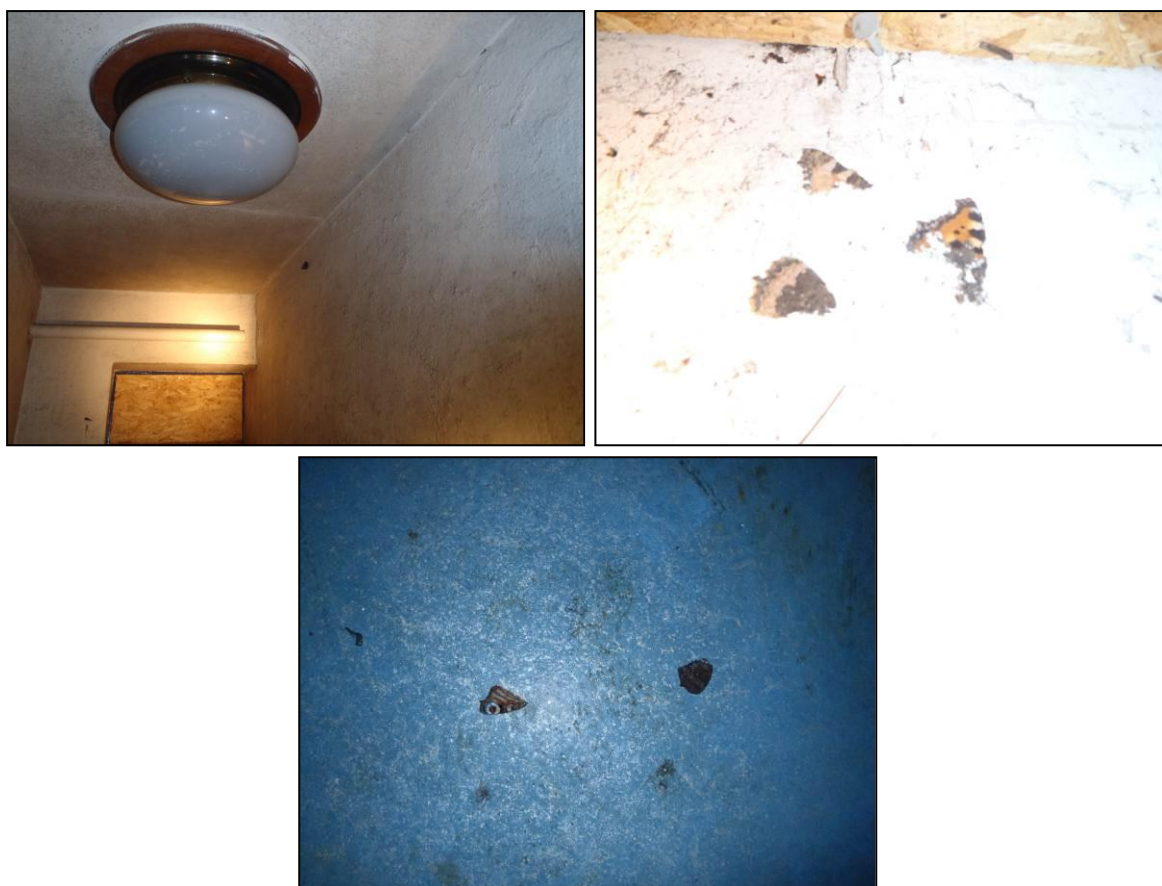
The roofs of the Section 3 and 4 were in a poor condition with numerous gaps created beneath lifted tiles and where tiles were missing. Gaps were all visible around some windows frames where the brickwork had been weather and between the wooden fascias and the wall. Access to the interior of the property was possible via a broken window pane. The interior was dark and sheltered suitable for bat-use however it was damp and dirty. A number of sheltering/hibernating peacock butterflies (*Inachis io*) were present on the interior walls on both the ground floor and second floor. Feeding remains (wing fragments) were found on a window-sill on the first floor (three fragments) and on the bathroom floor on the second floor (two fragments). These are likely to be feeding remains from spiders rather than birds (e.g. wrens) or bats.

Bat activity surveys (evening emergence / dawn swarming surveys) between May-September using electronic bat detectors are required to ascertain whether bats are using the features identified. To meet current industry guidelines and planning requirements a minimum of two activity surveys are likely to be necessary to determine whether the works can proceed without specific mitigation and consultation with Natural England regarding a possible EPS (Bats) licence.

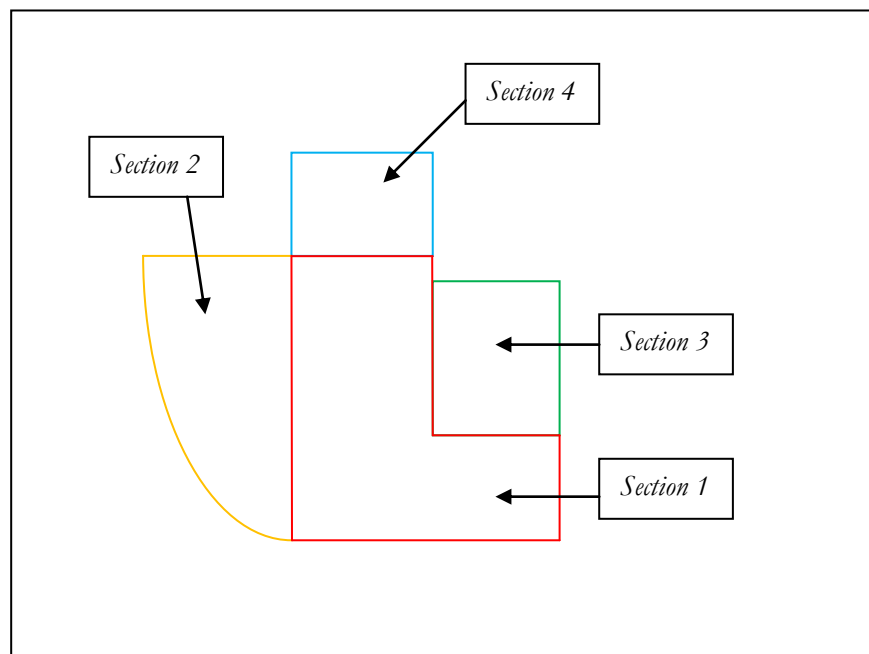
Figure 2: Site plan

The building comprises of numerous extensions attached to the original main structure which forms a central 'L-shape' which is three storeys with an additional small four storey section (Section 1 – see Figure 2 in Appendix 1). There is a single storey flat roof extension to the west elevation (Section 2). A three storey extension is present on the eastern elevation which creates an overall rectangular shape (Section 3). A final extension is present on the northern elevation of the main structure which is not accessible from the interior and boarded on the exterior (Section 4).
