Land between 35/37 Novi Lane Leek ST13 6NX

R. D.(Leek) Ltd

TREE SURVEY REPORT

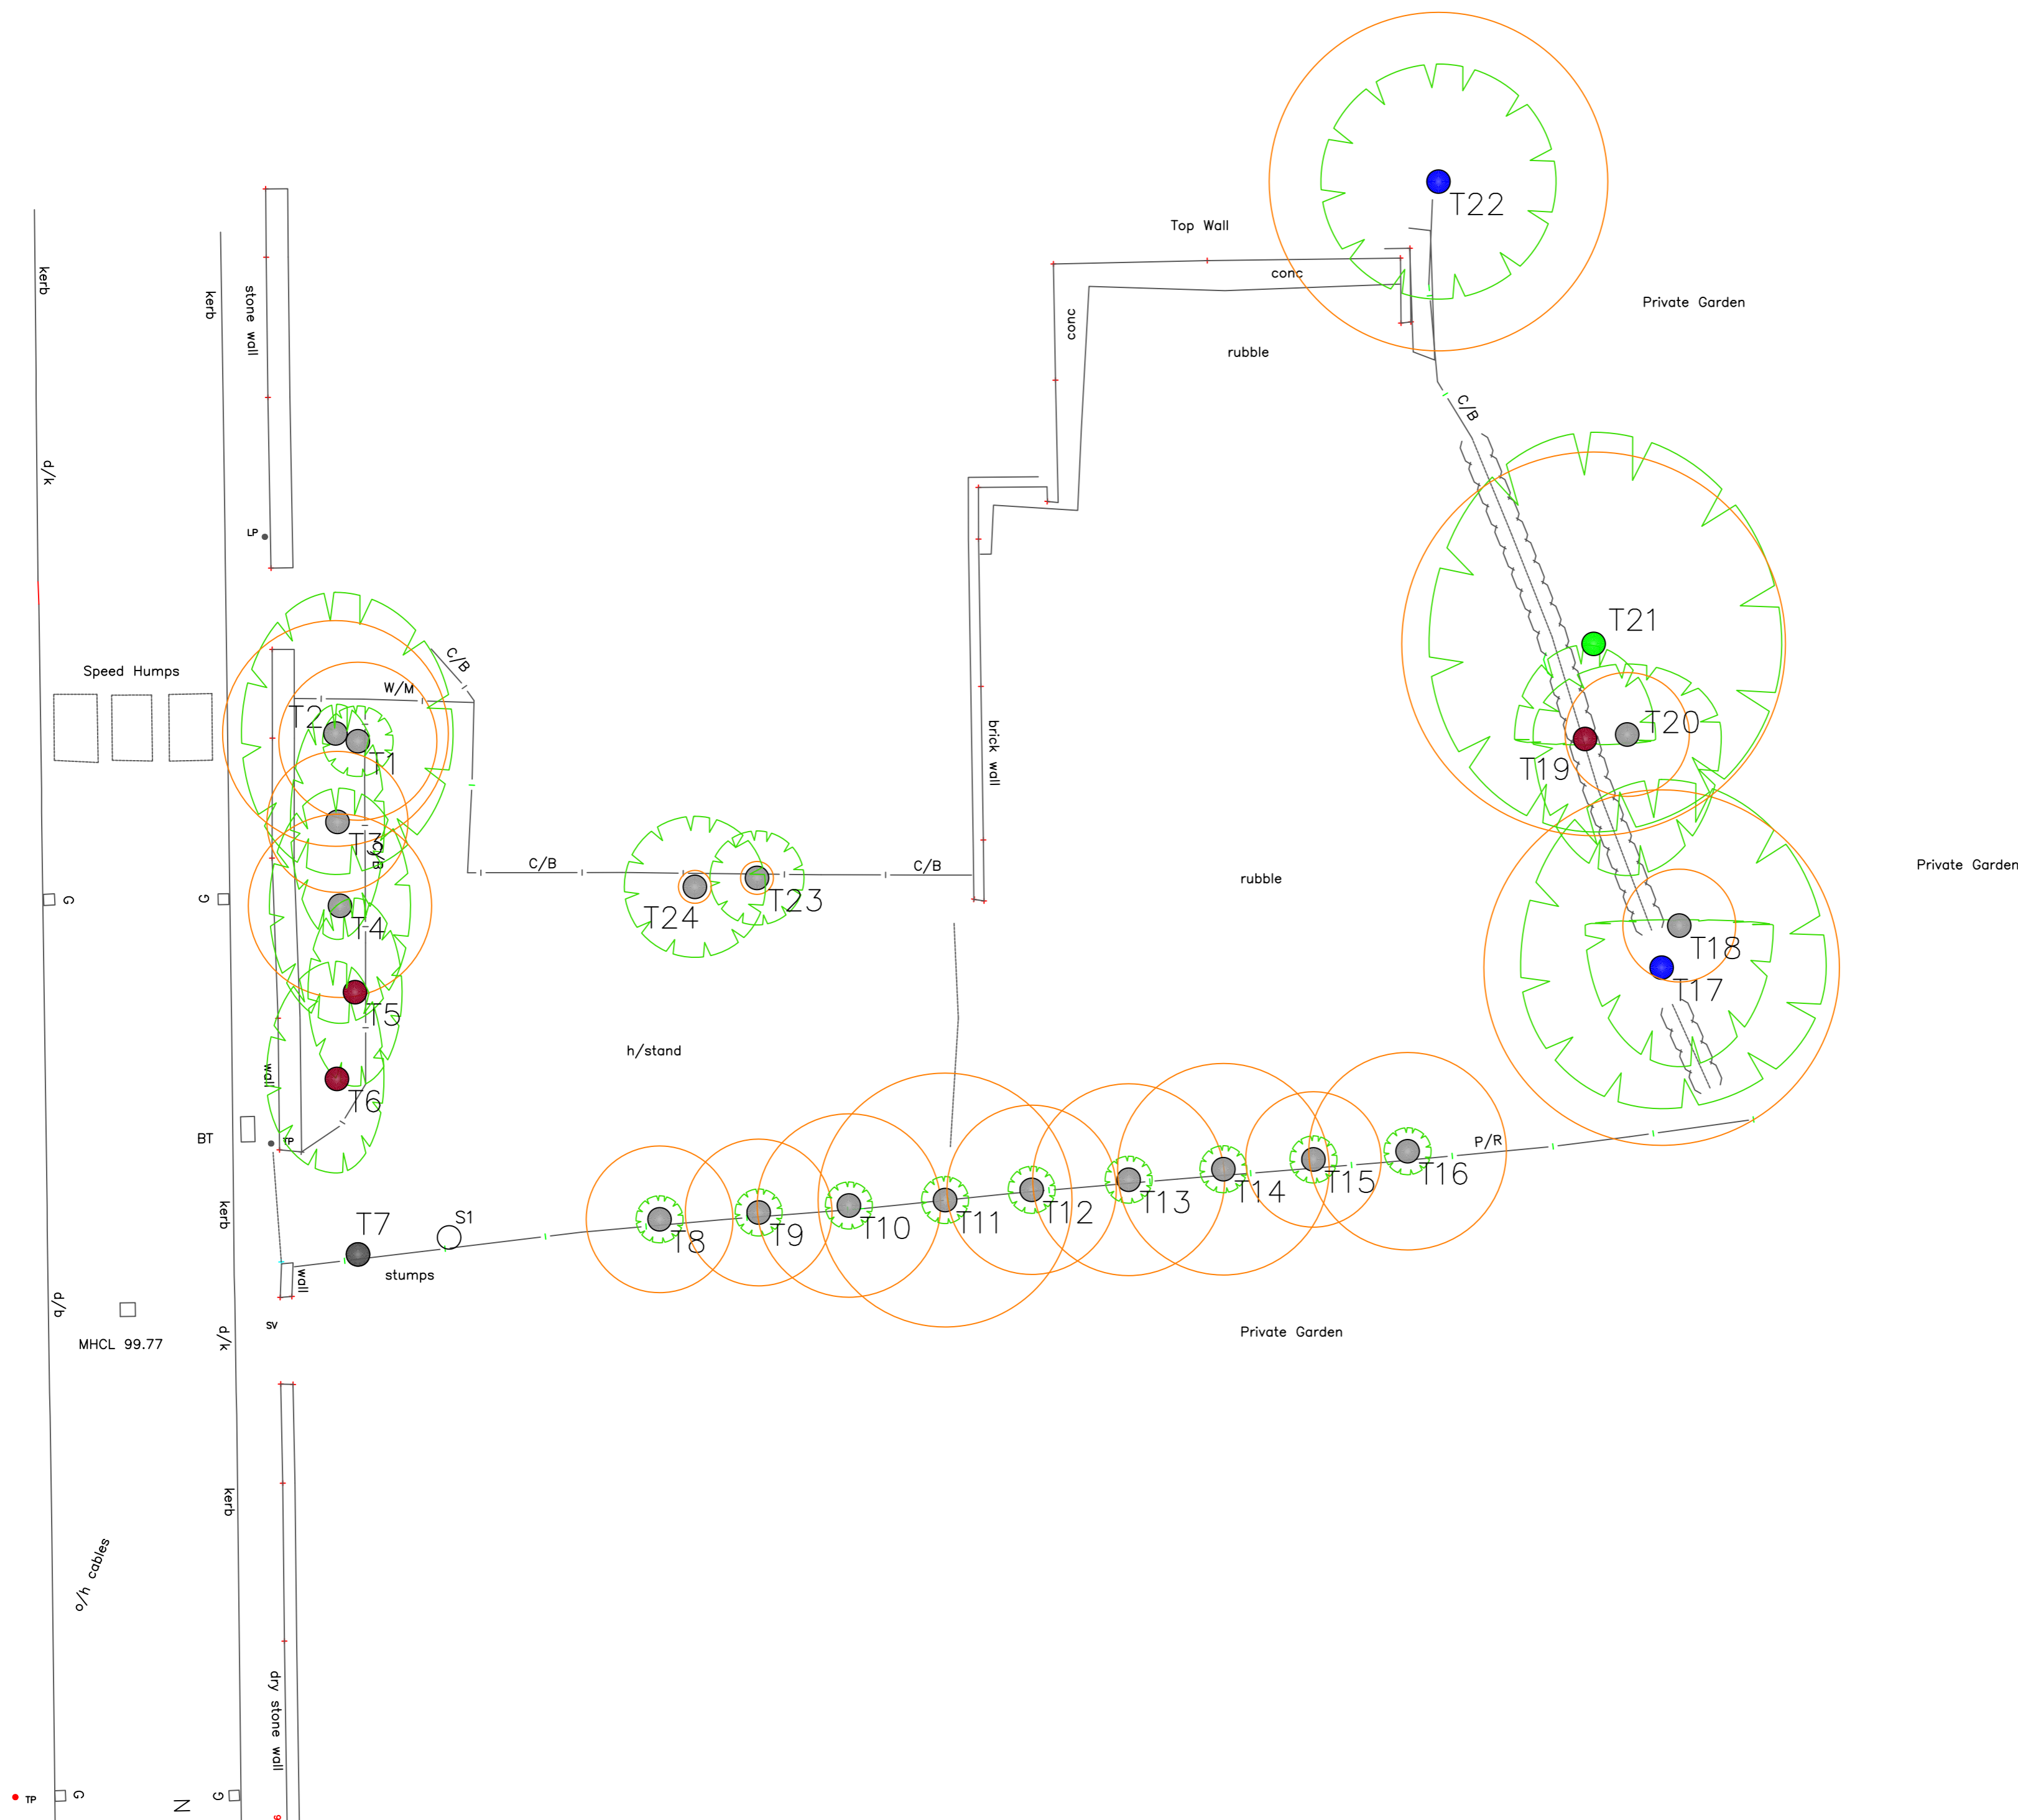
Arboricultural Implications Assessment

- 9.1 There are only three important trees on this site that should pose any significant constraints on its development. The Oak T21 is a good Category A specimen and should be retained and protected if at all possible especially as it is over the boundary on the allotments. The large Sycamore T17 is a Category B tree that is just inside the boundary is also a key landscape feature and should also be retained and protected. There is another Oak T22 that is a Category B tree and whilst not as important as T21 it is on adjacent land and requires protection. The remaining trees are all to be considered fairly low in value as individuals and these should pose any significant constraint on the development.

- 9.2 The proposed development has been designed to have minimal effect on the trees but requires the RPAs of the rear trees to be offset by 20%. This is permissible when the land involved is not being developed or has no buildings. In this case the land is being used for allotments and so is unlikely to be developed in the near future. In the case where offset is used then it is vital that the remaining RPAs are strictly maintained. The barriers should be erected prior to the start of any clearing work and only hand work allowed within the RPAs.

- 9.3 The exact position of the Tree Protection Barriers should be discussed on site with the agreement of the LPA Tree Officer. It is essential that they are erected before any work starts on the site.
