# Arboricultural Report BS5837 (2012) Anzio Camp

Trees in relation to design, demolition and construction

Client: Enhanced Developments Ltd

21/10/2014

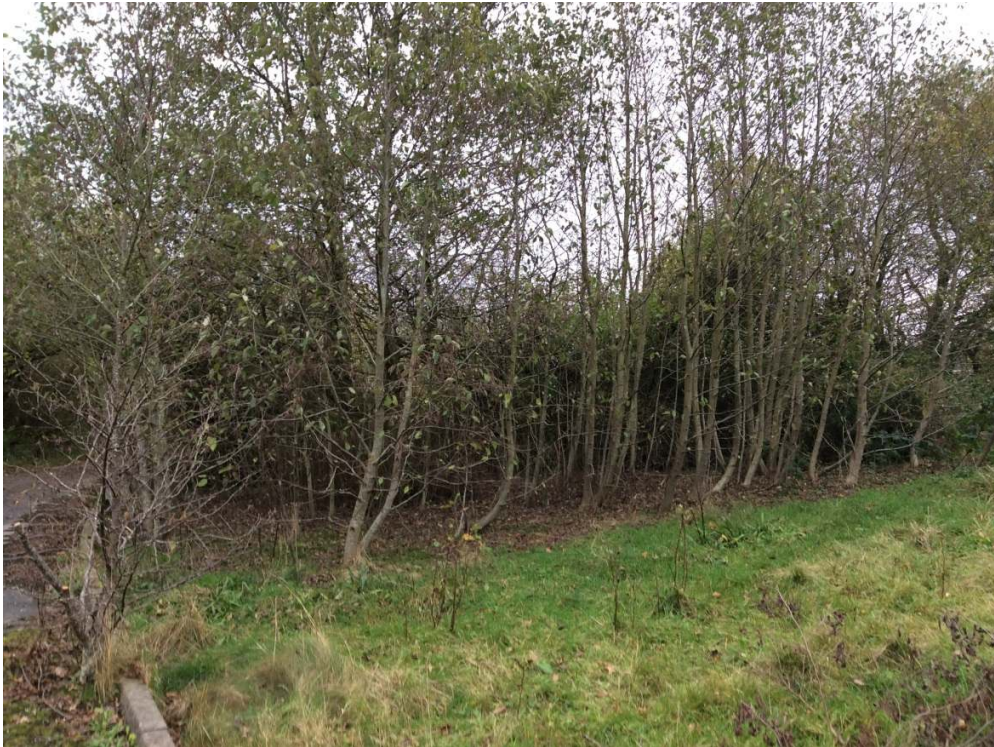
The site has returned quickly to a wild habitat in which many of the trees have produced suckers from the roots which now are significant and in some places dominant (see photo 1). Some areas have been enhanced by areas of natural regeneration from seed (see photo 2).

Photo 1 Example of Alder suckers T514 B

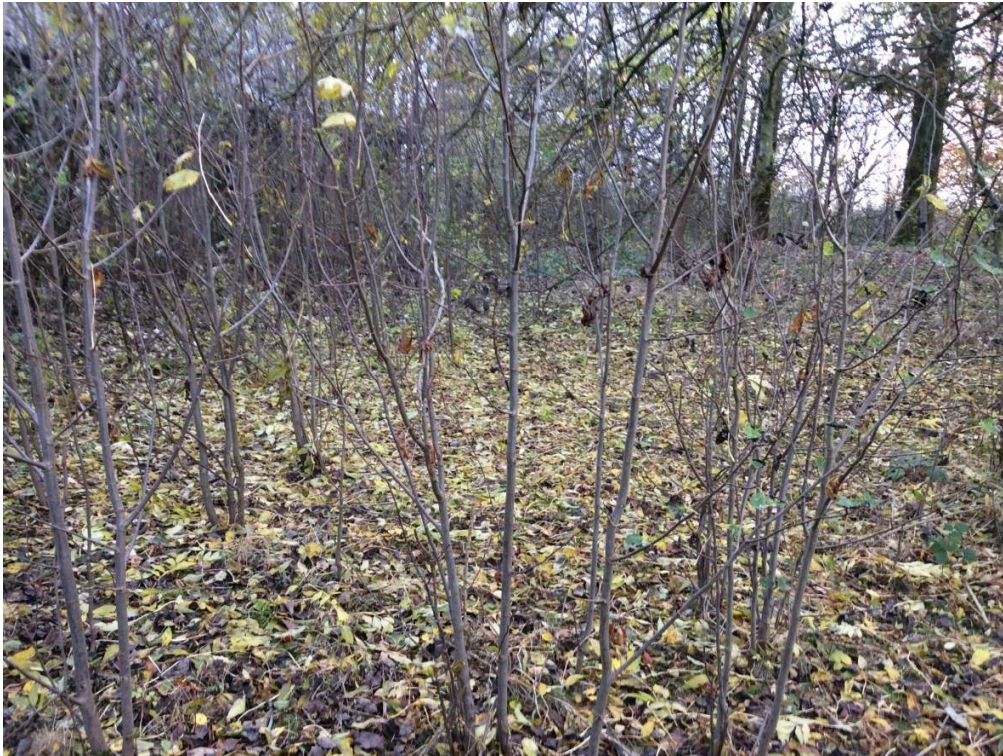
Photo 2 Natural Regeneration from seed in the area of T261 and T270
