Proposed Hydroelectric Power System at Consall Mill, Staffordshire

It is our understanding that Derwent Hydroelectric Power Ltd are working with the landowners towards the submission of a planning application for the installation of a hydroelectric system adjacent to Consall Mill. The Planning Authority has requested an update of the Ecological Walkover Survey carried out by Peak Ecology Ltd in September 2013.

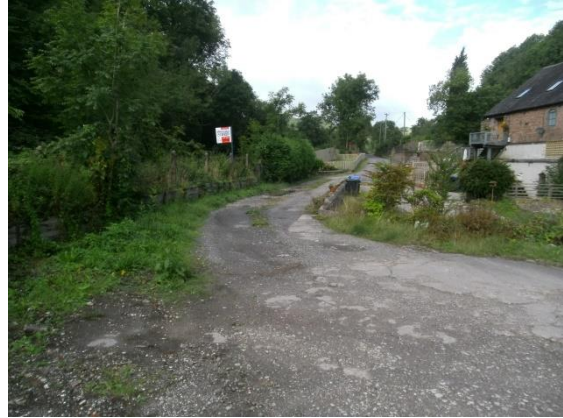
Photograph 1: Site overview – looking north-west

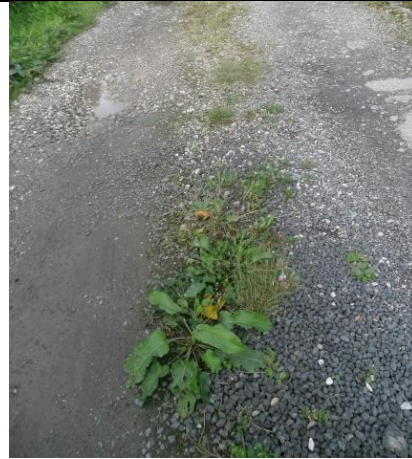
Ephemeral, short perennial species had begun to grow within the hardstanding, with species such as greater plantain *Plantago major*, red clover *Trifolium pratense* and broad leaved dock *Rumex obtusifolius* all present. Longer grassland and immature scrub had also begun to grow at the edges of the hardstanding, primarily immature ash *Fraxinus excelsior*, bramble *Rubus fruticosus*, meadow grass *Poa* sp. and hedge bindweed *Calystegia sepium*. The scrub on the site did not show signs of management and had become denser, particularly around the existing pond, such that the surveyor could not get close to the proposed turbine shed location.

Photograph 2 – ephemeral, short perennial species within hardstanding

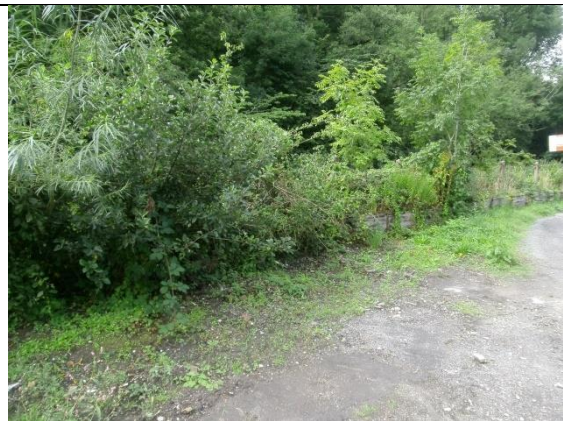
Photograph 3 – Scrub and grassland at edges of hardstanding

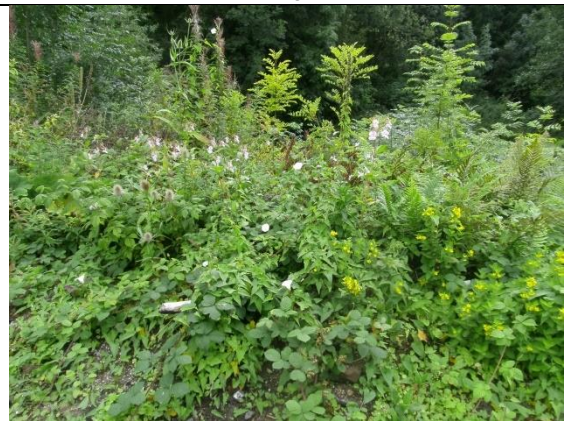
Himalayan balsam *Impatiens glandulifera*, which had previously been noted as a small stand within an area of scrub close to the north-western boundary of the survey area (adjacent to the existing culvert from the canal), did not appear to have spread outside of this area. However, a few individual Himalayan balsam plants were noted within the scrub on the banks of the pond and it could be seen within scrub outside of the survey area boundary, along the adjacent railway line.

Photograph 4 – dense scrub around pond, with individual Himalayan balsam plants visible

- Himalayan balsam and soil that could potentially harbour Himalayan balsam seeds, should be dealt with appropriately and this plant must not be spread;

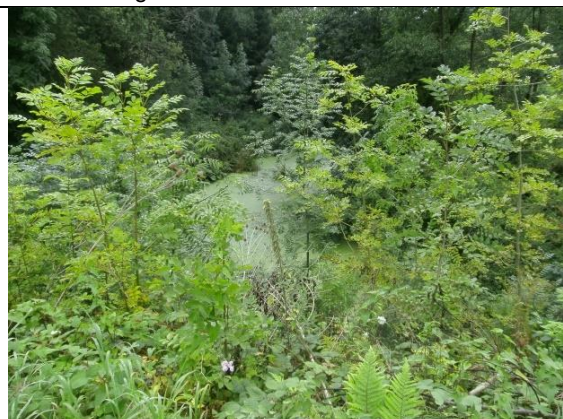
Photograph 5 – view of pond obscured by dense scrub

- Dredging of the pond is not recommended and the introduction of a small flow of water is likely to improve ecological conditions within the pond;
- Any trenches should be covered over at night or left with a ramp/sloping end, to allow any mammals that may fall in a chance to escape;

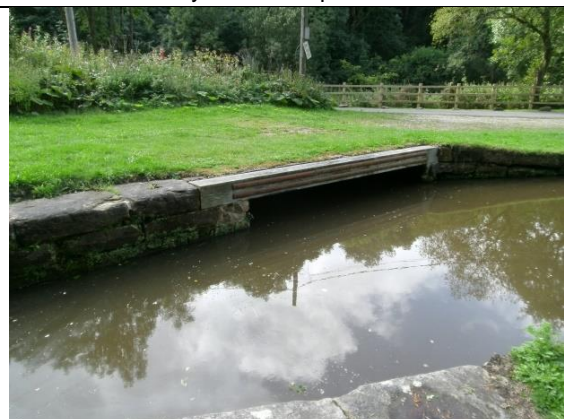
Photograph 6 – existing culvert, improved grassland and scrub by proposed intake.
