**Preliminary Roost Assessment for Bats & Birds**

**Location: London Mill, Leek**

**Date: January 2015**

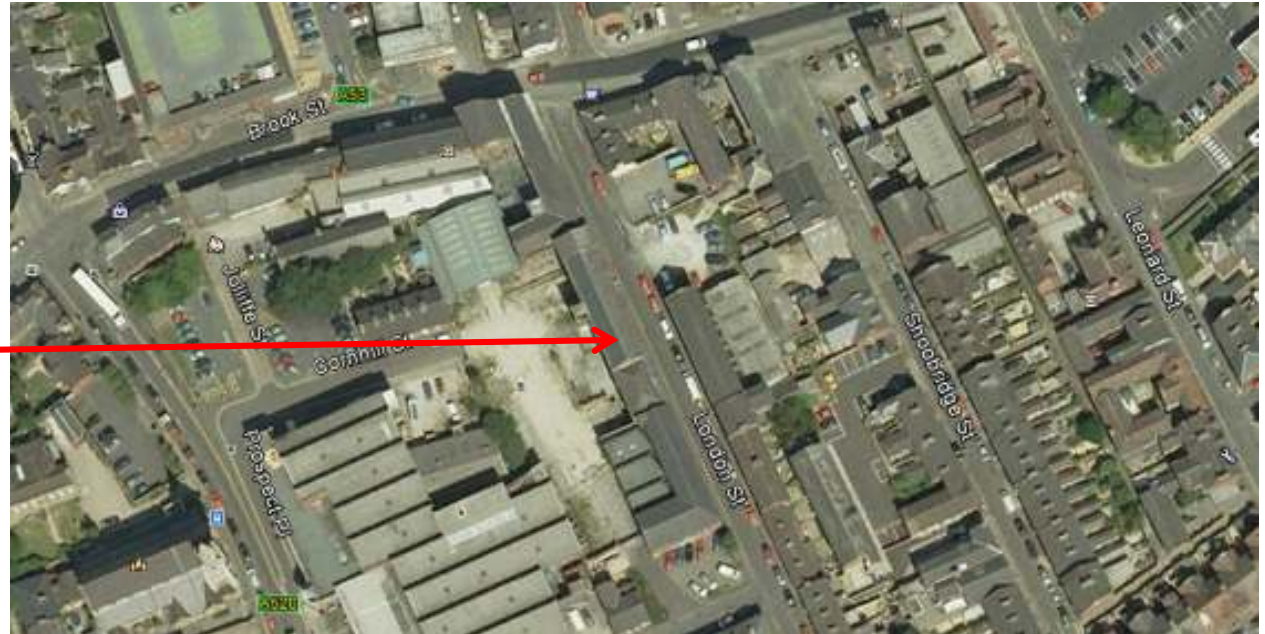
### Evidence Plan of Bat Activity within London Street Mill

Level 5d is used by roosting bats as the interior is undisturbed. It is easily accessible by bats through crevices along the brick work of the window. There was a high quantity of droppings found in one of the 5d rooms and corridors. The type of roost could not be determined but the location and number of droppings indicates that the building is likely to be used as a maternity roost, this is where females give birth to their young.

In order to gain sufficient information for an EPS licence application, further surveys are recommended on London Mill, which is known to support roosting bats. It is recommended that 3 dusk emergence and dawn re-entry surveys be undertaken on this building in accordance with the Bat Conservation Trust guidelines (BCT, 2012) 2<sup>nd</sup> addition, the surveys should be conducted between May and September with a month between each survey.

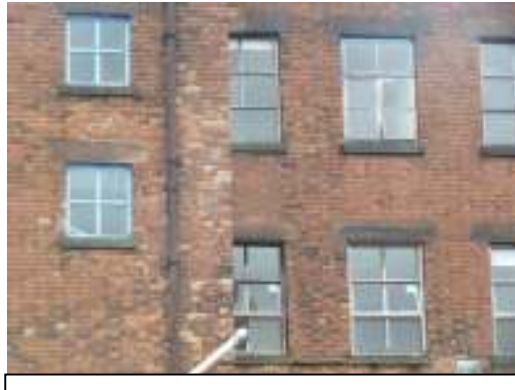
Area 5d is a large area divided into office spaces and corridors with a suspended ceiling, some of the offices were locked preventing any inspection. The walls are wooden panels and it was noticeable along the top end of the windows there were gaps on the south west elevation which were suitable for bats especially crevice species such as Pipistrelle species. The inspection found a hundred plus bat droppings through the corridor, attached to the window internally and externally and some scattering of droppings within the offices particularly noticeable on desks. One dead young male Pipistrelle species was evident on the floor possibly a young born 2011, due to the fading color of the fur it prevented a full identification of the species. Measurements were made of forearm length and facial shape though the phalanx could not be measured therefore determination of Pipistrelle species could not be made. The small area of roof voids were inspected where possible as some sections could not be accessible, no further bat evidence was found.

Plate 2: Views of western elevation where bat evidence was located (5d).

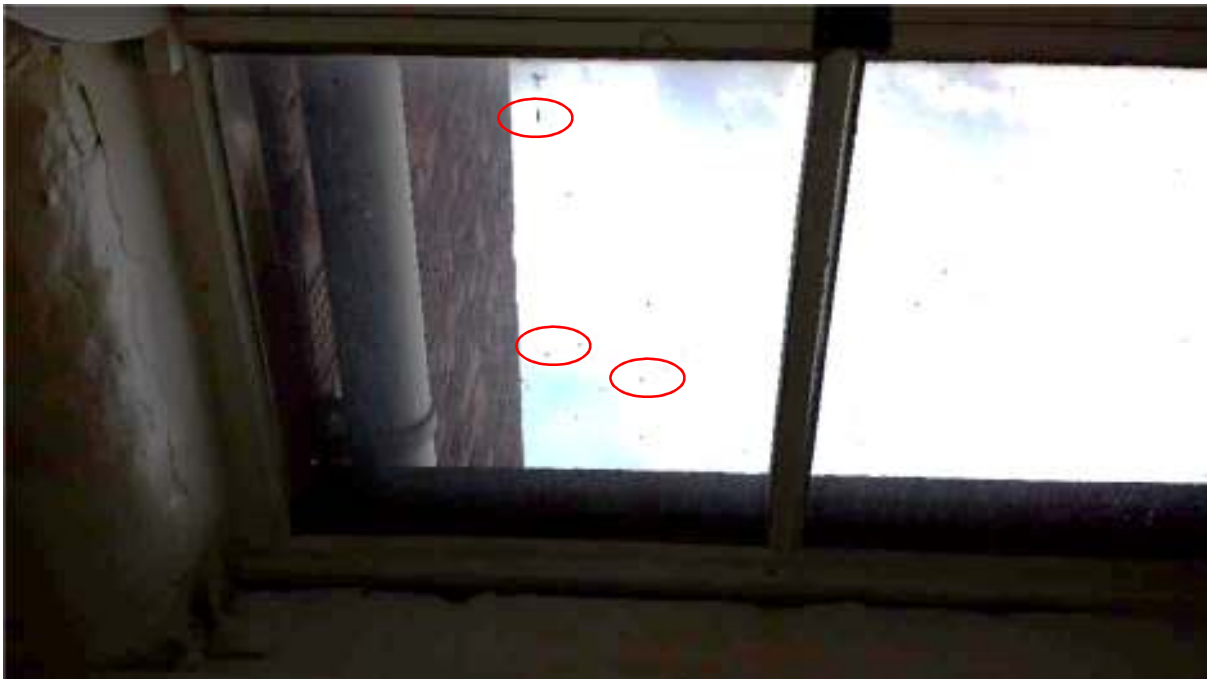
Plate 3: Views of western elevation where some bat evidence was located on window (5d).

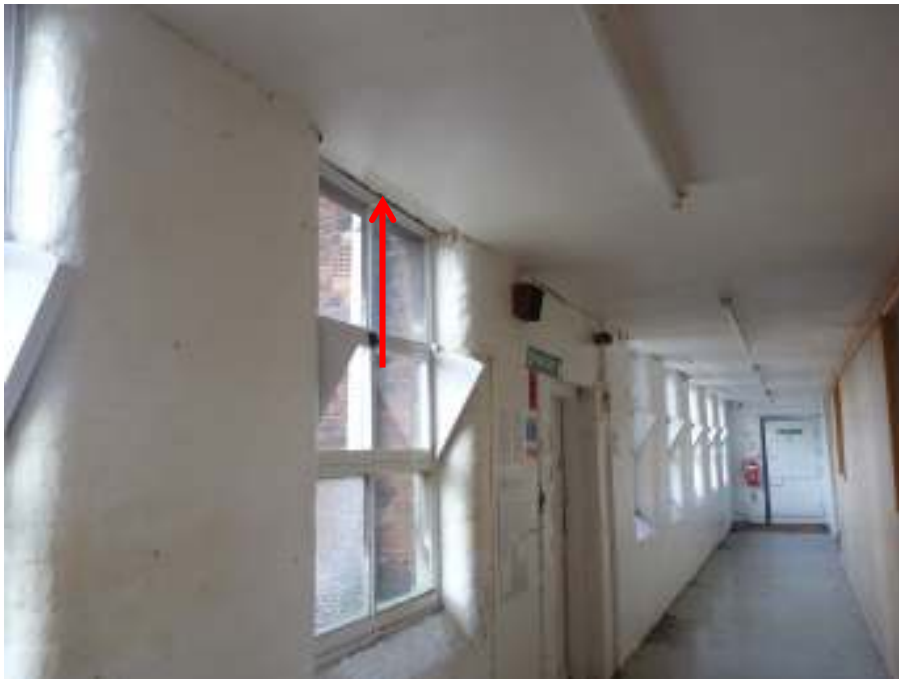
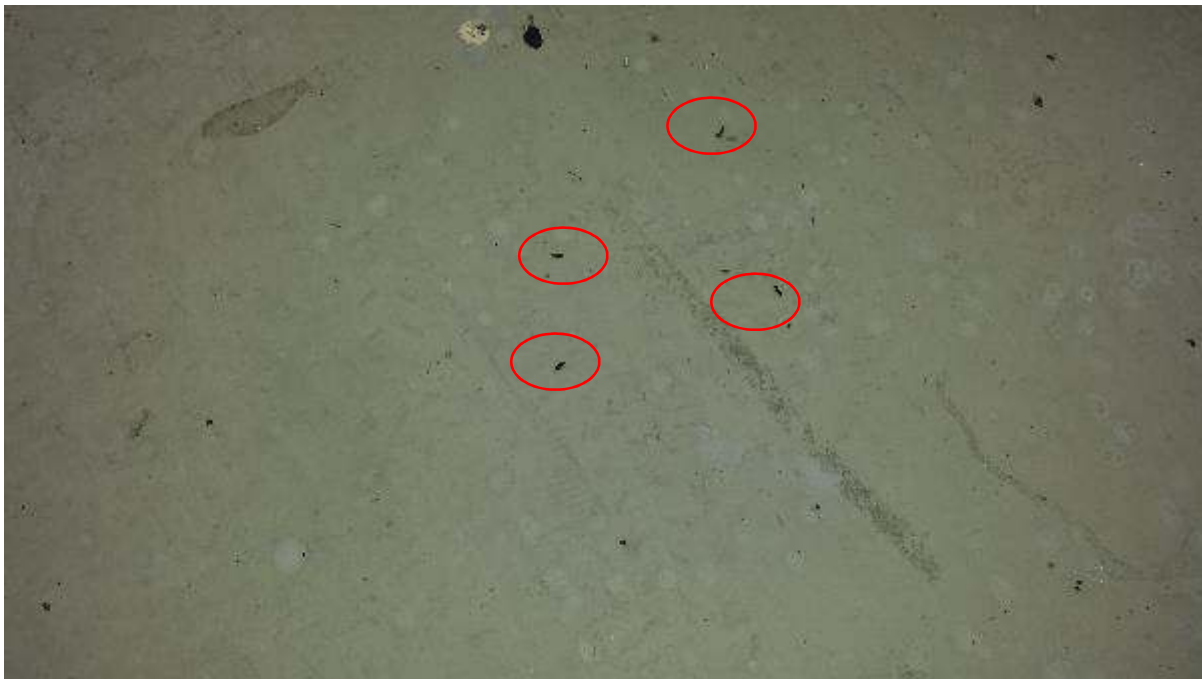
Plate 4 & 5: Views of corridor where bat evidence was located (5d).
