**Bat and Bird Survey for,
Mr. H. Scott-Moncrief.
Folly building at,
Basford Hall,
Basford Green,
Basford,
LEEK,
Staffordshire,
ST13 7ER.**

**Map Ref SJ 9904 5116
1st September 2015.**

**S. Christopher Smith MRICS MSc CEnv.
Suite D,
4/5 Market Street,
TAMWORTH,
Staffs.
B79 7LU
01827 310475
Mobile 07967 636115
Natural England License Number 2015-12865-CLS
E mail; chris@bat-survey.co.uk
©Tamworth Property Services.**

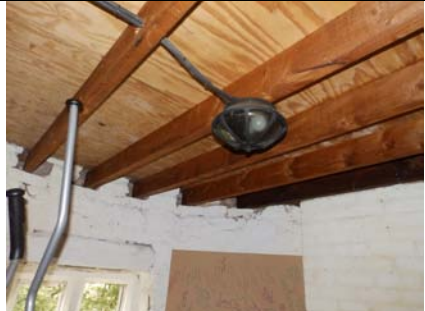
Feature.	Evidence of bats.	Likelyhood of bats roosting.	Photograph.
In splits in timber floor joists.	None.	None. Machine cut timbers.

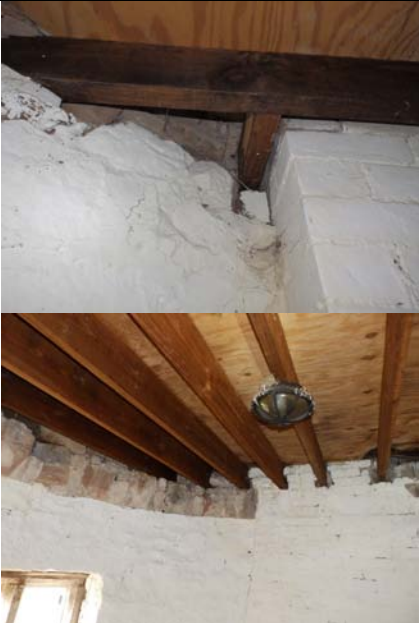
Between end of the floor joist and stonework external wall.	Bat droppings and butterfly wing fragments.	Poor. There is a gap that bats could use and two droppings were found on the floor that could be from bats perching in this area or just flying around the building. The gap is very open and would only be used as temporary roosting by individual bats.

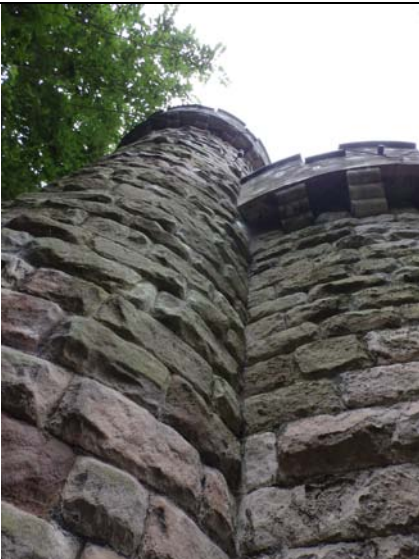
Feature.	Evidence of bats.	Likelihood of bats roosting.	Photograph.
In external gaps in stonework.	None.	None. No gap with access for bats.

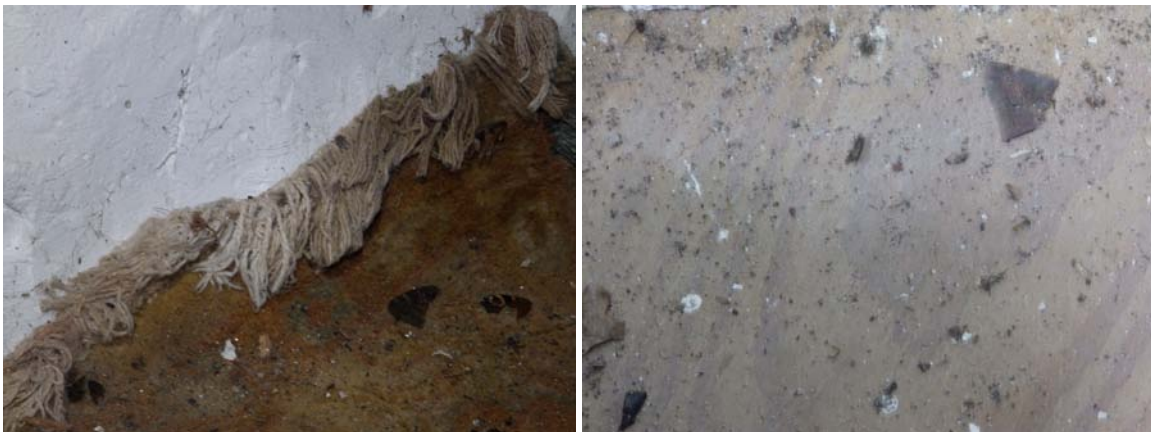
Bat droppings.

At first floor 2 medium sized bat droppings were found on the floor together with a number of butterfly wing fragments.

The bat droppings are most likely to be from a Brown long eared bat that has used the building as a feeding perch.

There was evidence of bats using the dwelling as a place of shelter. The number of droppings is small and the presence of butterfly wings make it most likely that this is a feeding perch. The feeding perch use can be replaced by erecting two bat boxes on adjacent trees if planning

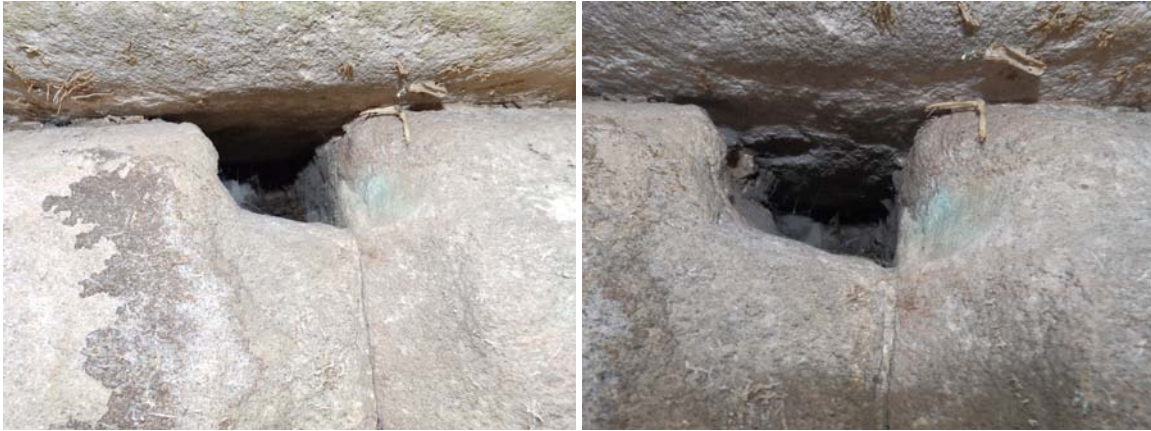
A Wren's nest was found in the only hollow in the external stonework. The young had all fledged when the nest was found and checked.

The change of use of the Folly will affect nesting birds. There must be no disturbance of birds that are nesting. Before any works starts the nesting areas should be checked. If birds are sitting on eggs or there are young birds in the nest then work must be delayed until the young have fledged.

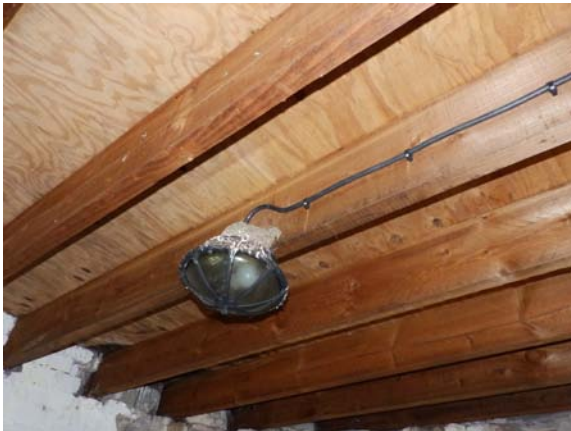
At first floor in the Folly there is a Swallow's nest on top of the light fitting.

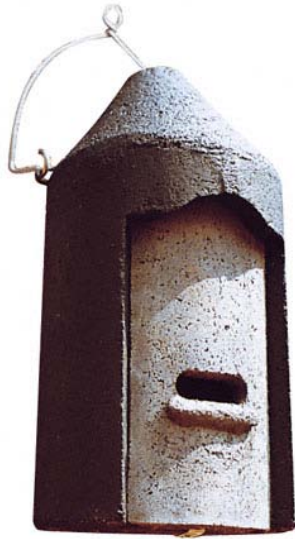
Two Schwegler 2F bat boxes should be erected on adjacent trees at a height of 4-5m above ground level in a location where there are no branches beneath the bat box that could restrict the flight path into and out of the bat box.
