21 HIGH STREET, CHEADLE - PROTECTED SPECIES APPRAISAL

AUGUST 2016

Arc Ecology were commissioned to undertake a Protected Species Appraisal of an outbuilding at 21 High Street, Cheadle, Staffordshire to attempt to determine the presence/absence of any such species within the building prior to a planning application being submitted for demolition of the building.

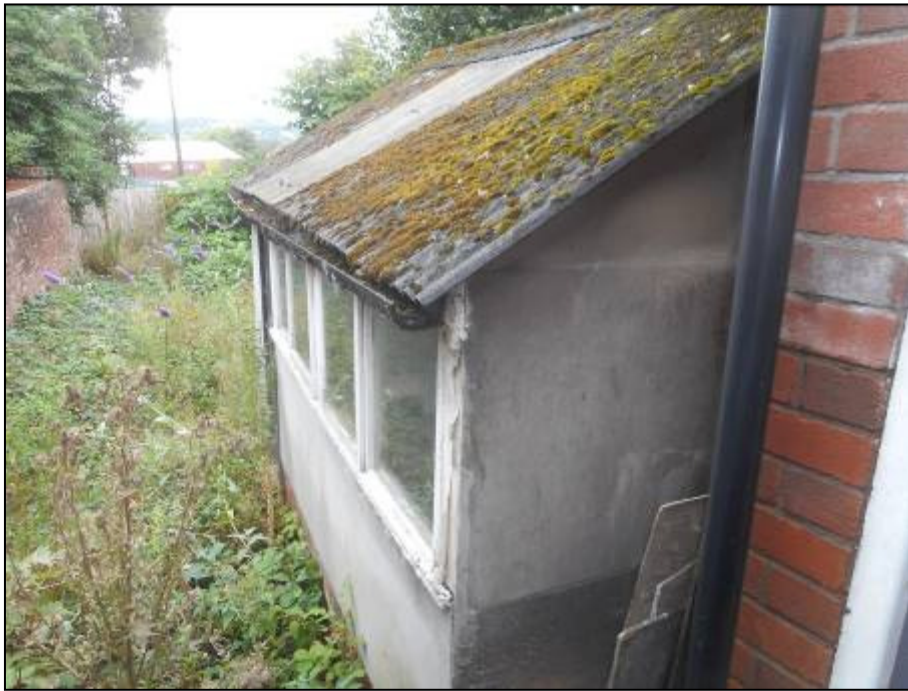
Photograph 1 - View of building from north-east

The building is of brick construction and is predominantly clad with asbestos sheeting. The roof is mainly corrugate asbestos with an area of corrugate plastic covering. Internally there is no roof void and a suspended ceiling is present throughout (see Photographs 1 and 2).

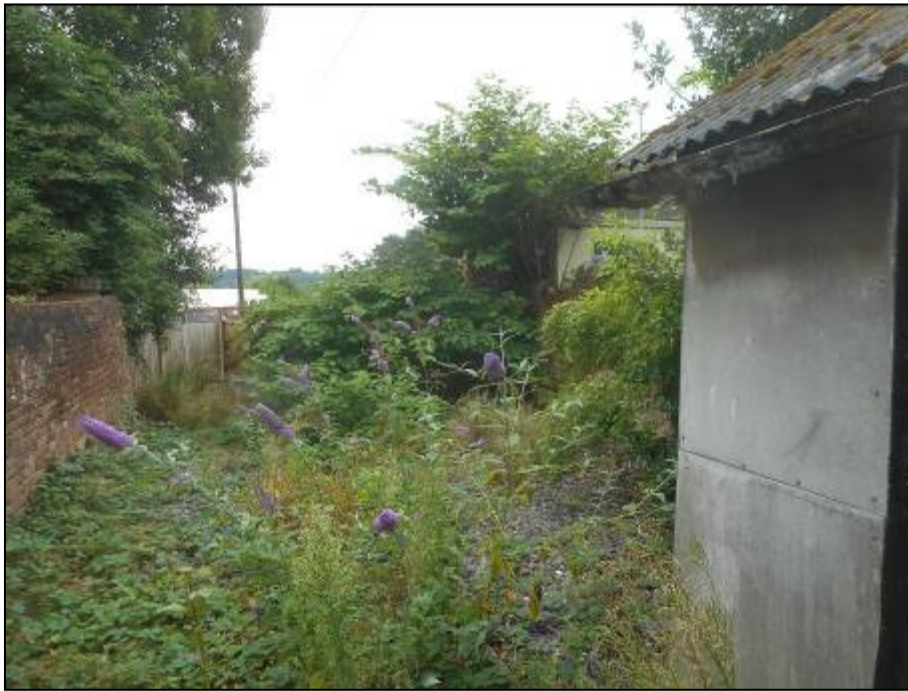
Photograph 3 - Building and area of hard-standing surrounding it

The area of hard-standing surrounding the outbuilding consists of concrete and slate chips with early succession vegetation including creeping thistle (*Cirsius vulgare*), rosebay willow-herb (*Chamerion angustifolium*), cleavers (*Gallium aparine*), nettle (*Urtica dioica*), bramble (*Rubus fruticosus*) and buddleia (*Buddleia davidii*) (see Photograph 3).

Where the site adjoins the neighbouring property in the south-western side of the hard-standing area, there is a stand of the injurious weed Japanese knotweed (*Fallopia japonica*). The plant is also present in the adjoining property (see Photographs 3 and 4).

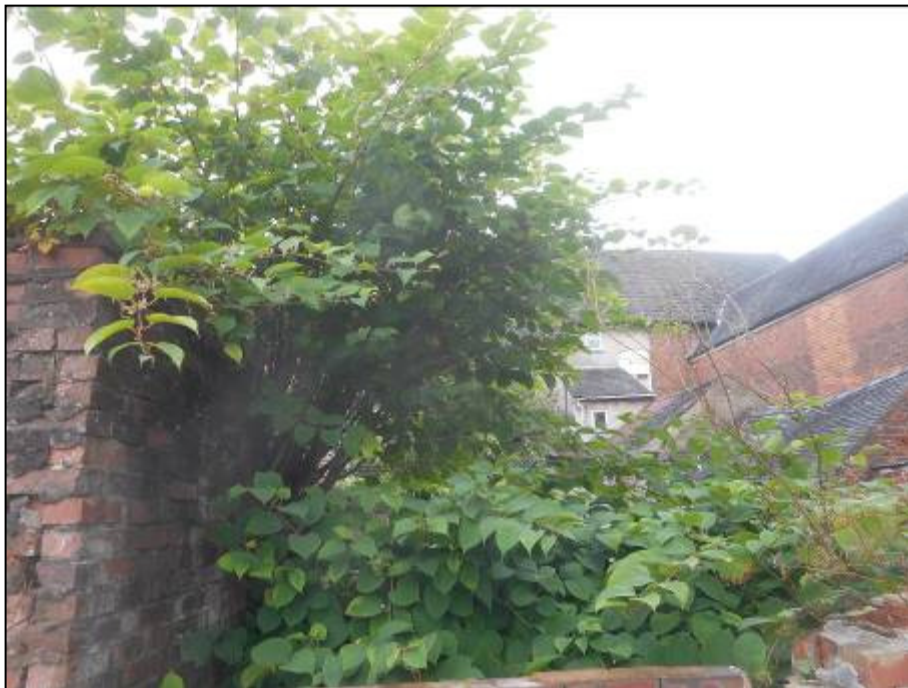
Photograph 4 - Stands of Japanese knotweed within site and adjoining property

There were stands of Japanese knotweed present both within the site and also in the adjoining property.

The total size of the stands was estimated to be 5m x 5m (25m²).

All treatment for this species should be undertaken by a company specialising in removal of Japanese knotweed, and all works in the area should be avoided until such time as the treatment is completed to avoid spreading of plant material.

- Stands of Japanese knotweed were found within the site and within the adjoining property. Advice should be taken from a company specialising in the treatment of this species on how best to remove it and works in the area should be delayed until treatment of the plant is complete.
