BAT SURVEY REPORT

**STAFFORDSHIRE FARMERS SITE
CHEADLE ROAD, CHEDDLETON**

SEPTEMBER 2016

Project Name	Staffordshire Farmers Site, Cheadle Road, Cheddleton
Project Number	C117
Document Name	Bat Survey Report
Author	Eleanor Weir
Version	01
Date of issue	21/09/16

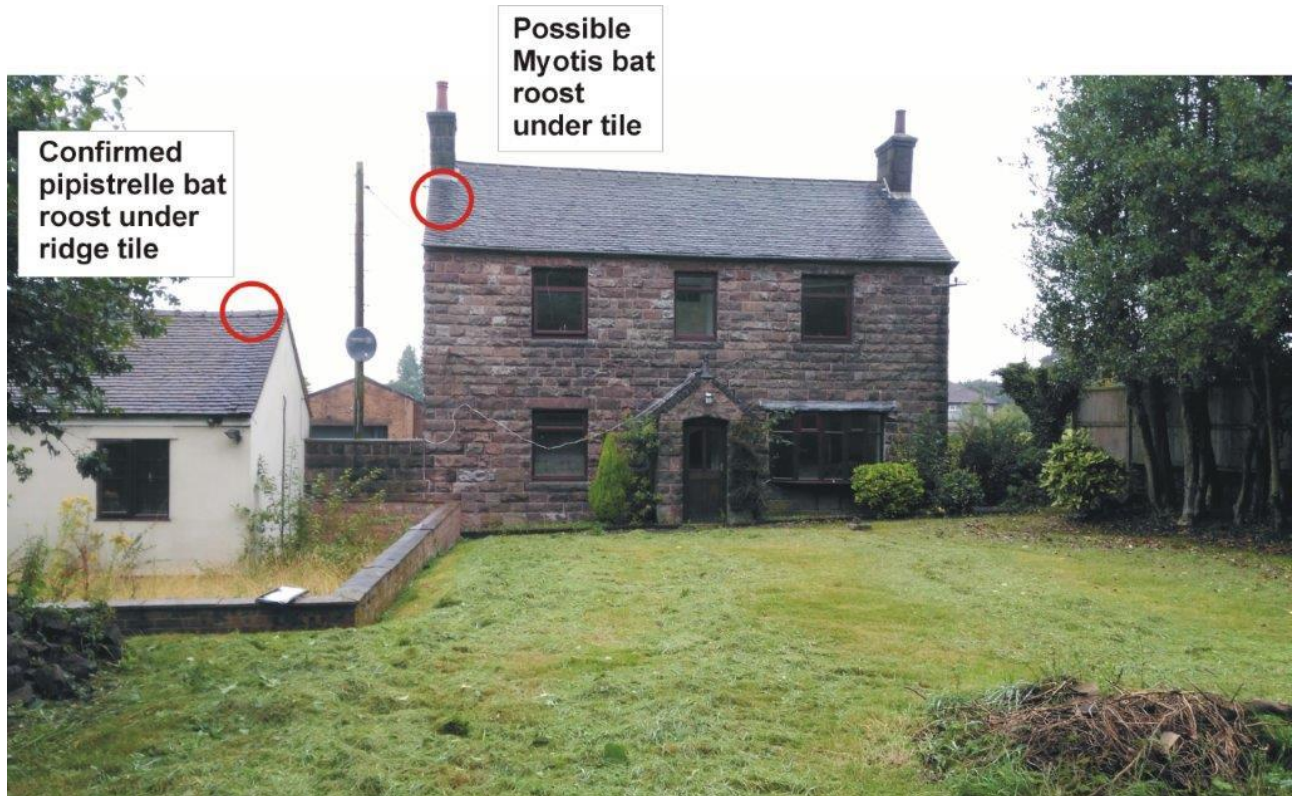
The dusk emergence survey of the house undertaken on 28 August 2016 recorded a *Myotis* species of bat which appeared to emerge from near to the western chimney as it flew from this direction of the roof at 51 minutes after sunset. The other surveyor did not record the bat, suggesting it did not fly over the top of the roof but more likely emerged. Bat activity was occasional during this survey, despite suitable conditions, and was limited to occasional passes of commuting common pipistrelles *Pipistrellus pipistrellus*.

A dawn survey of the office building was undertaken on 29 August 2016. A pipistrelle species (echolocating at 50 KHz so either common pipistrelle or soprano pipistrelle *Pipistrellus pygmaeus*) was recorded flying around the eastern end of the office building before returning to roost via a gap under a ridge tile on the eastern end of the building at 34 minutes before sunrise.

Plate 1: South aspect of the house (Building 1) and offices (Building 2) showing bat roost locations

The house (Building 1) appeared to support a roost for a *Myotis* species of bat. The offices (Building 2) were found to support a roost for a pipistrelle species of bat (either common or soprano pipistrelle).

- The roof of the house and offices should be soft-stripped by hand prior to any demolition, under supervision of a licensed bat worker to ensure tile removal proceeds sensitively and to transfer any bats found to the bat boxes.

- Permanent replacement roosting opportunities suitable for *Myotis* species and pipistrelle bats should be provided in a new build. These could be:
 - Creating a small gap (20mm x 30 mm) under ridge tiles or end tiles of either a house or garage, to allow bats to roost between the underfelt and tiles (in which case traditional bitumen felt Type 1F must be used);

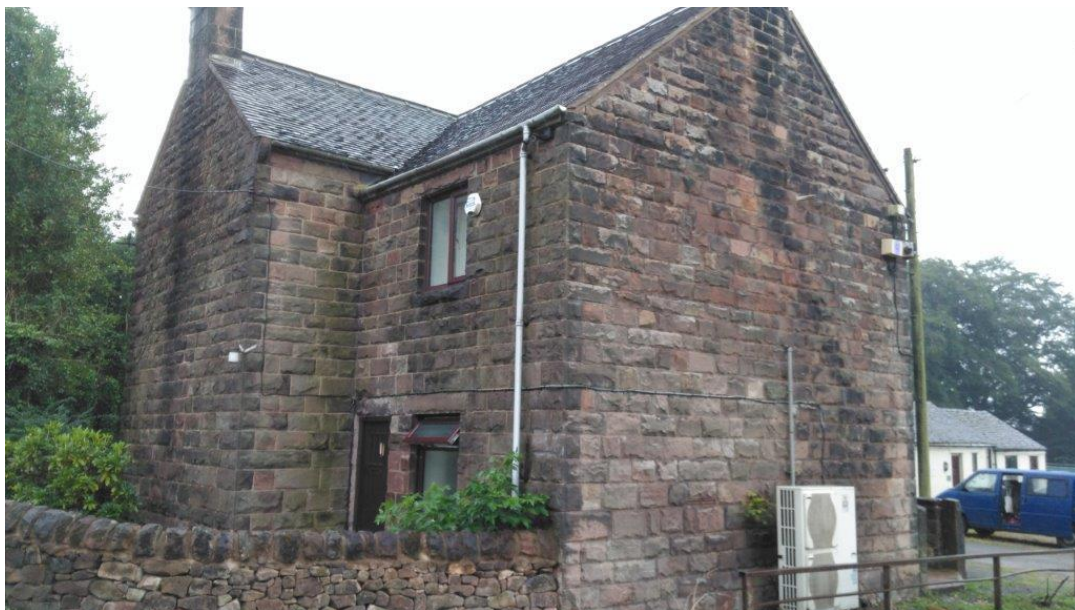
Building 1 was a two-storey house which was occupied at the time of survey. The house was constructed of stone with a pitched clay tile roof. The roof space was insulated at roof level, with thick fibreglass insulation between the rafters, creating a warm and draught-free roof space. Consequently, there were few potential access points noted into the roof space. The floor was relatively clean and the ridge was heavily cobwebbed. No evidence of bats was found inside the roof space. Externally, the ridge appeared well sealed. There were several gaps noted under lifted tiles on the south and north sides of the roof. No evidence of bats was found externally. The building was assessed to have **Moderate** potential for roosting bats.

Plate 2: North and east aspect of house which was well lit by sodium lighting at night

- Incorporating at least two bat boxes into a south or west facing gable wall (e.g. Schwegler 2FR bat tube).
- Any lighting planned for the development will need to be approved by Natural England. Some species of *Myotis* bat are particularly sensitive to artificial lighting. Security lighting will need to avoid illuminating the roof / access points and any other lighting will need to be limited and of sensitive design (e.g. low wattage, downward pointing, timed motion sensors).

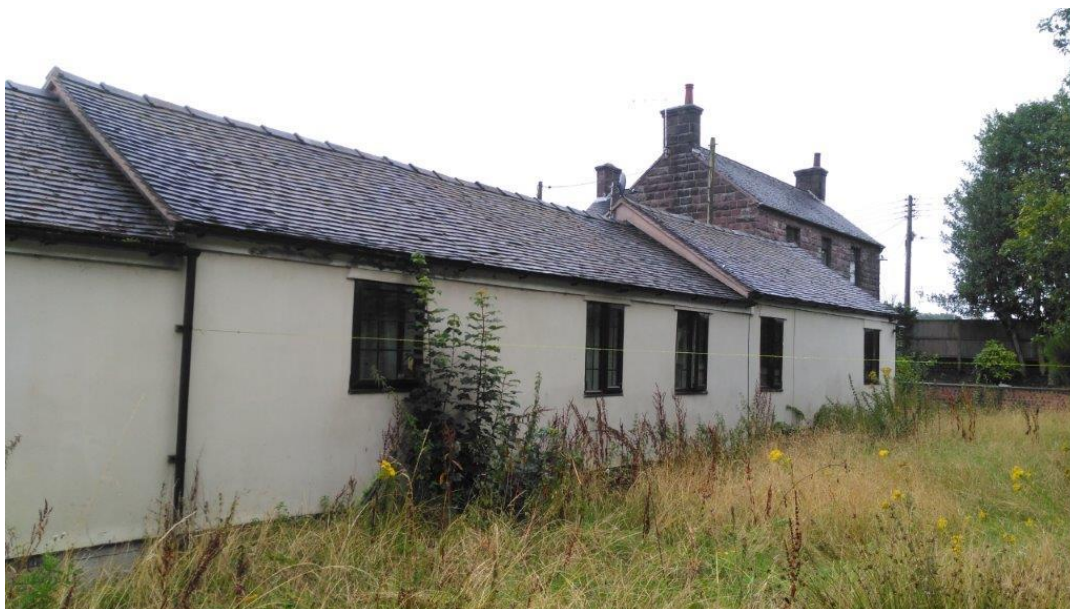
Building 2 was a single storey building split into three office units which a stepped roof line suggesting there was not a continuous roof space present. The west end of the building could be accessed, and this was a boiler room which was open to the roof showing a breathable membrane was present below tiles. No evidence of bats was found in this area. The other two units were not accessible for inspection inside and it is not known if roof spaces were present in those areas of the building. Externally the building had several gaps under ridge tiles and tiles on both the north and south side of the building. No evidence of bats was found externally. The building was assessed to have **Moderate** potential for roosting bats.

Plate 3: South side of office building showing stepped roof line

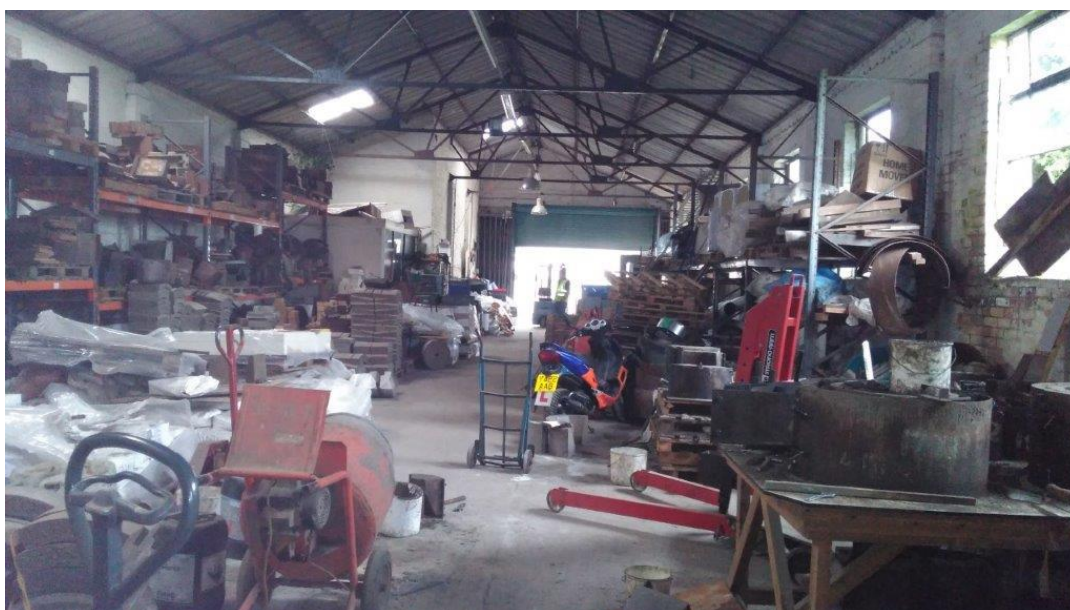
Building 3 was a large storage warehouse with brick walls and a corrugated asbestos / concrete roof. The building appeared regularly used for storage at the time of the survey. There were windows along both sides of the building, and two of the windows on the west side were unglazed allowing potential flight access inside the building. There was a suspended ceiling creating a smaller room at the north end of the building. The building was very light and airy inside, and there were no crevices noted which could support a bat roost either internally or externally. No evidence of bats was found inside or outside of the building. The building was assessed to have **Negligible** potential for roosting bats.

Plate 4: View inside warehouse (Building 3) showing lack of suitable roost features and assessment of 'Negligible' potential for roosting bats.

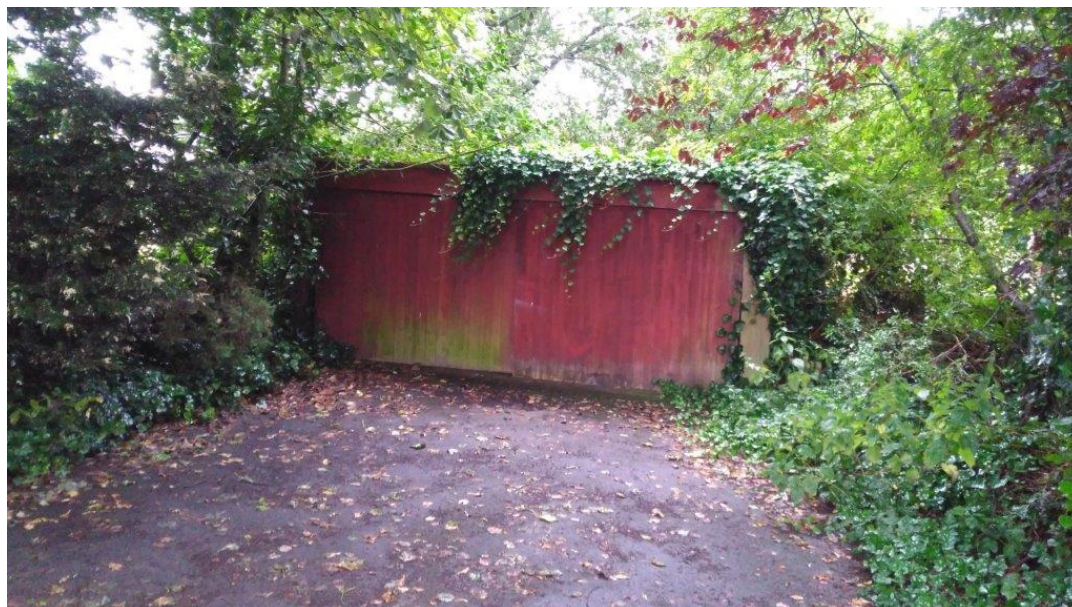
Building 4 was a small wooden shed / garage which had a flat corrugated asbestos /concrete roof. The building was covered in ivy and surrounded by scrub, and was completely full of stored items so access inside was difficult. No uncluttered roosting crevices were observed. The building was assessed to have **Negligible** potential for roosting bats.

Plate 5: Wooden garage / shed (Building 4) filled with stored items and covered with ivy and cluttered with scrub and trees.
