Gatehouse Cottage,
Kingsley Road,
Cellarwood,
ST9 0DJ,

Report number: James/16-001

Bat Scoping and Nesting Bird Survey Report

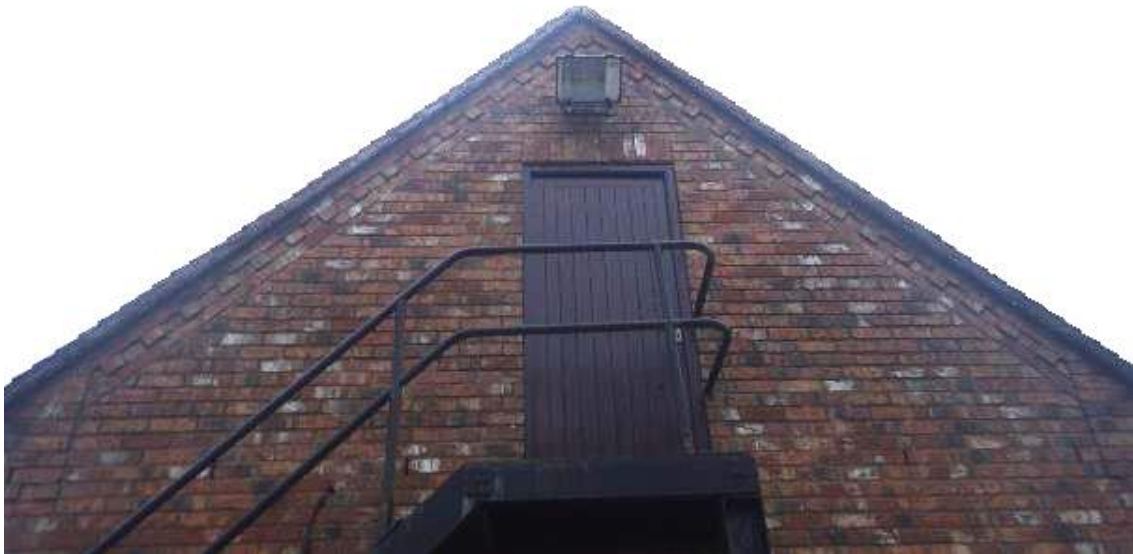
Fig 2. The gable end of the building is well pointed, and sealed with no potential crawl holes or gaps to be used as a bat roost point.

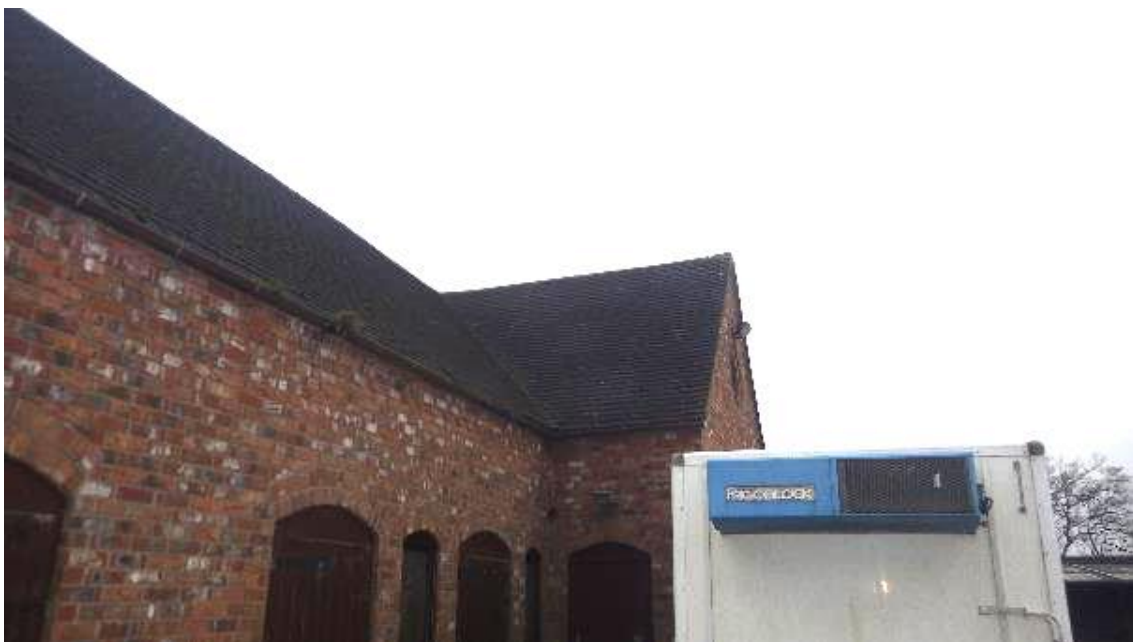
Fig 3. The roof is in very good condition with no slipped or missing tiles, the ridge is in good condition and well sealed.

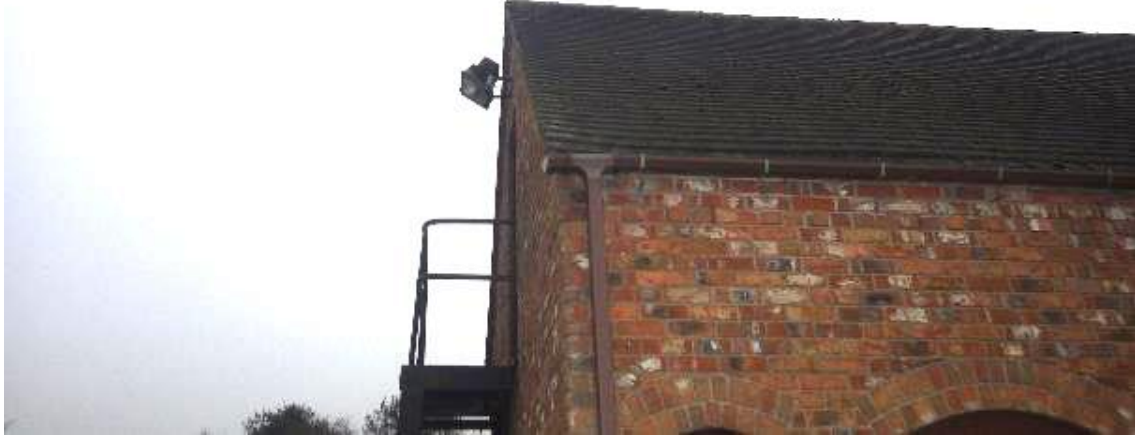
Fig 4. The building has no soffits or bargeboards; the roof/wall join is well sealed with no gaps.

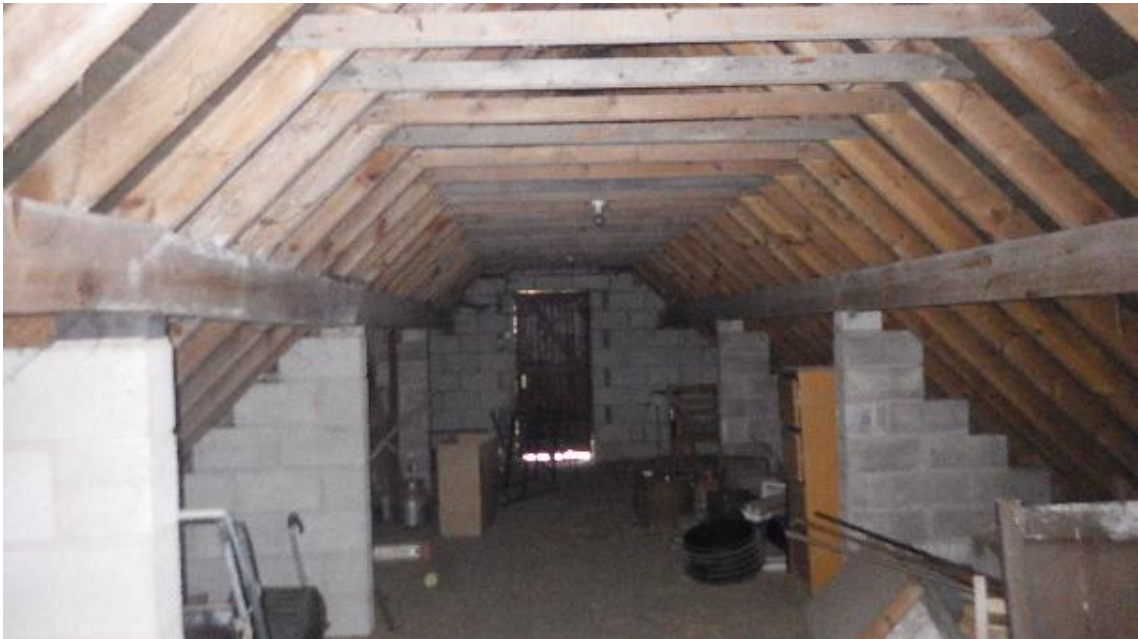
Fig 5. The underside of the pitched roof of the barn building, the roof is open and supported via a wooden A frame and roof truss configuration; this leaves little potential for bats to roost.

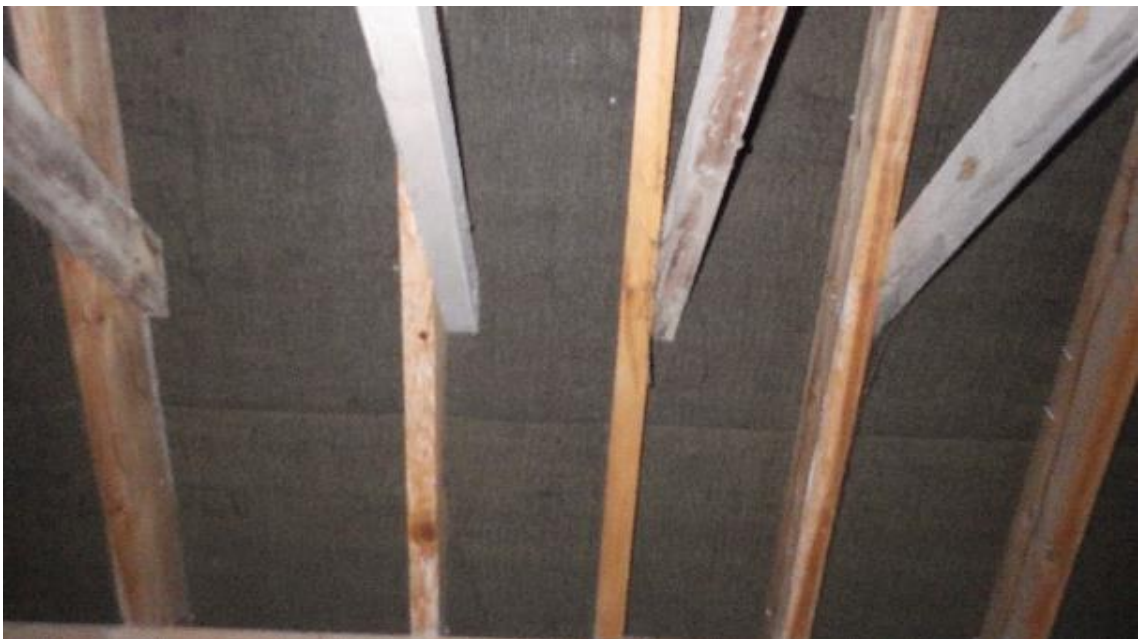
Fig 6. The underside of the tiled roof is lined with a felt membrane, which is in good condition with no tears or holes.

- The building inspection surveys recorded no signs of bat usage or presence within the target building.
- Therefore, it is recommended that the building conversions can proceed.
- Given that the building has felt roof lining fitted, it is suggested that the new build has bat friendly roof membrane installed.

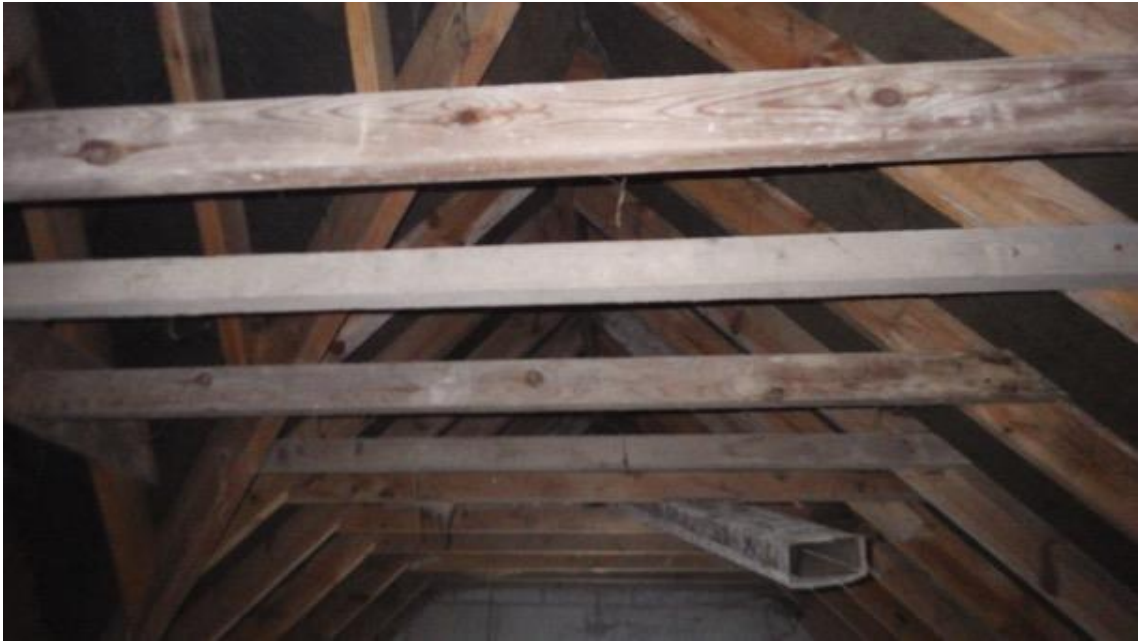
Fig 7. Wooden beams, which are supported by the external walls, support the roof; the joins are well sealed with no gaps or cracks.

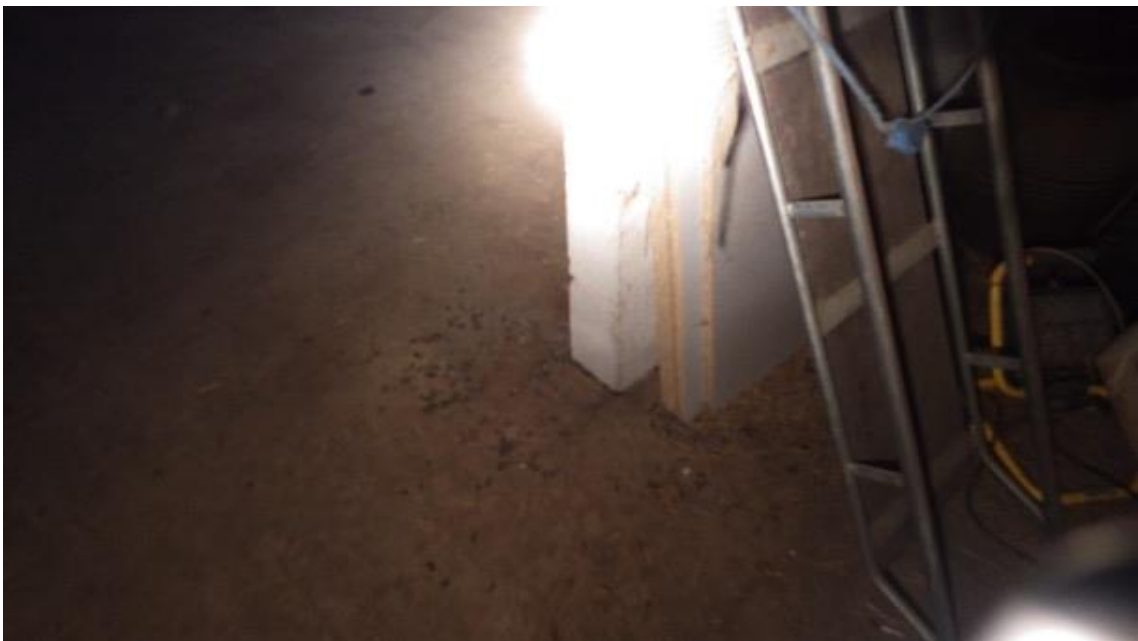
Fig 8. Some mammal droppings were found on the upper floor of the barn, these were closely examined and concluded that they emanated from brown rats *Rattus norvegicus*.

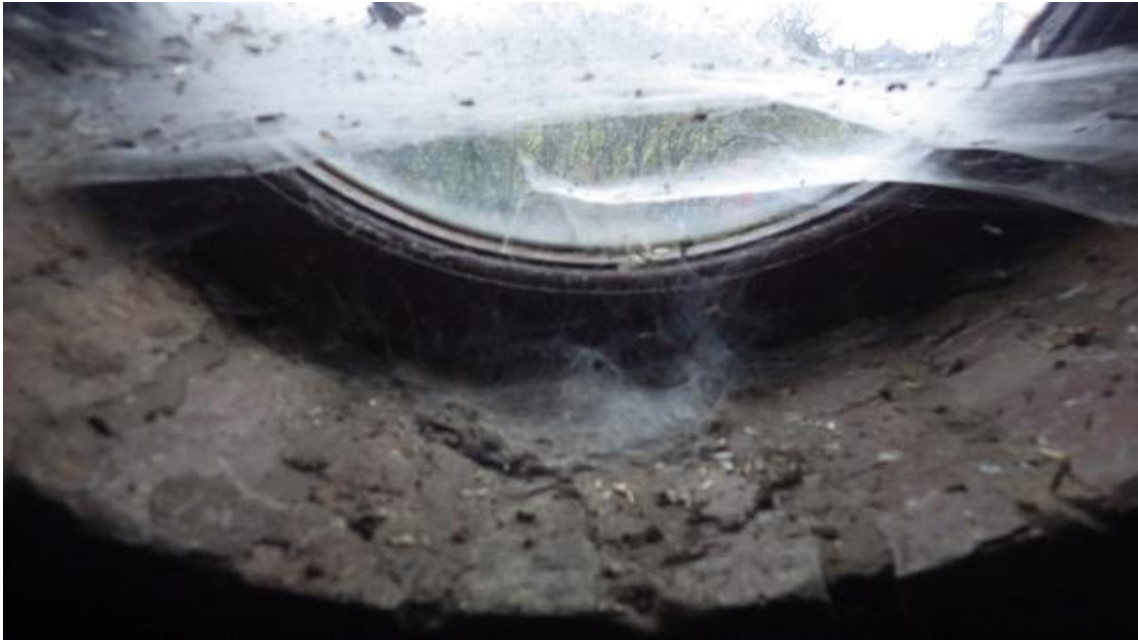
Fig 9. All flat surfaces were checked for bat droppings, including the cobwebs

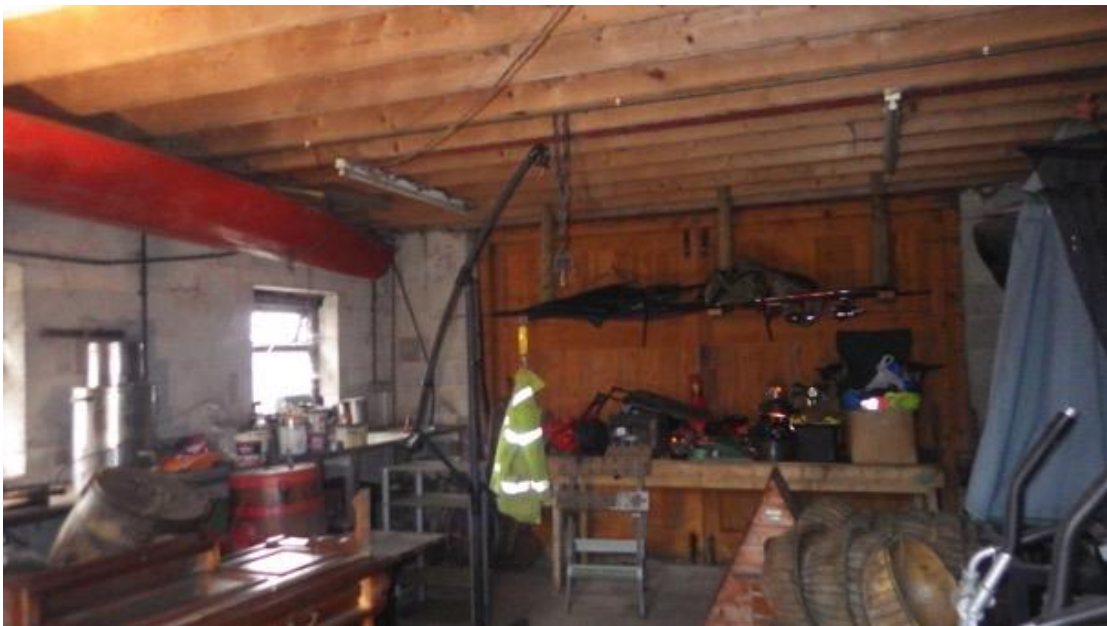
Fig 10. The ground floor is segregated into a smaller stable sections, no signs of bats or nesting birds was recorded during the survey.
