**LAND AT HURST QUARRY, BIDDULPH,
STAFFORDSHIRE -**

**DAYTIME BAT & DAWN RE-ENTRY
SURVEYS**

OCTOBER 2016

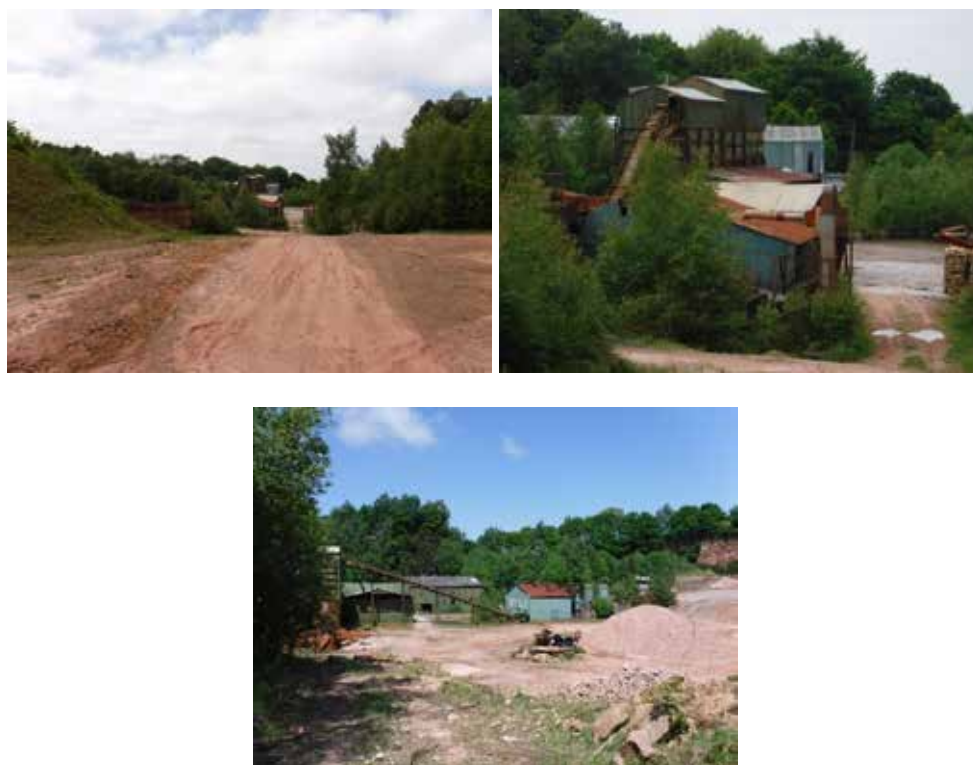
- 1.5 The site comprised a disused sand quarry and associated quarry processing buildings and work sheds.

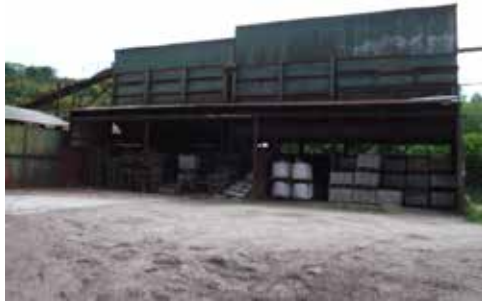
Building B01

- 1.7 This was a two-storey steel framed and corrugated sheet metal clad building. The ground floor was used as an open storage area. The first floor was enclosed with walls with the roof clad in corrugated metal sheets.

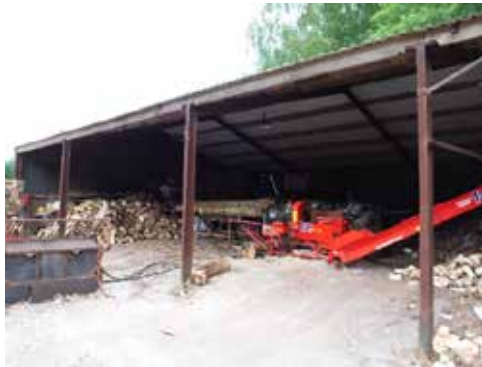
Building B02a

- 1.8 This building was a long steel framed single storey shed clad with corrugated metal sheets but open along its entire frontal elevation.

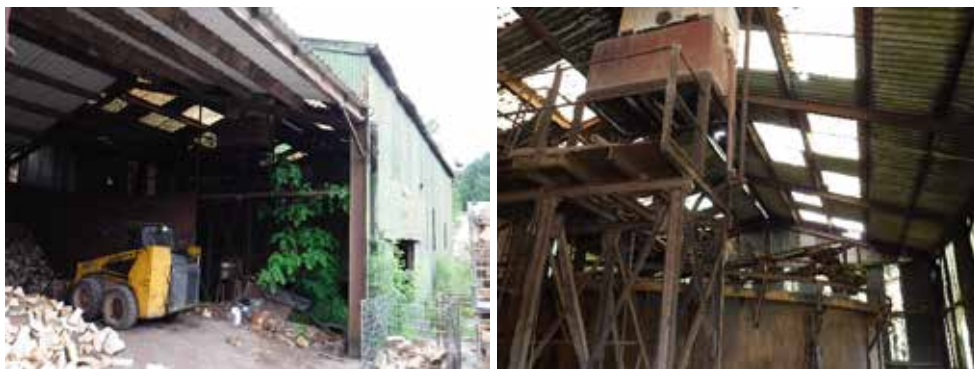
Building B02b

- 1.9 This building was a large single storey corrugated sheet metal clad shed.

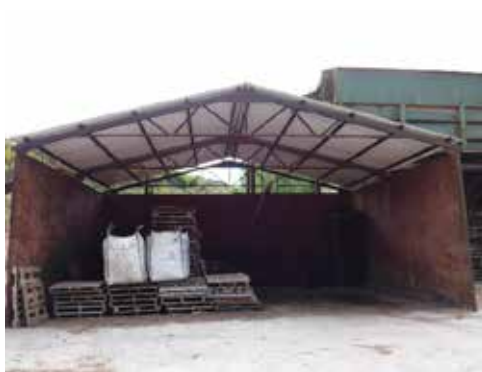
Building B03

- 1.10 This was a steel framed single storey open fronted shed which had partially clad walls.

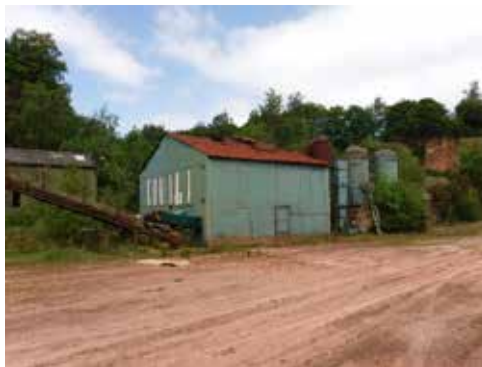
Building B04

- 1.11 This steel framed single storey shed was clad in corrugated sheet metal..

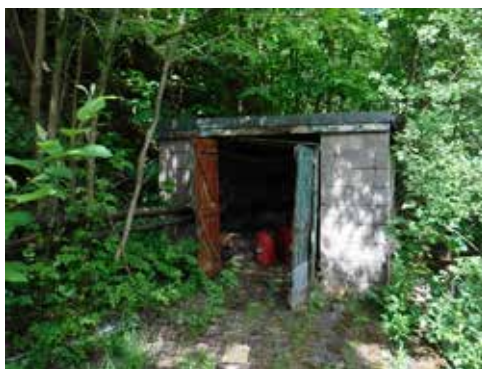
Building B05

- 1.12 This building was a small single storey block built pump house adjacent to a reservoir. It had a flat felt covered roof that was in a poor condition.

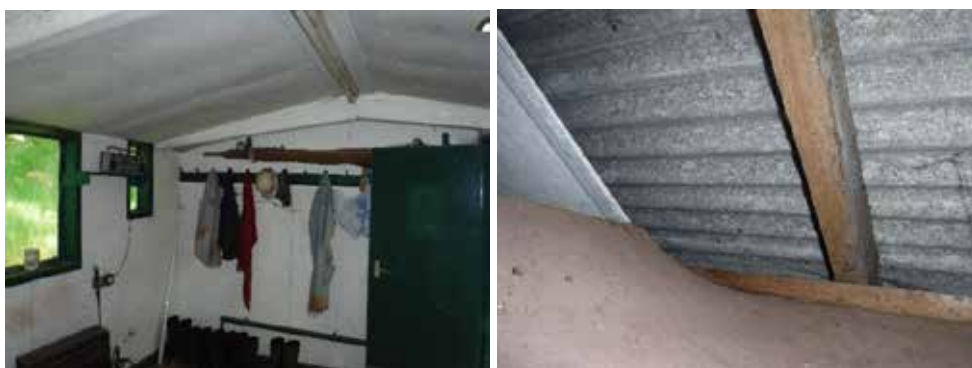
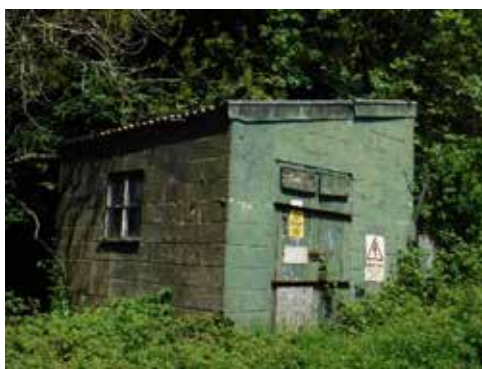
Building B06

- 1.13 These two small buildings were located on a small rise above the entrance to the site. These buildings had corrugated asbestos sheet roofs.

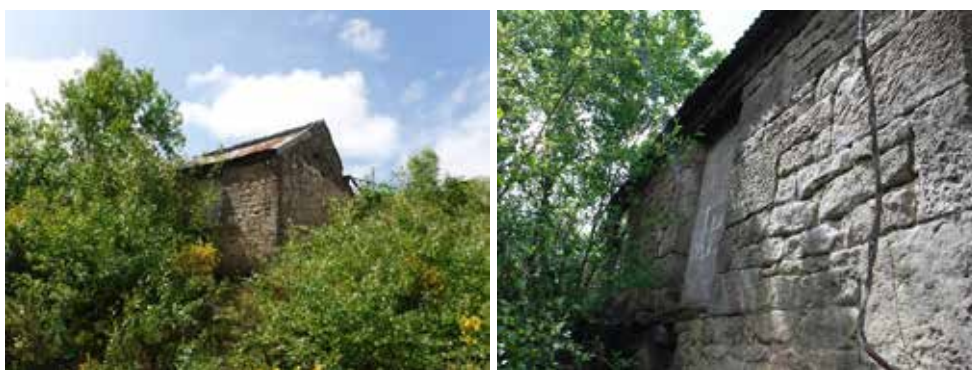
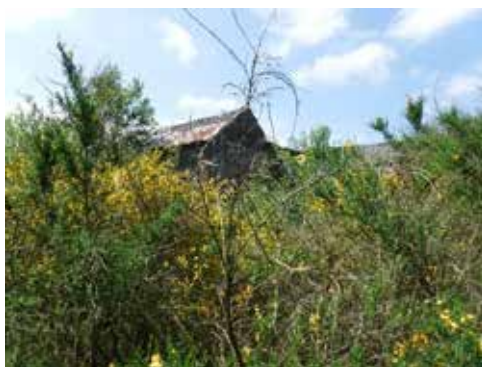
Building B07

- 1.14 This was a tall building built of stone which was in a poor state of repair.

- 7.4 The only building of a traditional construction was B07. This was made of stone with a corrugated sheet metal roof. However given the state of disrepair, this building is considered to only have moderate potential which is largely due to the number of cracks and crevices in the stonework which may offer hibernation opportunities.

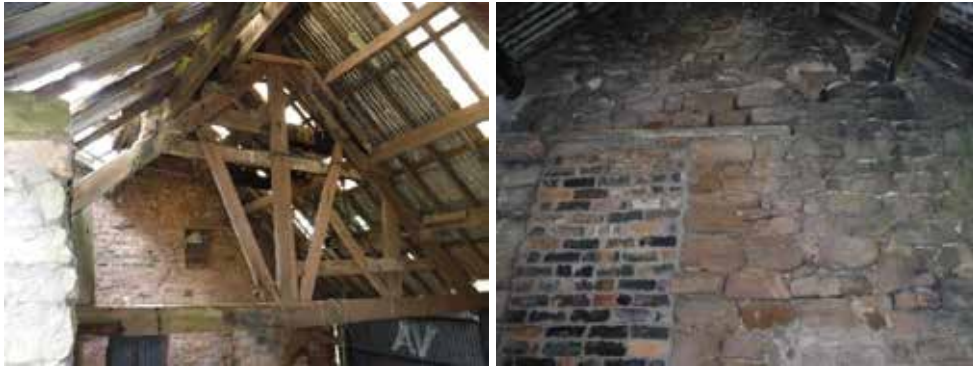
- 1.15 There was a part corrugated sheet metal/corrugated sheet asbestos/tile roof and a loft floor in one area.

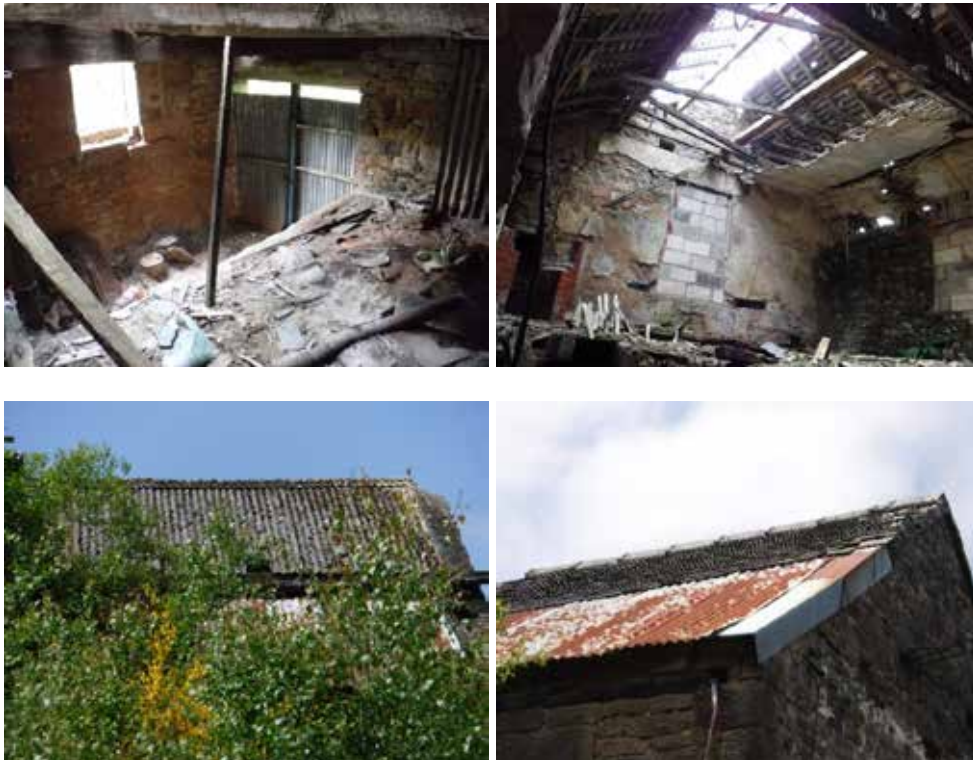
- 1.16 Only part of the building could be accessed due to the unsafe nature of the structure.

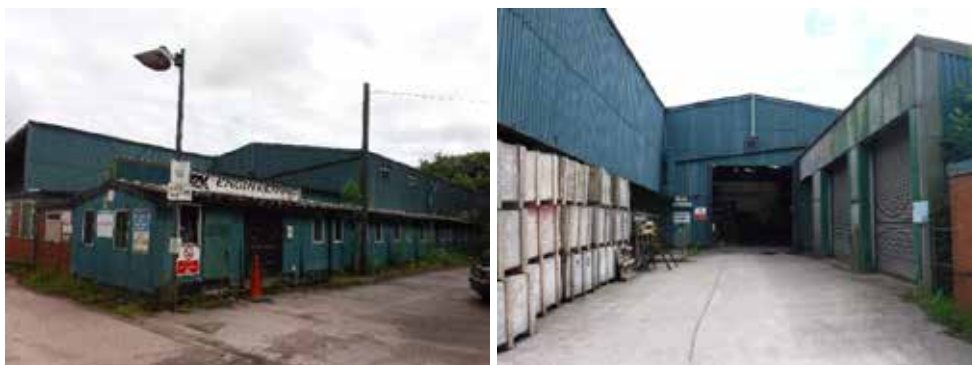
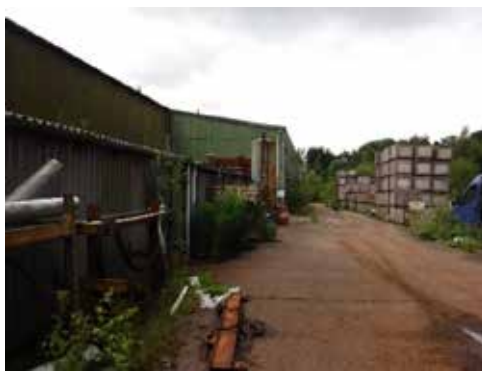
Building B08

- 1.17 This building comprised a number of large metal clad engineering sheds at the entrance to the site.

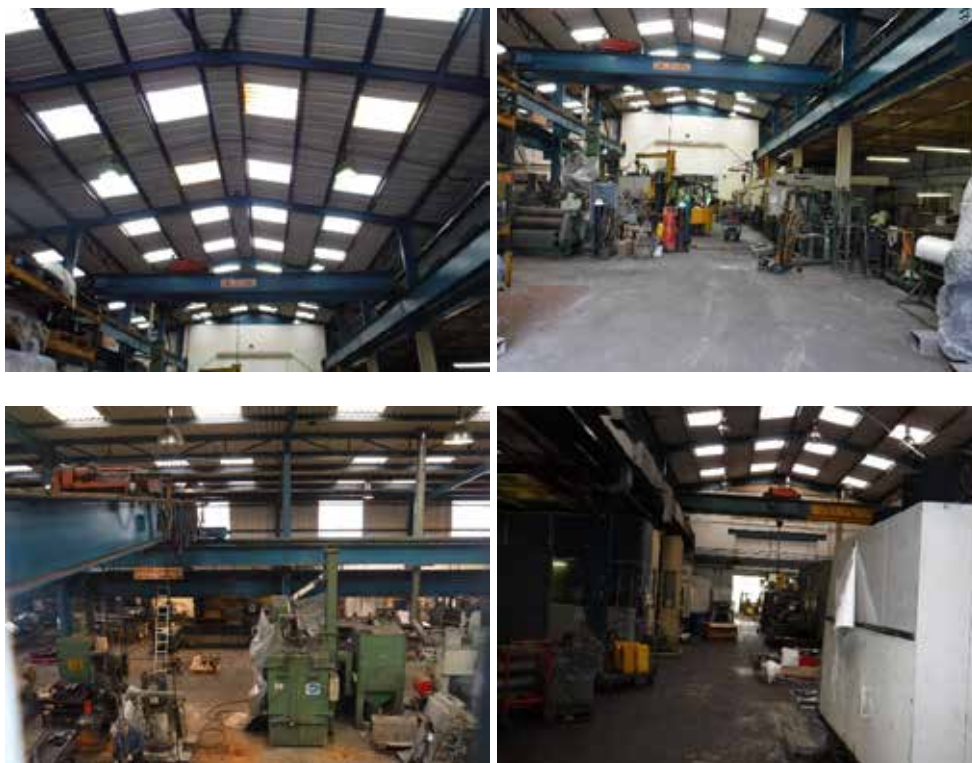
- 1.18 Internally the sheds were open from floor to roof and there were skylights in the roof. They were in use as an engineering works.

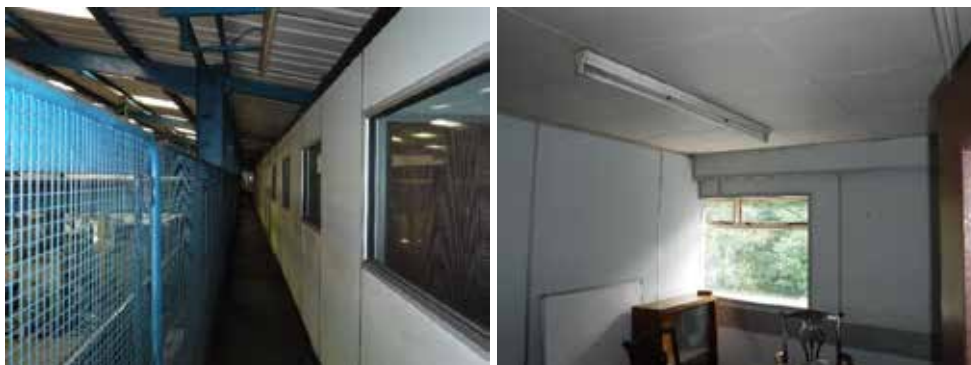
- 1.19 There were no roof voids but there was a mezzanine floor with former offices situated along one side.

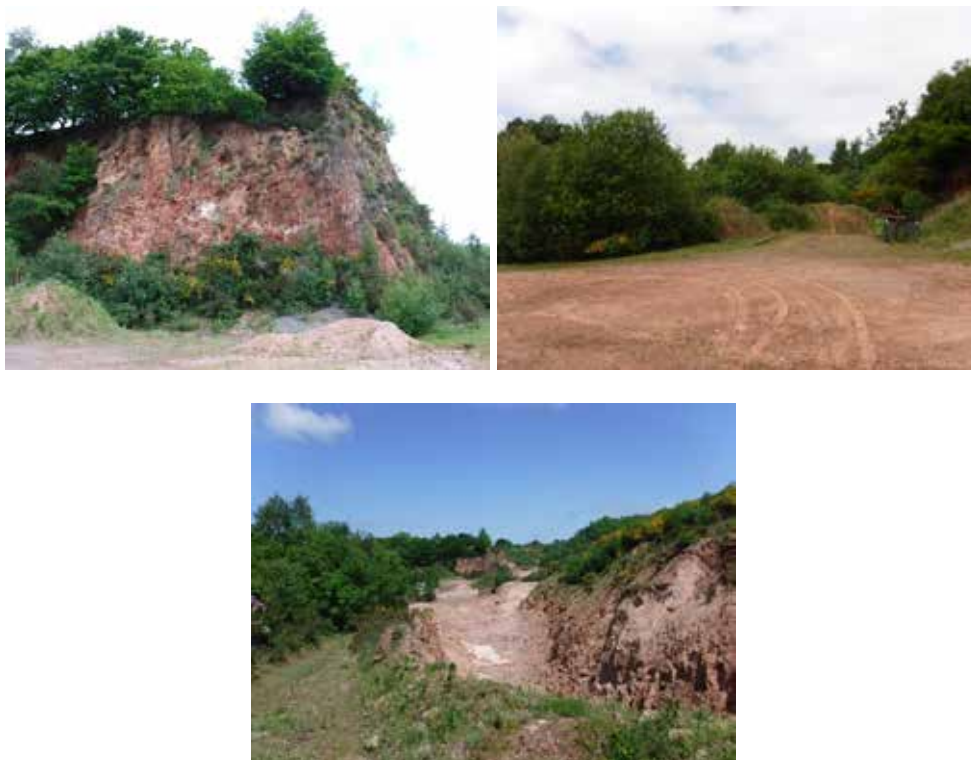
- 1.20 The 13.6 hectare quarry site is a former sand quarry bounded by steep slopes to the south and farmland to the north. Hurst Road bounds the site to the south west and there are sheer cliffs along part of the western boundary.

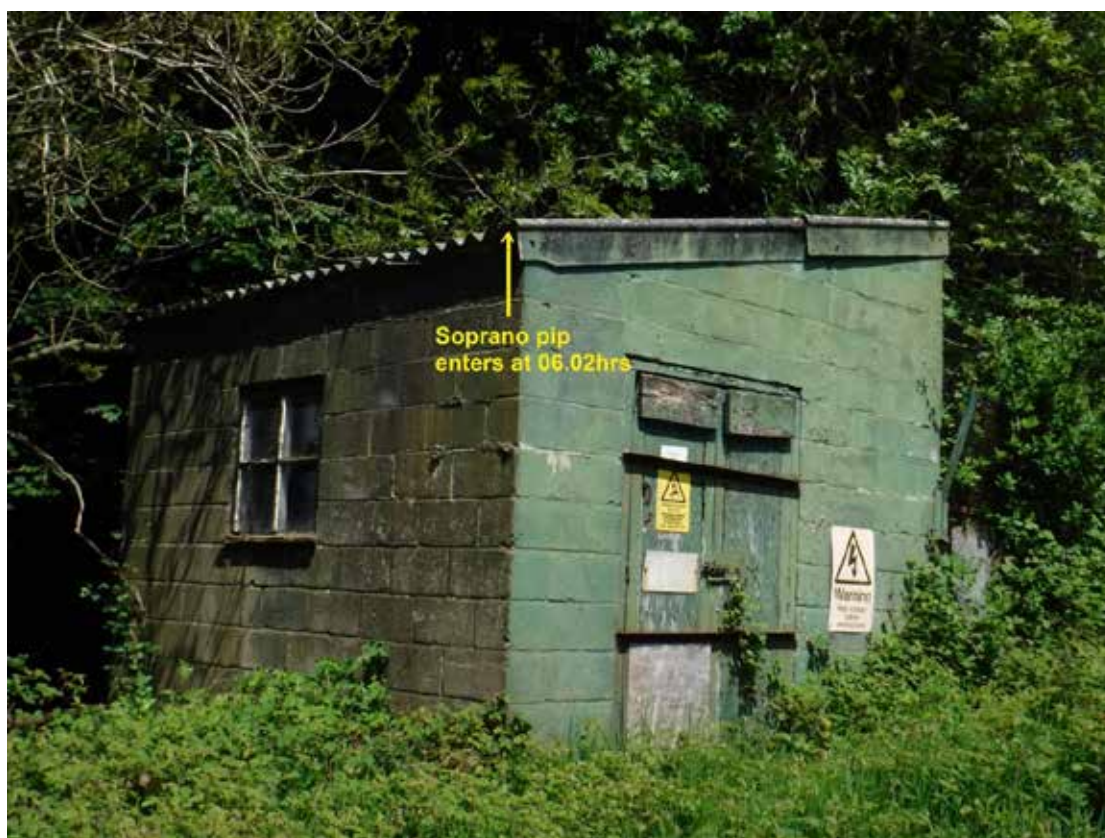
- 7.5 The only bat seen to enter any of the buildings on site during this dawn survey was a soprano pipistrelle that entered one of the buildings of B06 at 06.02hrs as depicted in the annotated photograph below.

- 7.6 This building is an electrical sub-station (or similar) and could not be entered.

- 8.1 Only a single soprano pipistrelle was seen to enter one of the buildings (the electricity building) at B06. This building is not typical of a bat roost site but any machinery inside may have made the building particularly warm. It is considered likely to be used only occasionally.

- 9.1 Whilst most of the buildings on site are considered to have **low** potential this categorisation does not mean they have **no** potential.
- 9.2 During the dawn re-entry survey a single soprano pipistrelle was seen to enter the electricity building at B06. Whilst this is an unlikely site for significant roosting it does show that this and other buildings could provide day roost sites for individual or low numbers of bats.
- 9.3 Bat activity surveys around the site are already being conducted to determine the nature of general bat usage (foraging and commuting) around the whole site.
